123 Main St Lot 45, Leesburg, VA

Prepared by House Inspection Associates LLC VA/DC/MD: 703 453-0442

January 19, 2018

The following items were found during a pre-drywall inspection.

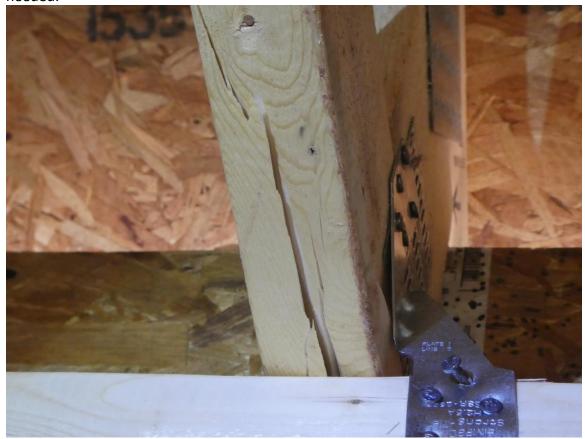
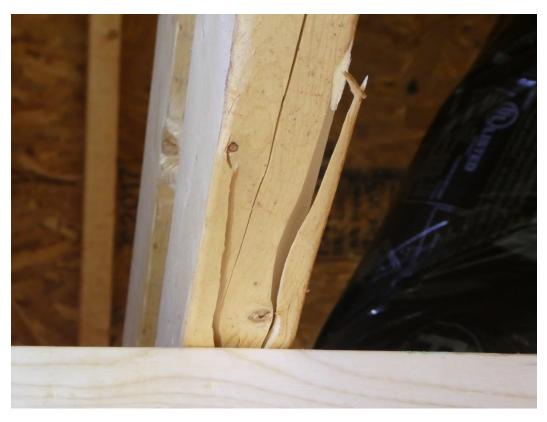
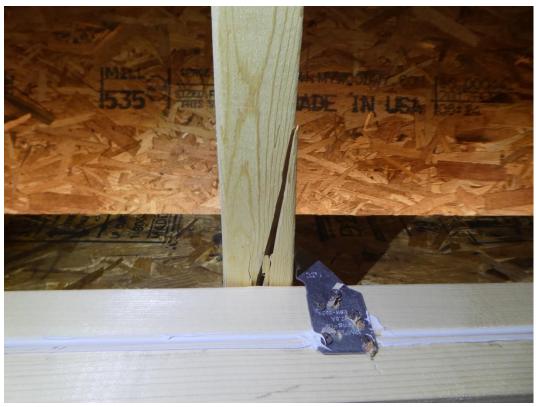
Damaged bottom chord of a truss in the front bedroom on the left side, A licensed structural engineer should be consulted to make further evaluation and repairs as needed.

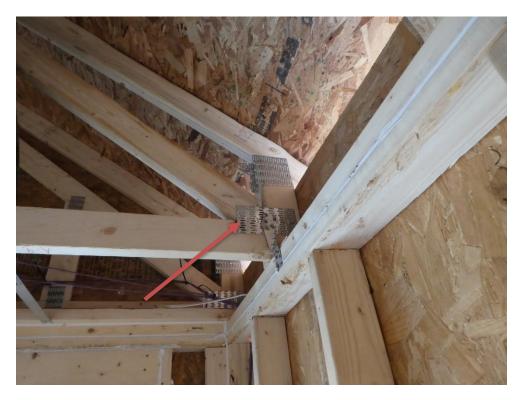
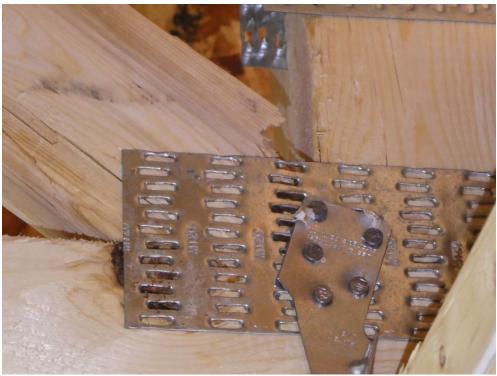
Damaged lumber of a truss in the gusset plate connection in the master bedroom

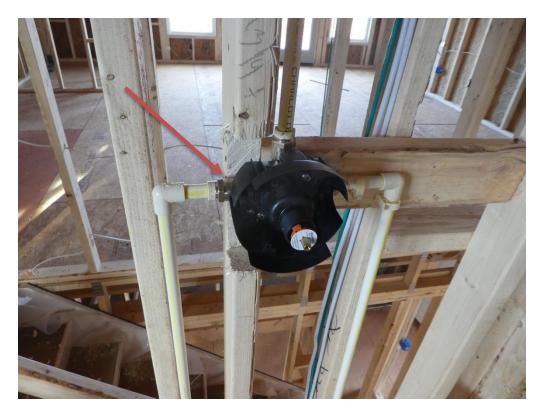
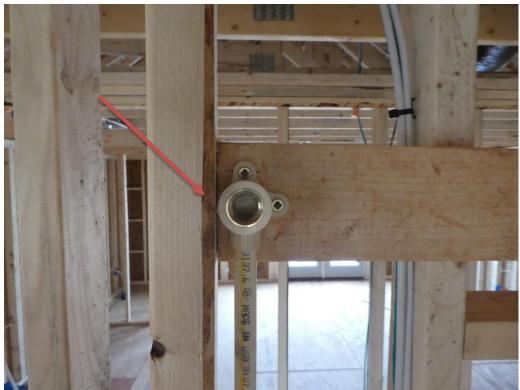
Poorly secured plumbing in master bathroom

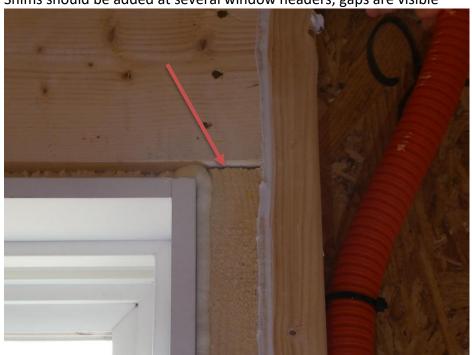
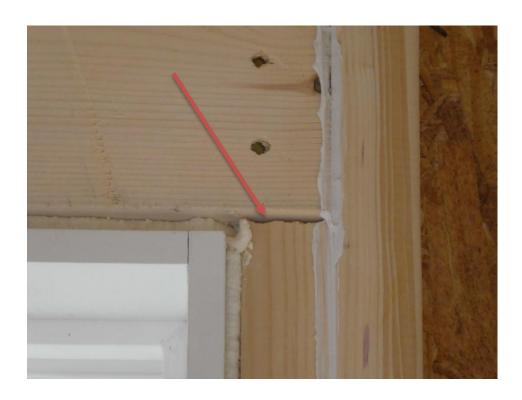
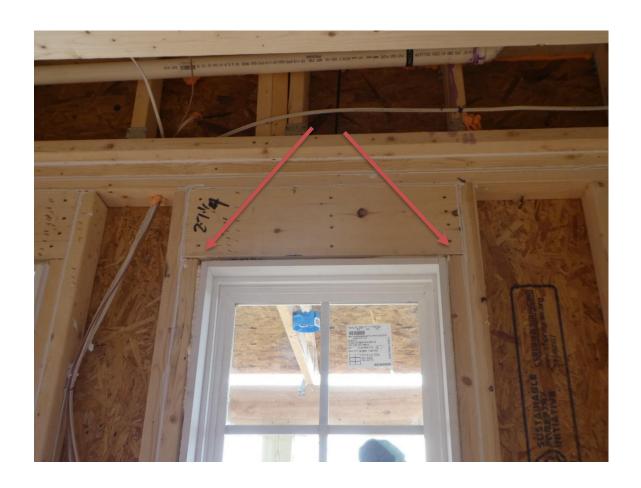
Shims should be added at several window headers, gaps are visible

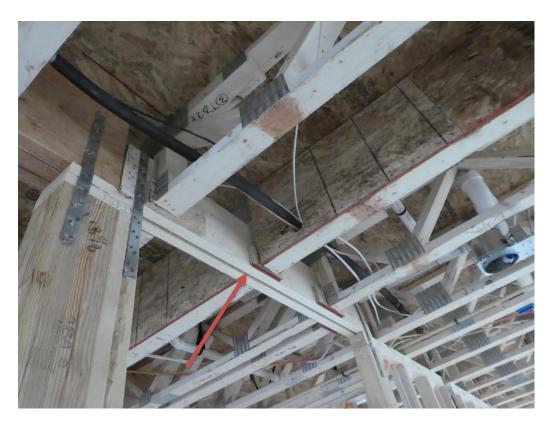
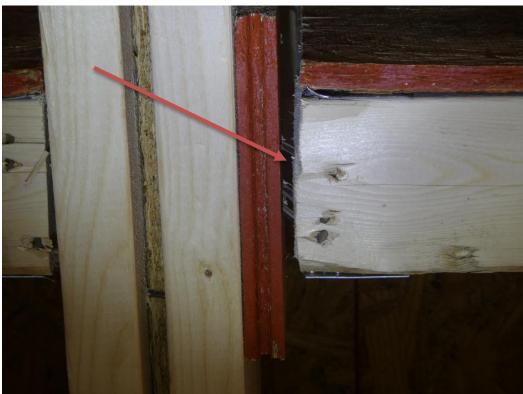
Shims at trust joists on the main level appear to be under-sized, gaps are visible

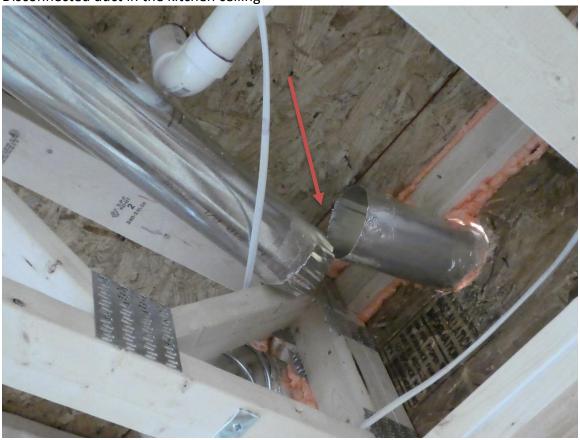
Disconnected duct in the kitchen ceiling

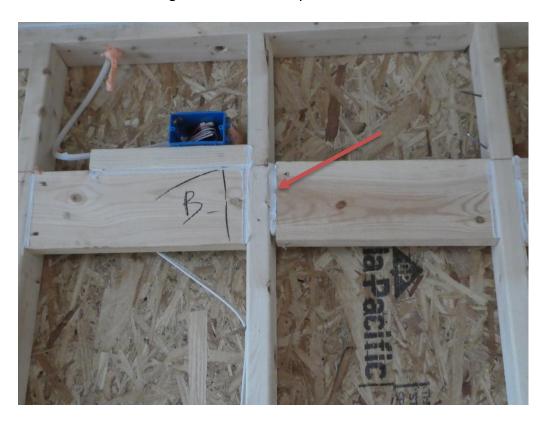
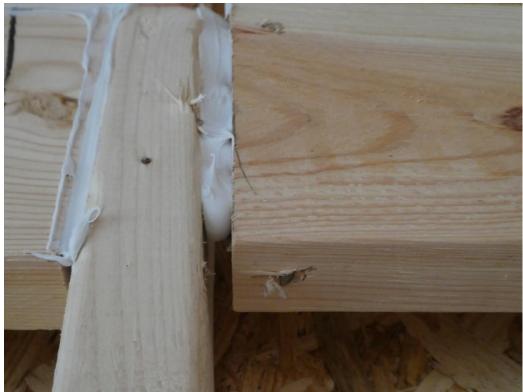
Kitchen cabinet blocking is too short and my result in a future movement

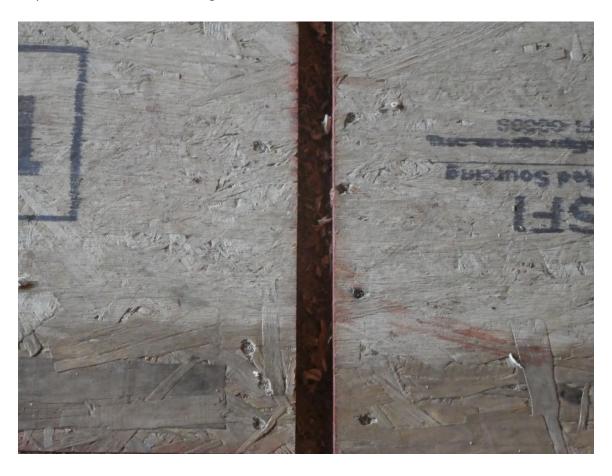
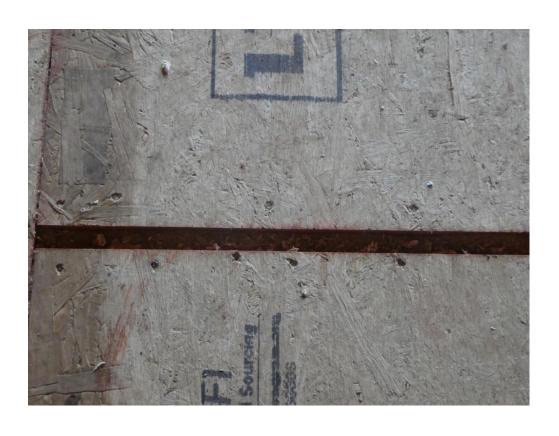
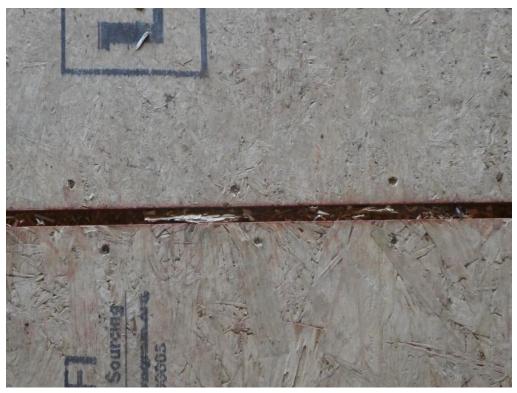
Gaps are noted at floor throughout

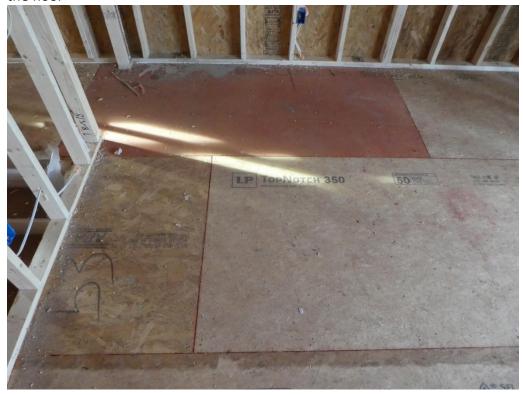
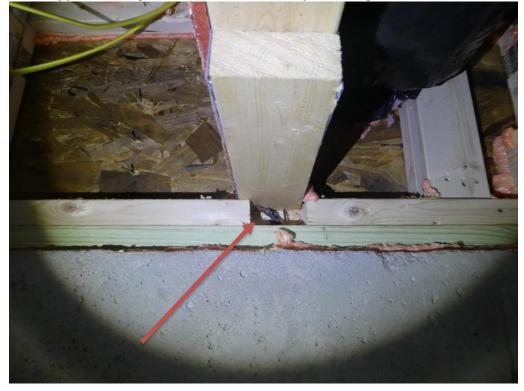
Ask Builder why there are three different kinds of plywood in the master bedroom on the floor

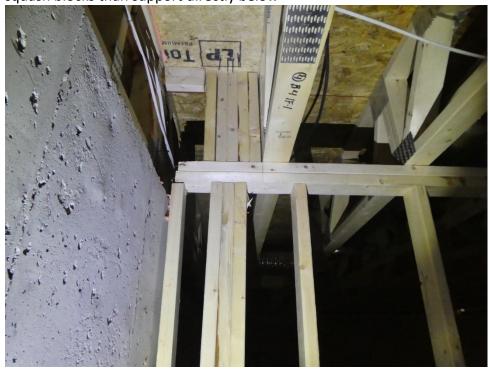
Load transfer appears to be under sized at the front basement wall, there are more squash blocks than support directly below

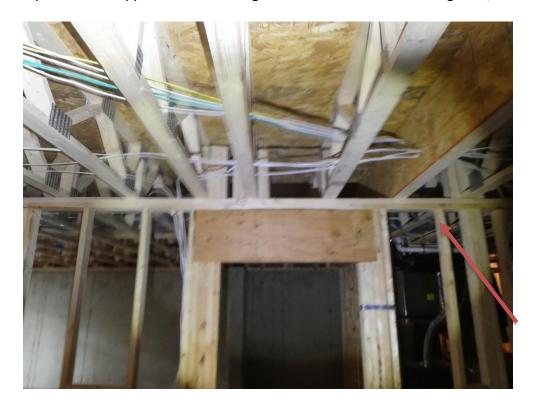
Squash blocks appears to be missing at the basement load bearing wall / header

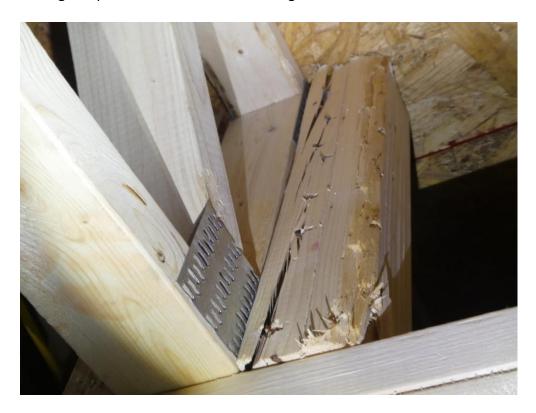
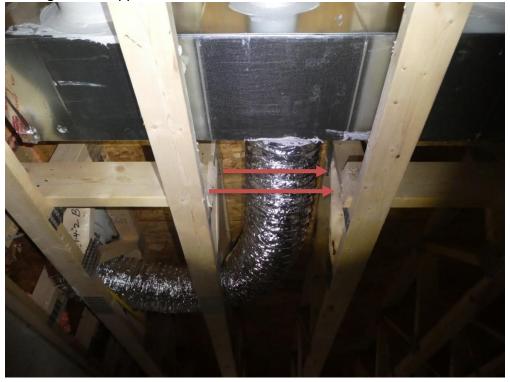
Damaged squash block at the load bearing wall in the middle of the basement

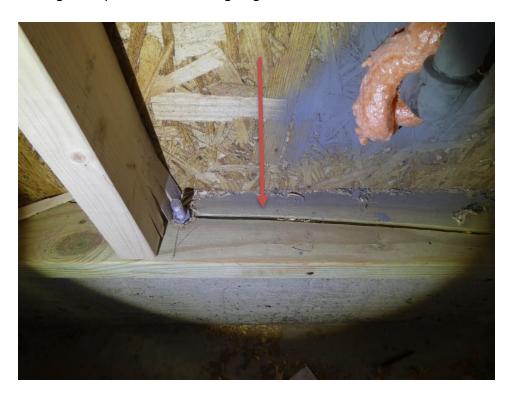
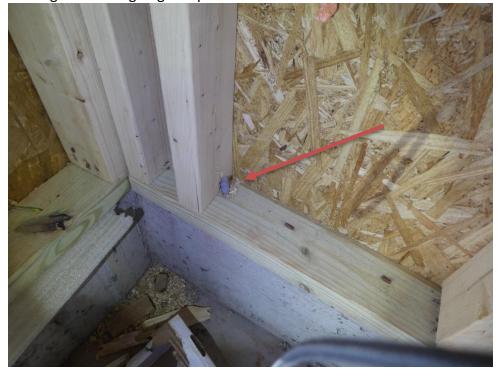
Damaged sill plate noted in the garage

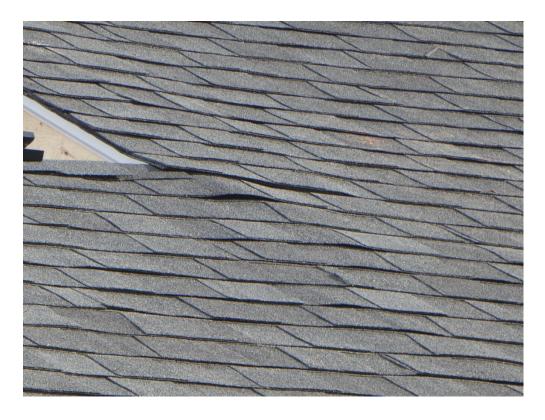
Uneven shingle / roofing installation noted at left rear

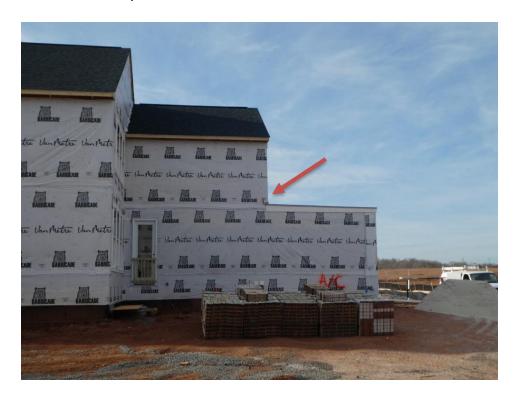
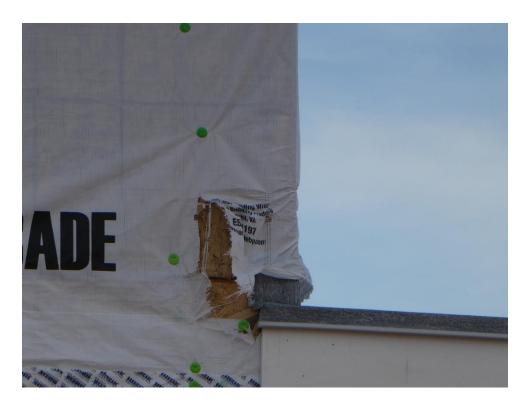
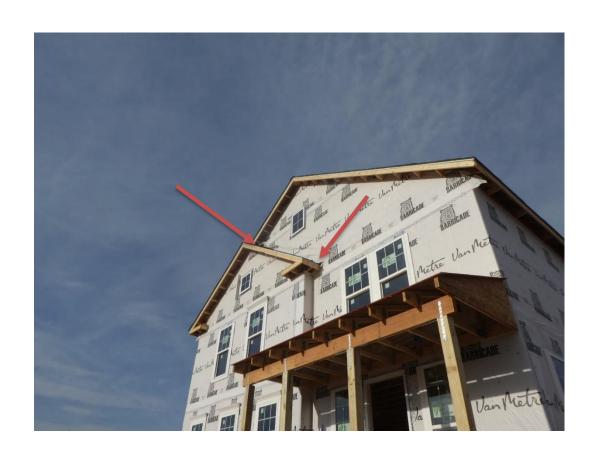
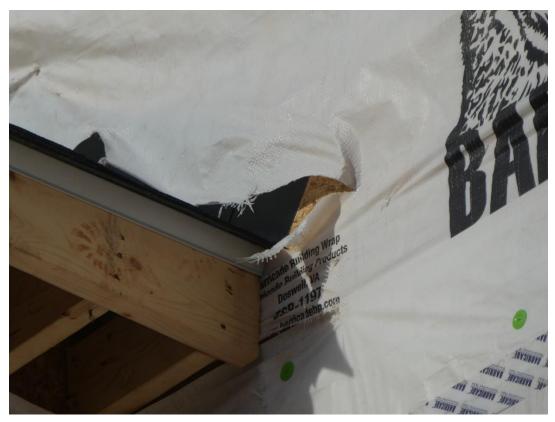
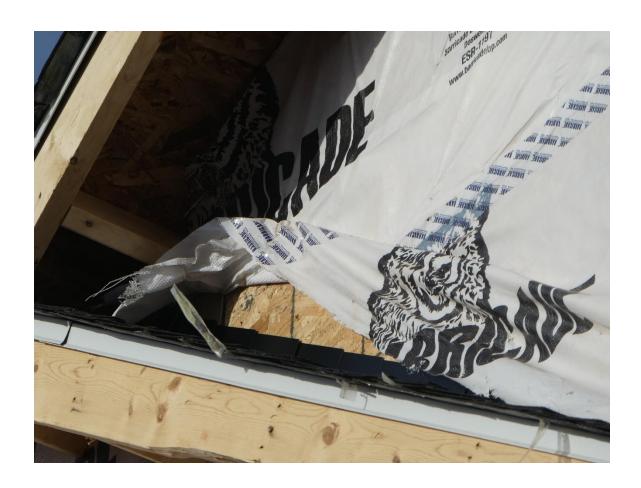
Loose house wrap at front and rear corner

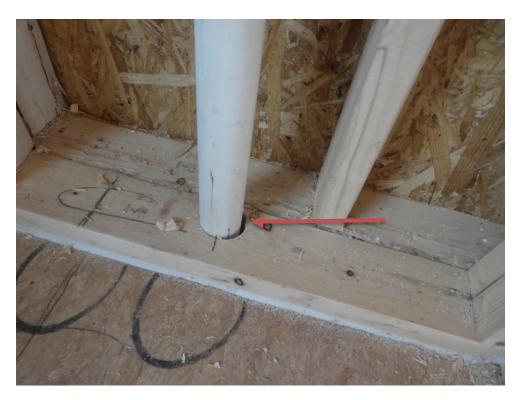
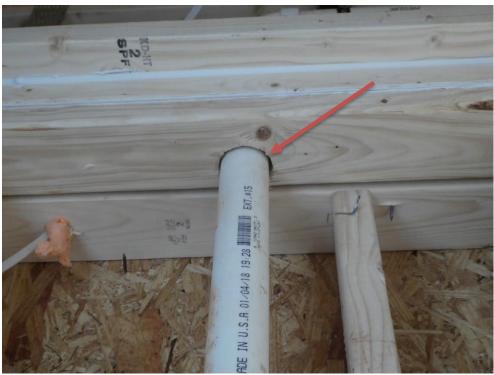
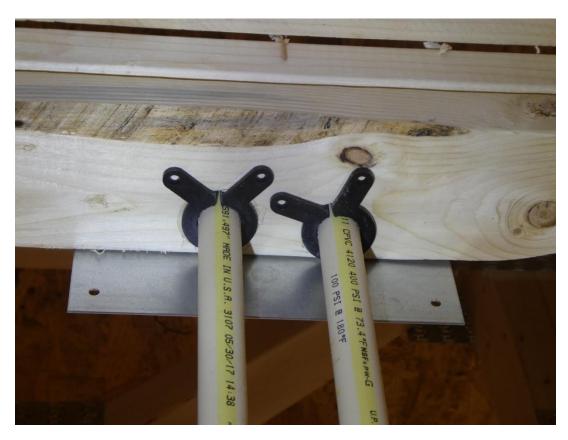
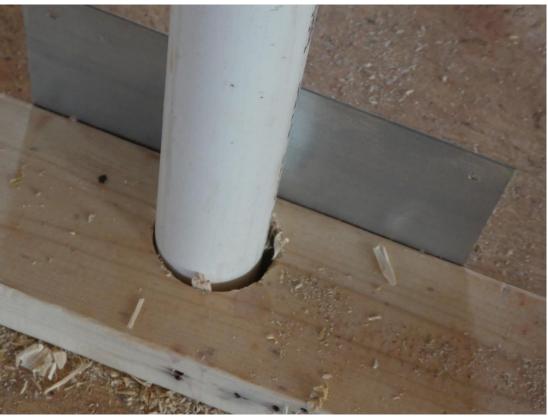
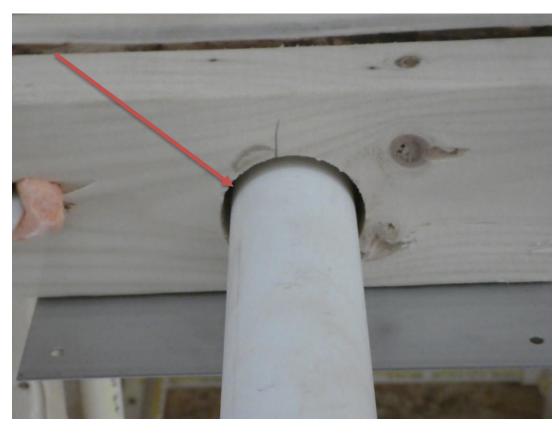
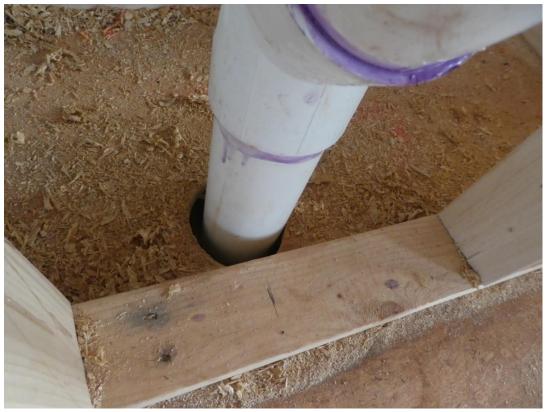
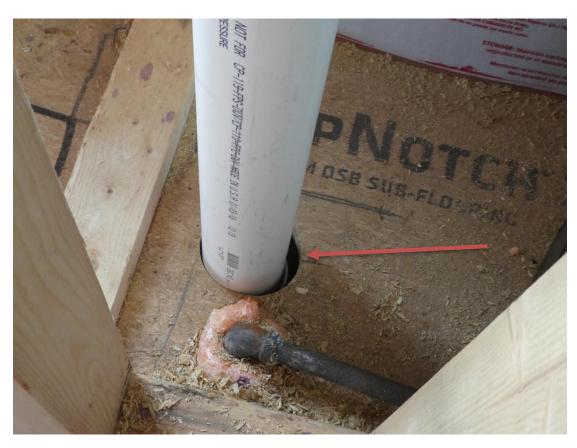
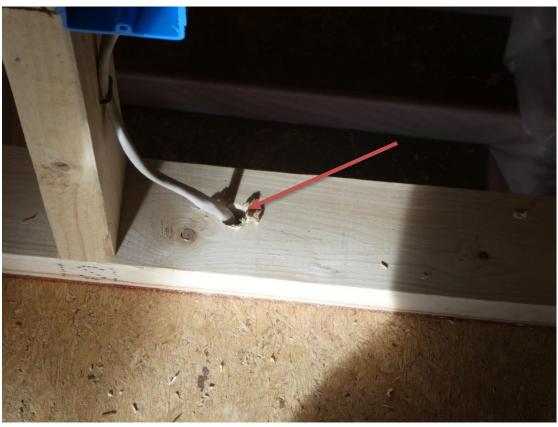
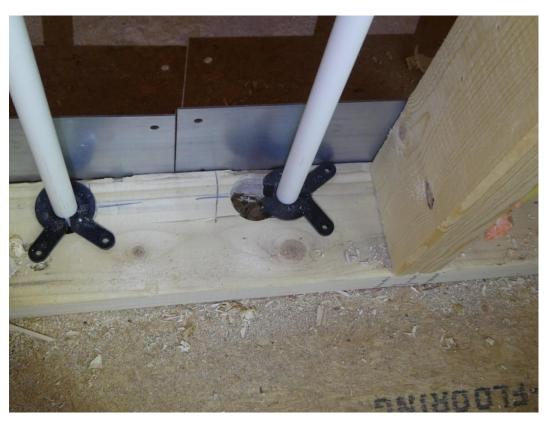
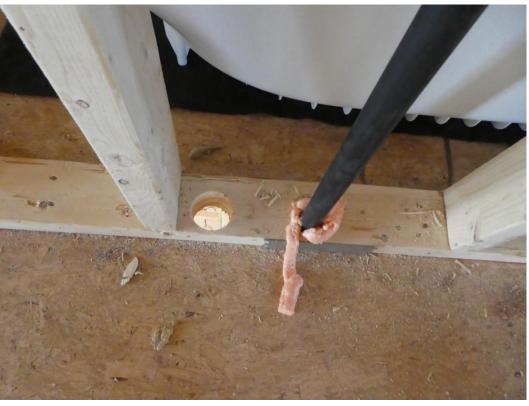
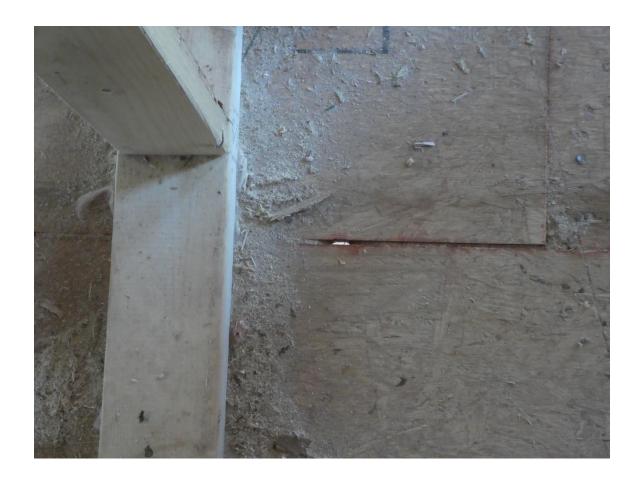
Missing fire stopping throughout
