**123 Main St
Fairfax, VA 22310**

**Prepared by
House Inspection Associates LLC
VA/MD/DC: 703 453-0442
www.HouseInspectionAssociates.com**

January 1, 2012

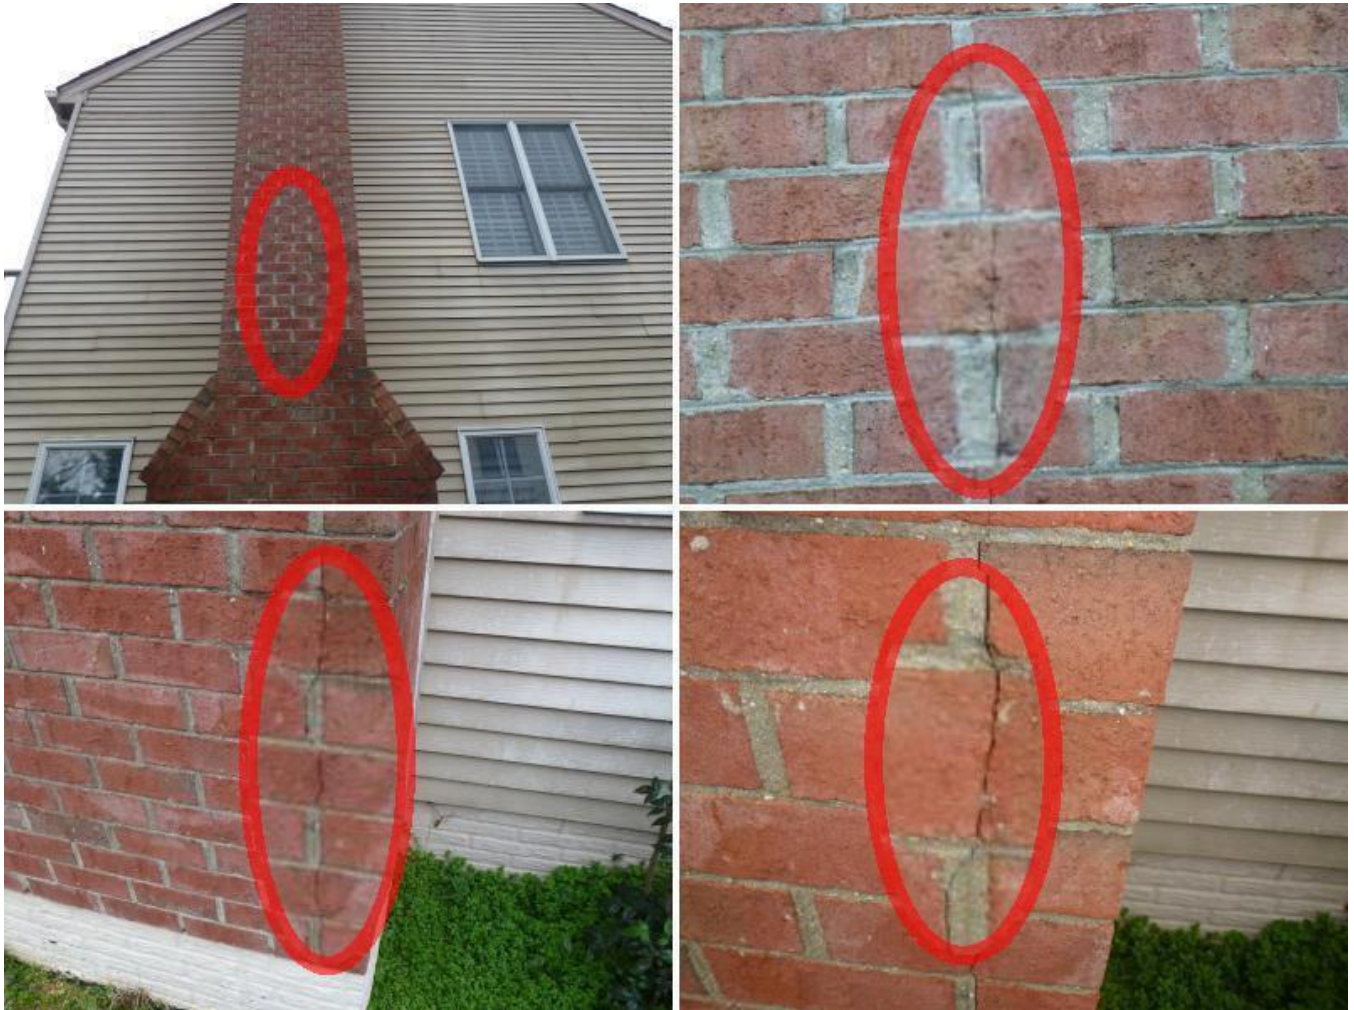
1. Cracks noted at chimney. The potential for water entry and damage is present. A licensed contractor should be called to make further evaluation and repairs as needed.

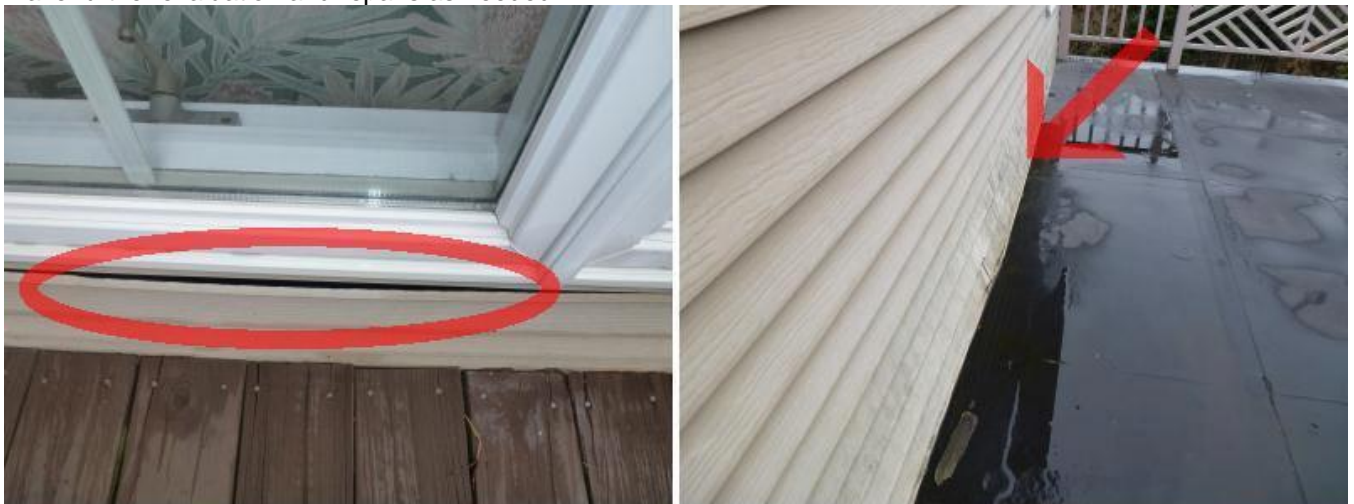
2. Loose siding noted at deck, improperly installed at flat roof at MBR. A licensed contractor should be called to make further evaluation and repairs as needed.

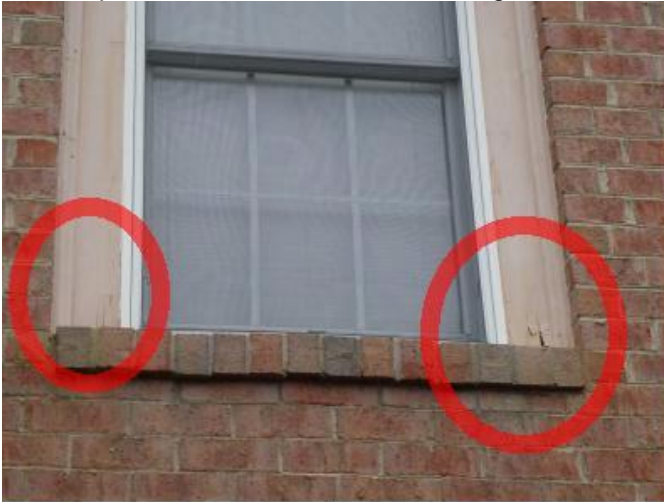
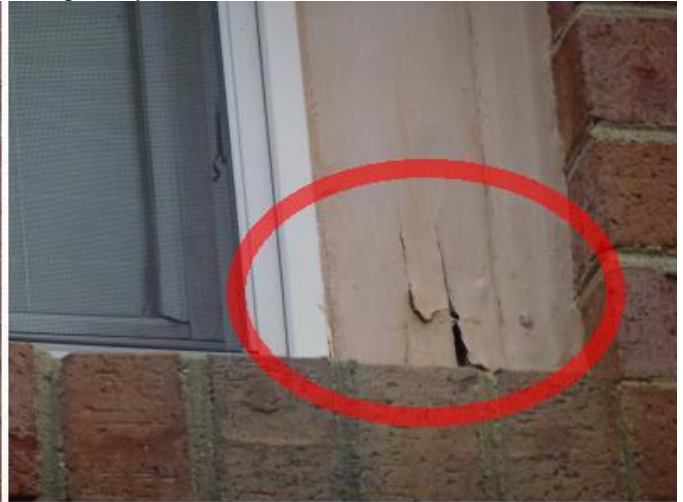
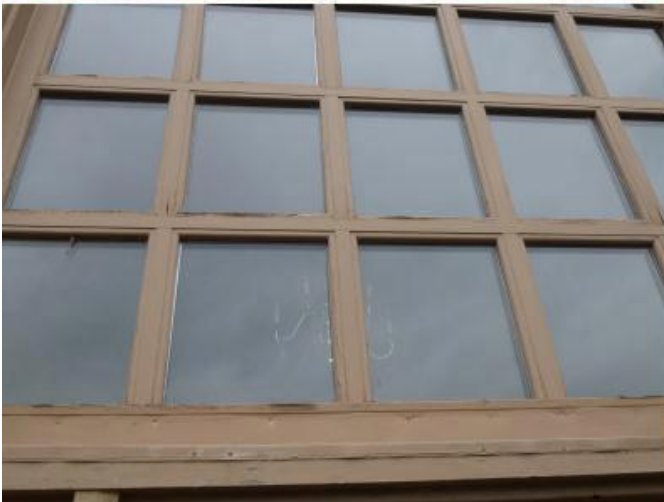
3. Soft spots/Rot noted at window/s throughout. Hidden damage may exist.

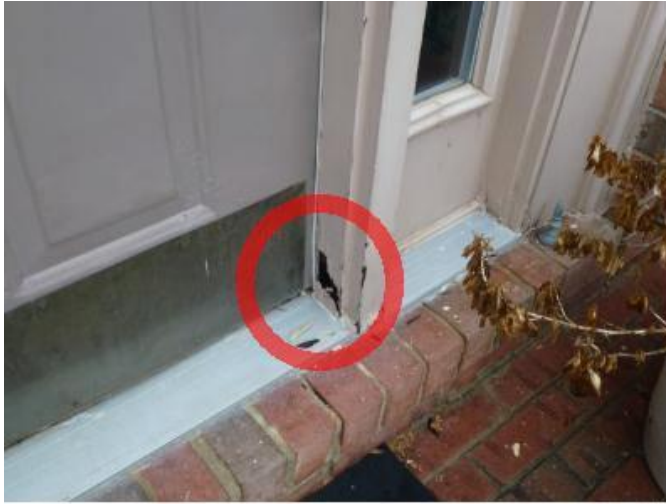
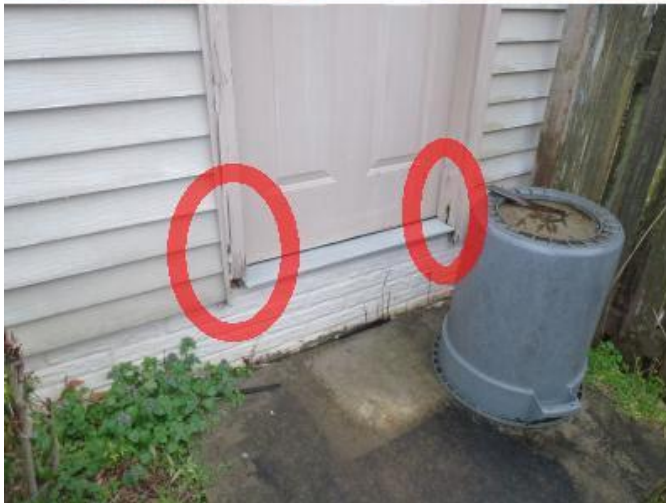
4. Soft spots/Rot noted at door trim throughout.

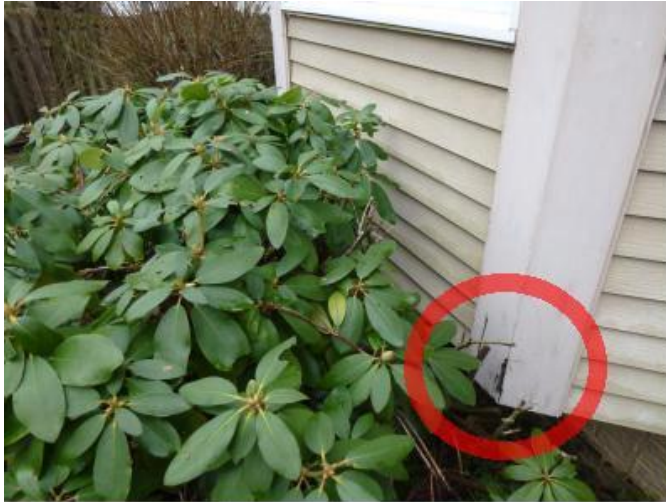
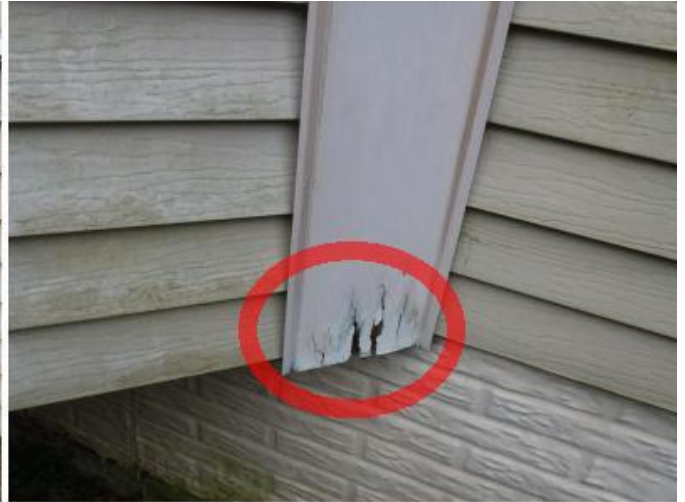
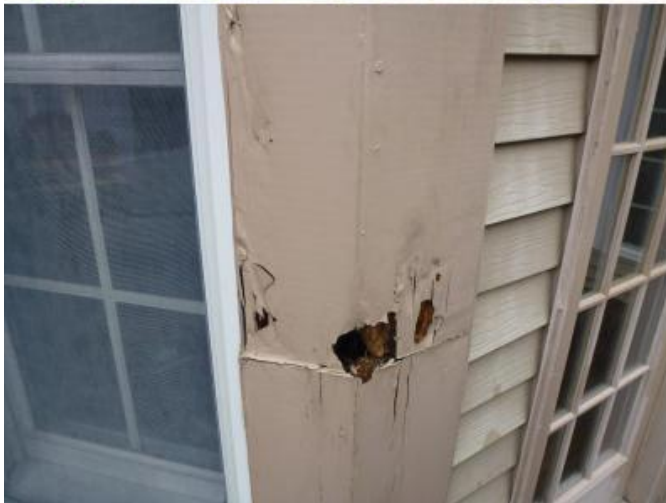
5. Soft spots/Rot noted at bay window/s, corner/s, and rake board/s.

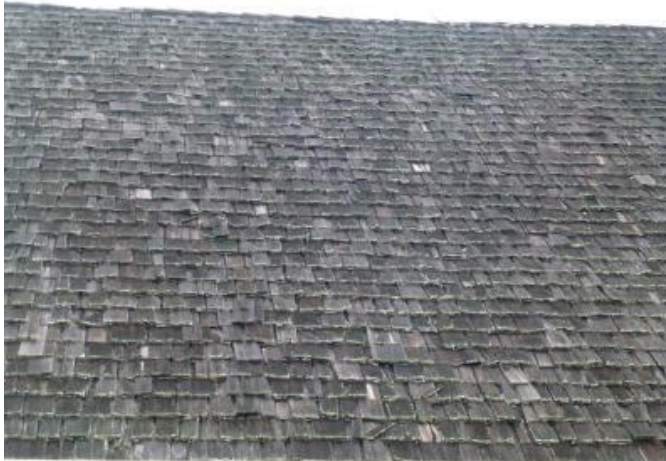
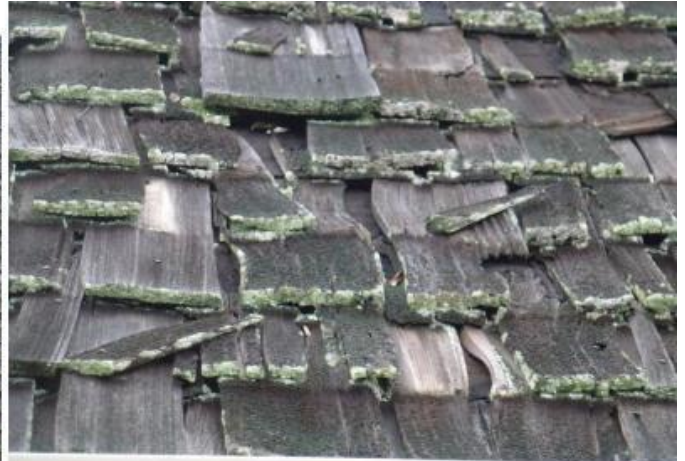
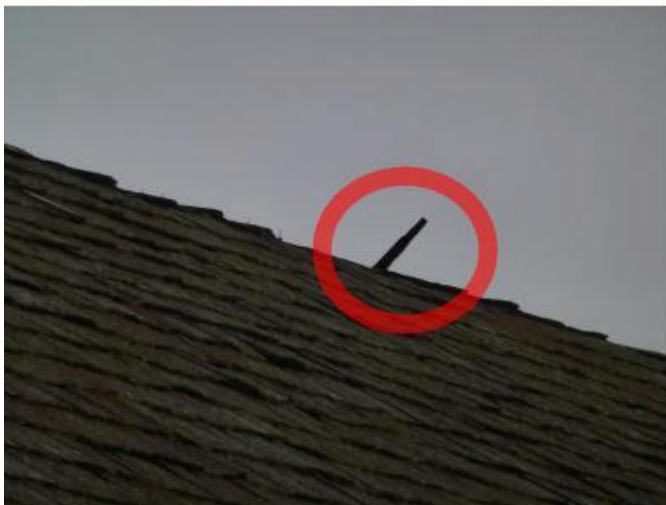
6. Damaged or missing shingles noted throughout. Roof is past the end of its useful life, A licensed roofing contractor should be called to make further evaluation and repairs as needed.

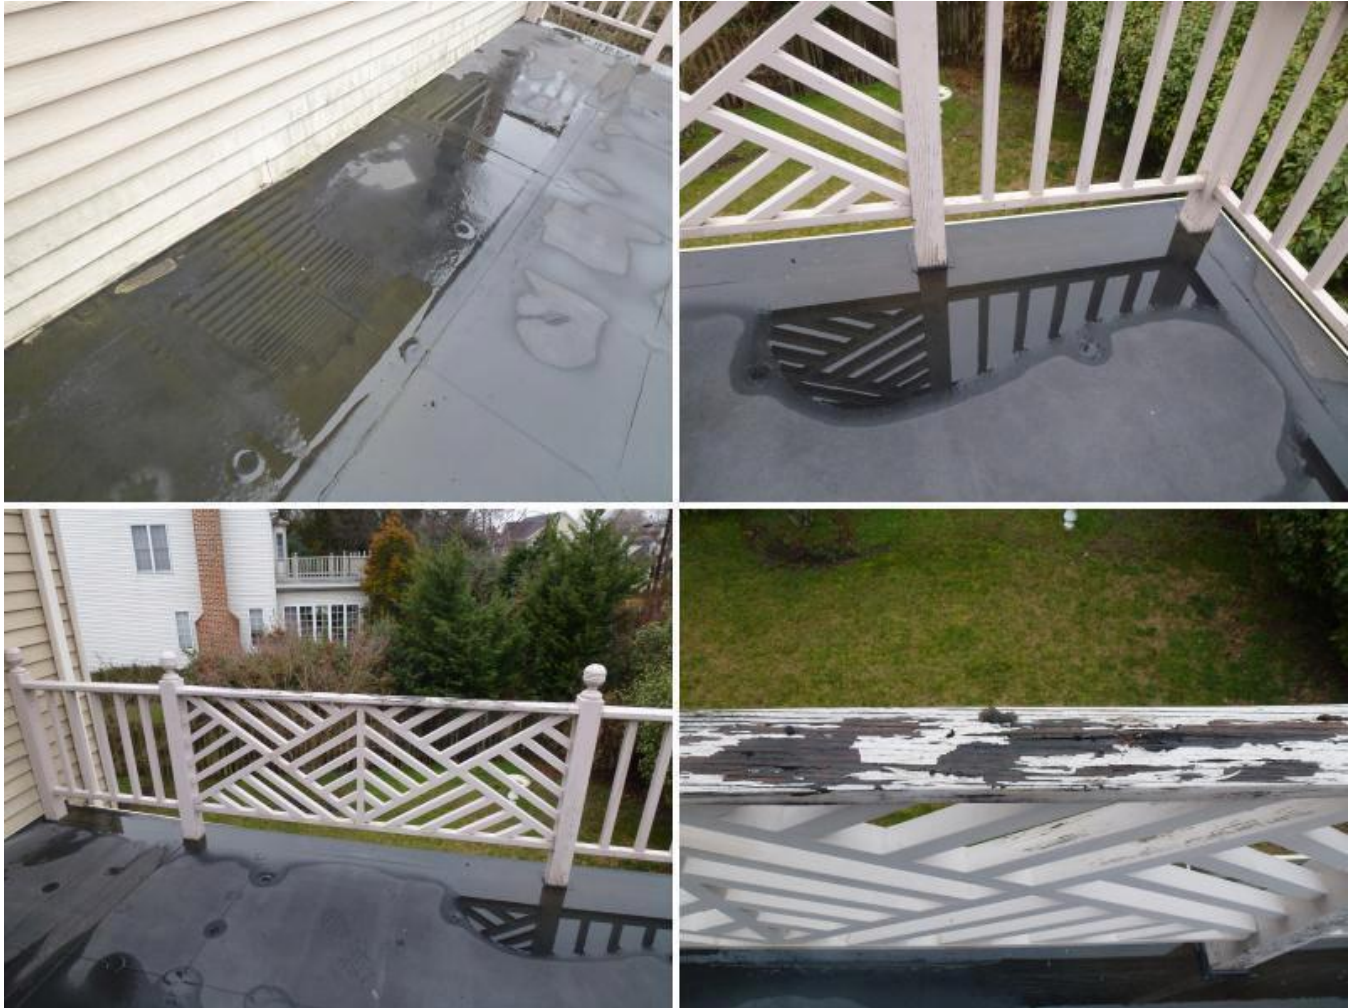
7. Evidence of ponding/poor drainage, The potential for water entry is present. Handrail is loose and rotted. A licensed roofing contractor should be called to make further evaluation and repairs as needed.

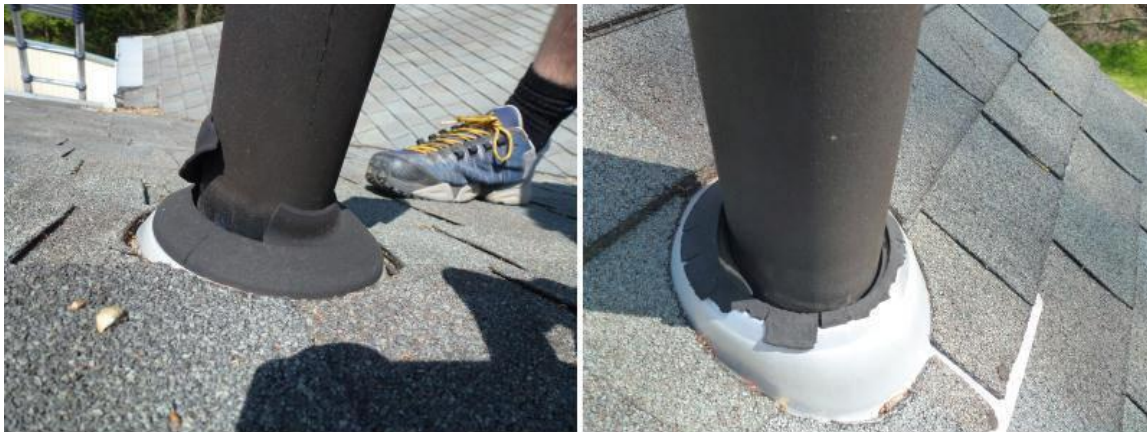
8. Separated/Deteriorated flashing noted at vent pipe/s. The potential for water entry and damage is present. Hidden damage may exist. A licensed roofing contractor should be called to make further evaluation and repairs as needed.

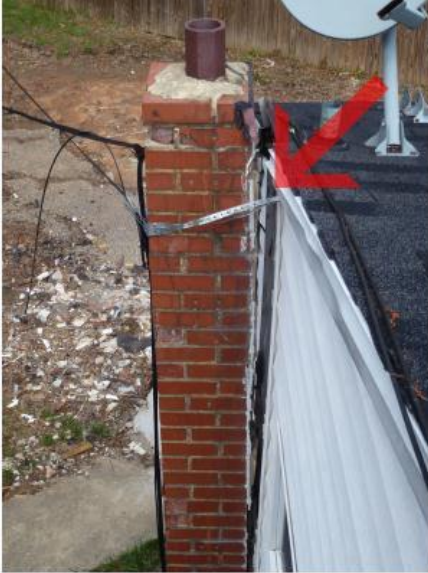
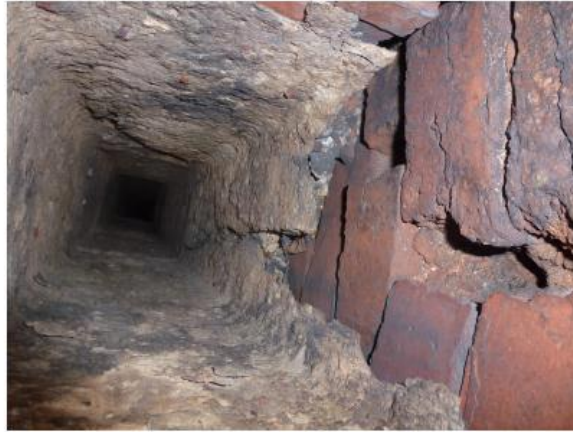
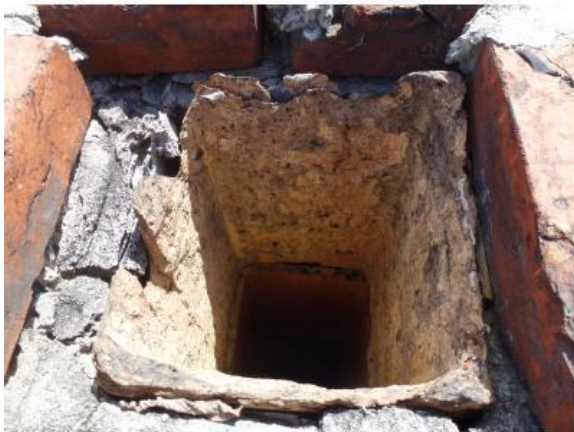
9. Chimney is separated. The flue is damaged/deteriorated, A licensed contractor should be called to make further evaluation and repairs as needed.

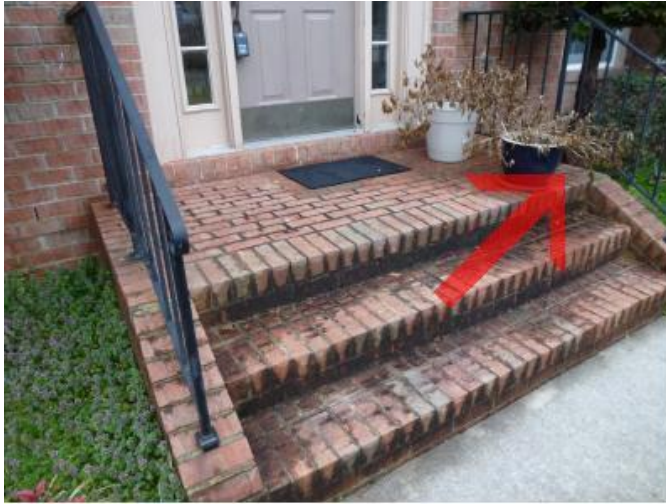
10. The following problems were noted at the handrail: damaged.

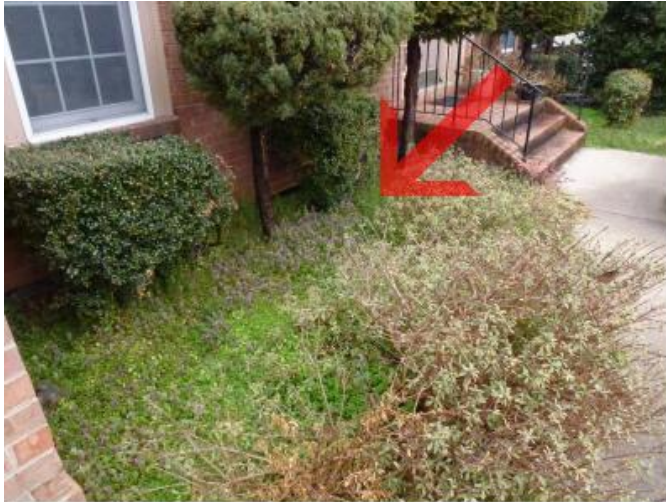
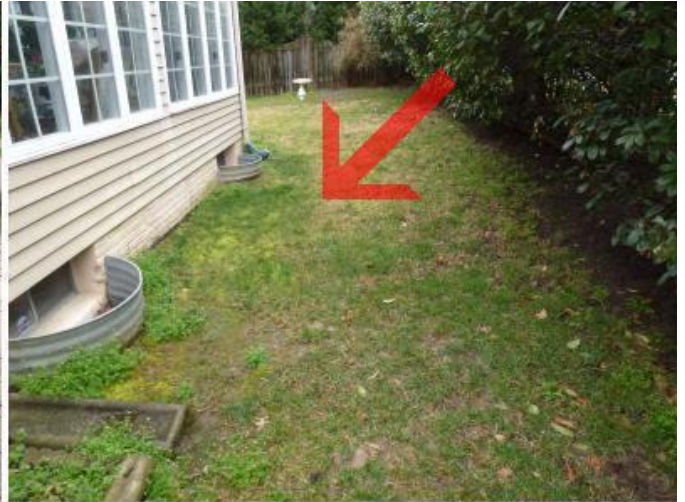
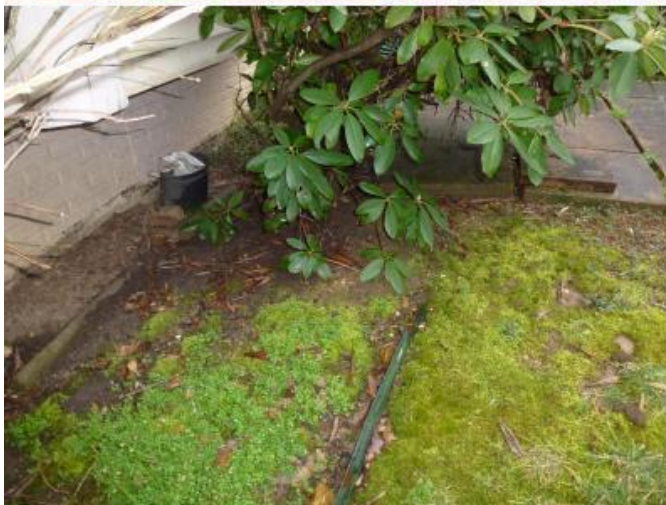
11. Gentle slope, Pitch slope of soils away from foundation. Slope should fall away from the foundation at a minimum of 1/2 inch per foot and extend at least 10 feet away from the foundation

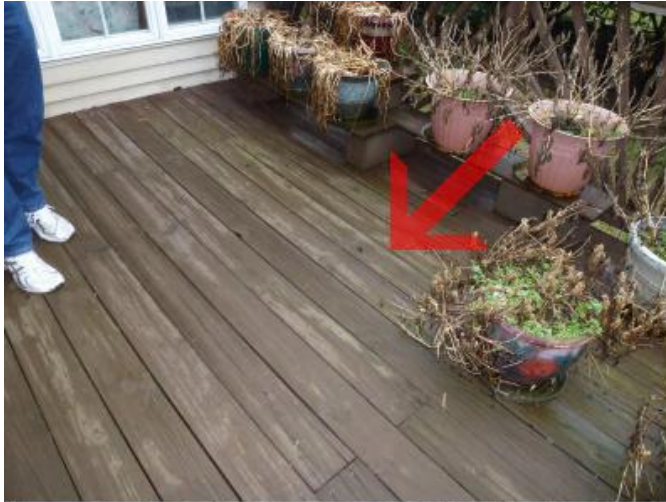
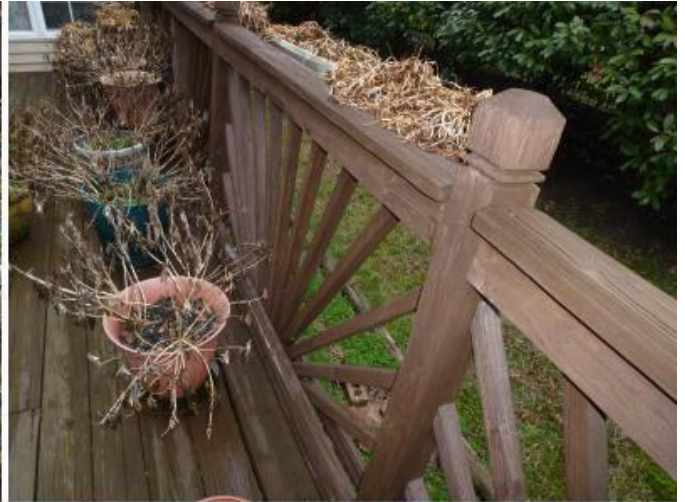
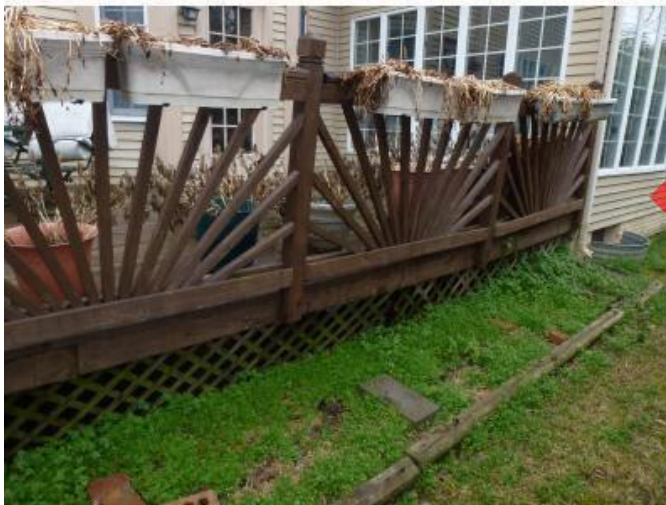
12. Improper conditions viewed, deck is sagging, handrail is loose, stairs have sunk. Contact a licensed contractor for further evaluation and repairs as needed.

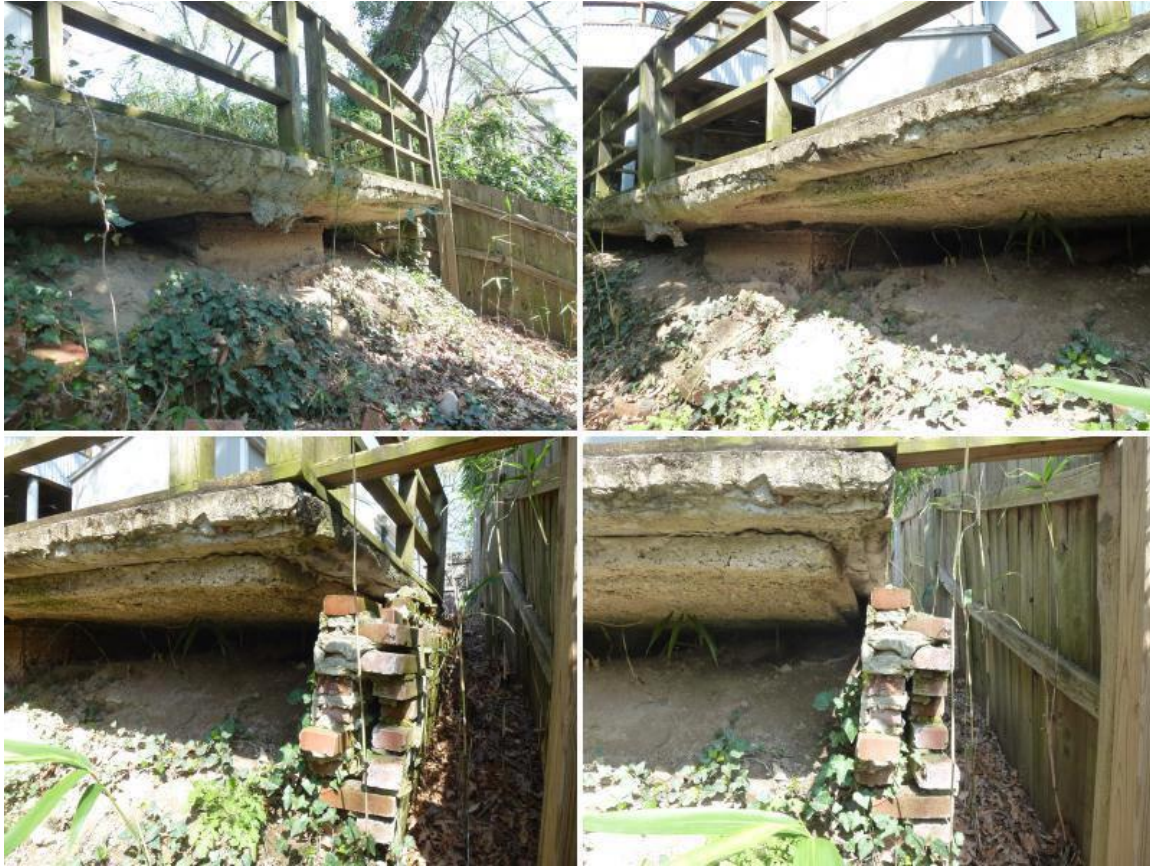
13. Damage/Displacement is noted, wall has collapsed. A structural engineer should be consulted.

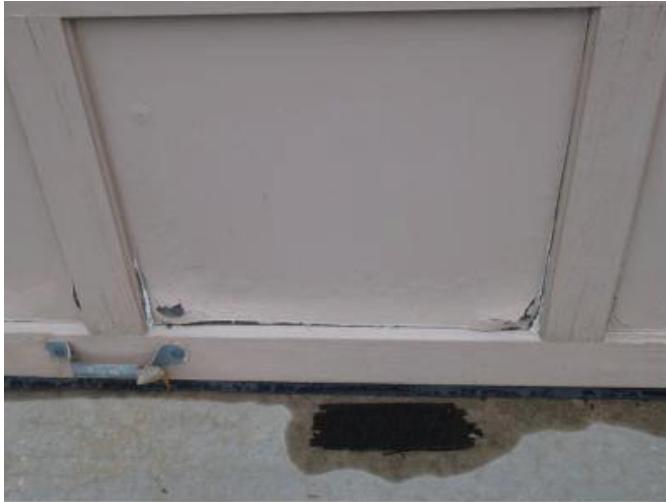
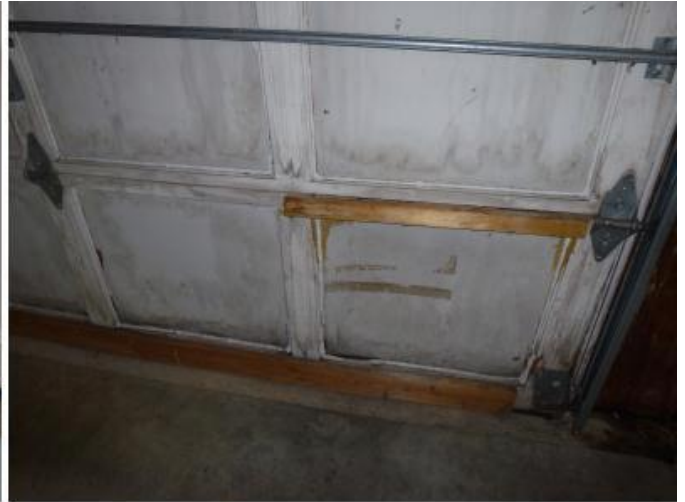
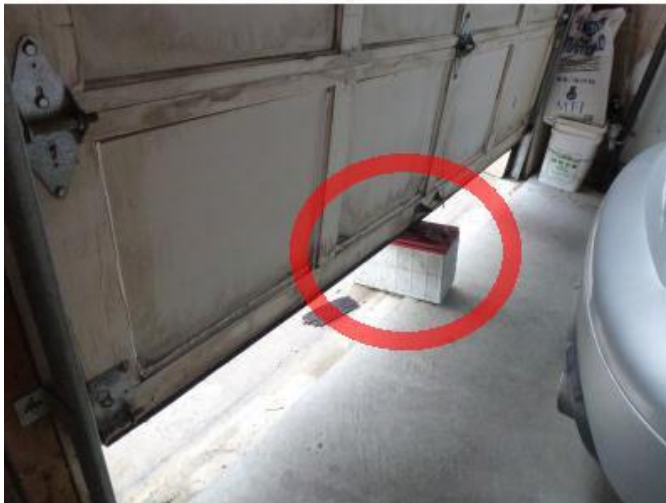
14. Soft spots/Rot and temporary repairs noted. The following problems were found at the automatic reverse feature: not operational at left door. Note: All overhead doors should have fully operational auto-reverse function.

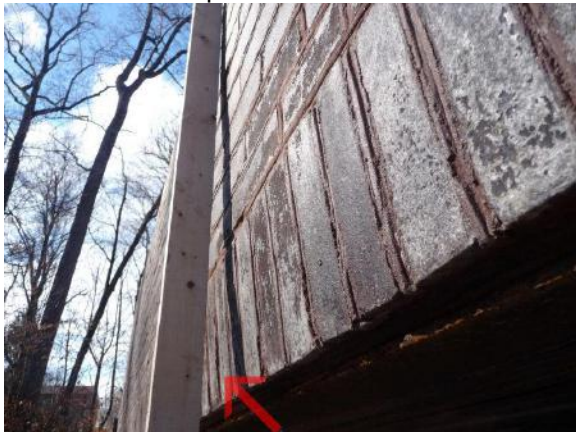
15. Bricks are bowed out above door, possible collapse, A licensed contractor should be called to make further evaluation and repairs as needed.

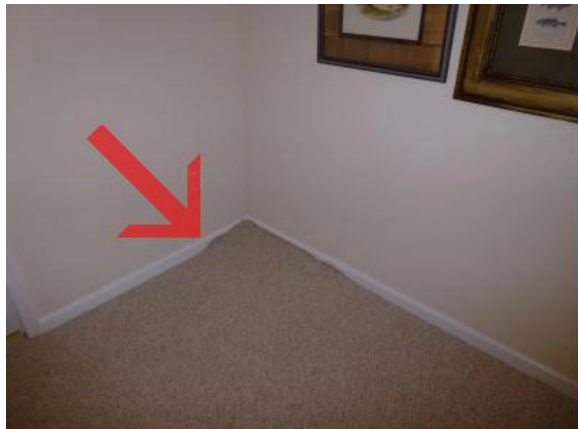
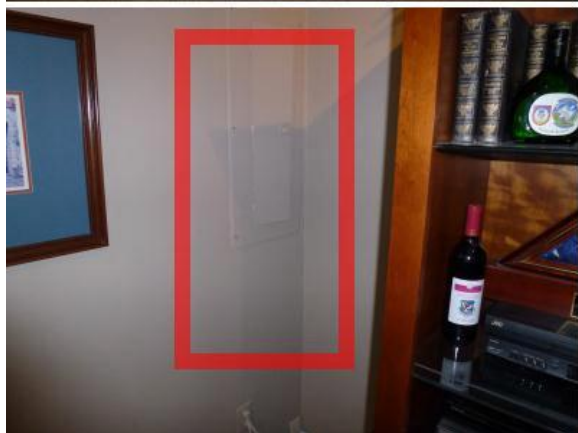
16. Staining was observed: Evidence of present water penetration is noted - seen at front wall (infrared photos attached). Water seepage may recur in the future. The first step in defense against water seepage is good drainage of soils near the foundation wall (slope should fall away from the foundation at a minimum of 1/2 inch per foot and extend at least 10 feet away from the foundation), cleaning gutters and extending downspouts away from foundation.

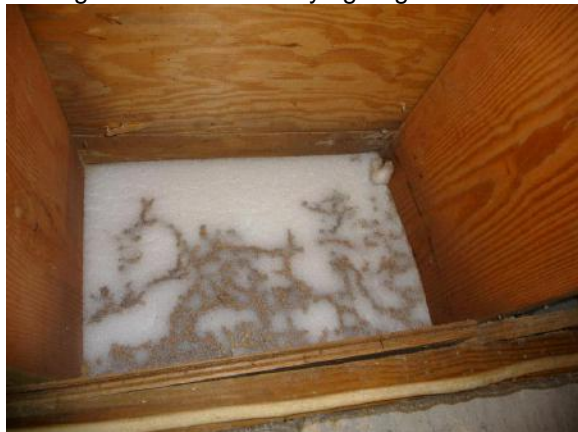
17. Signs of Wood Destroying Organisms in furnace room, consult a licensed Pest control company.

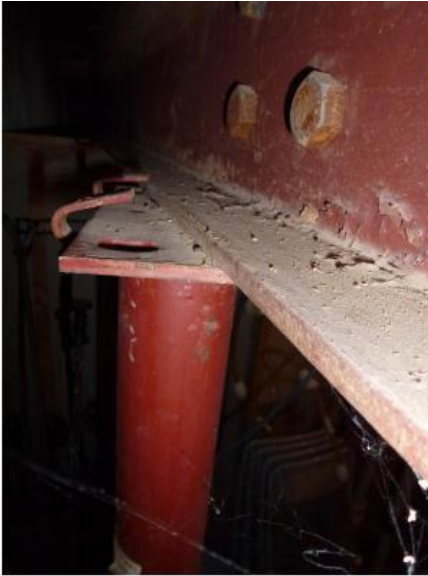
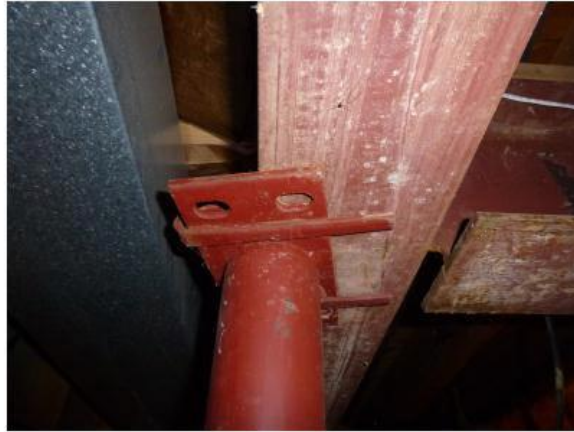
18. Metal, Post is not properly secured, Further evaluation and repair is needed by a foundation contractor.

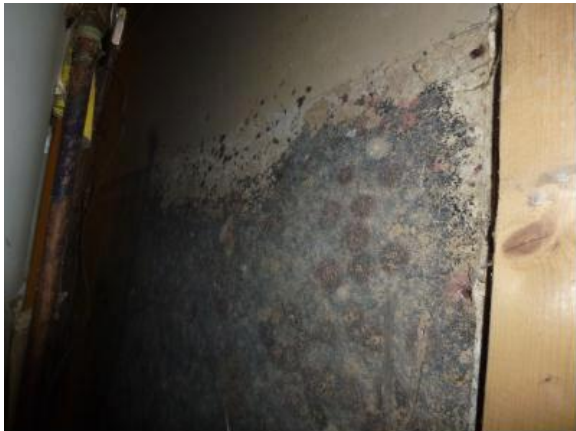
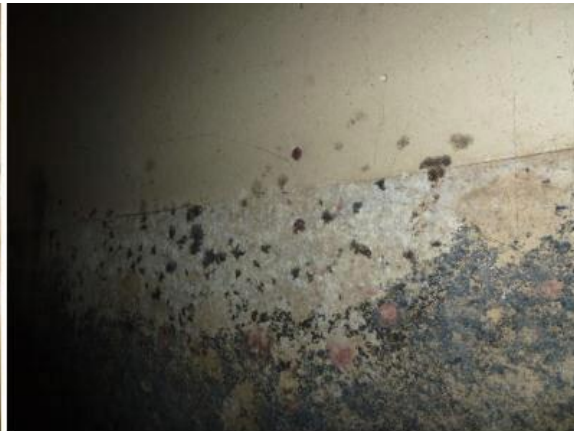
19. Organic material (possibly mold) visible at rear wall. CONSULT A MOLD EXPERT FOR FURTHER EVALUATION.

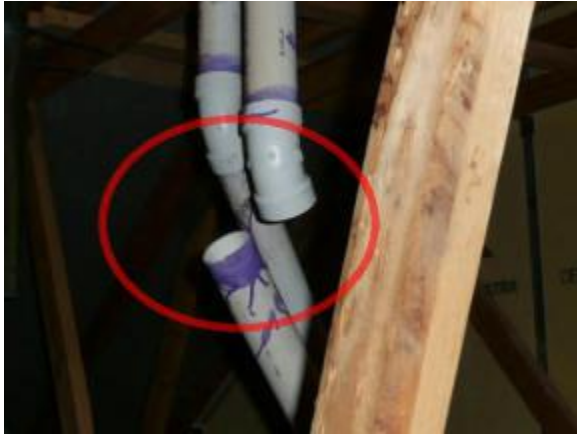
20. Vents are separated in attic, A licensed plumber should be called to make further evaluation and repairs as needed.

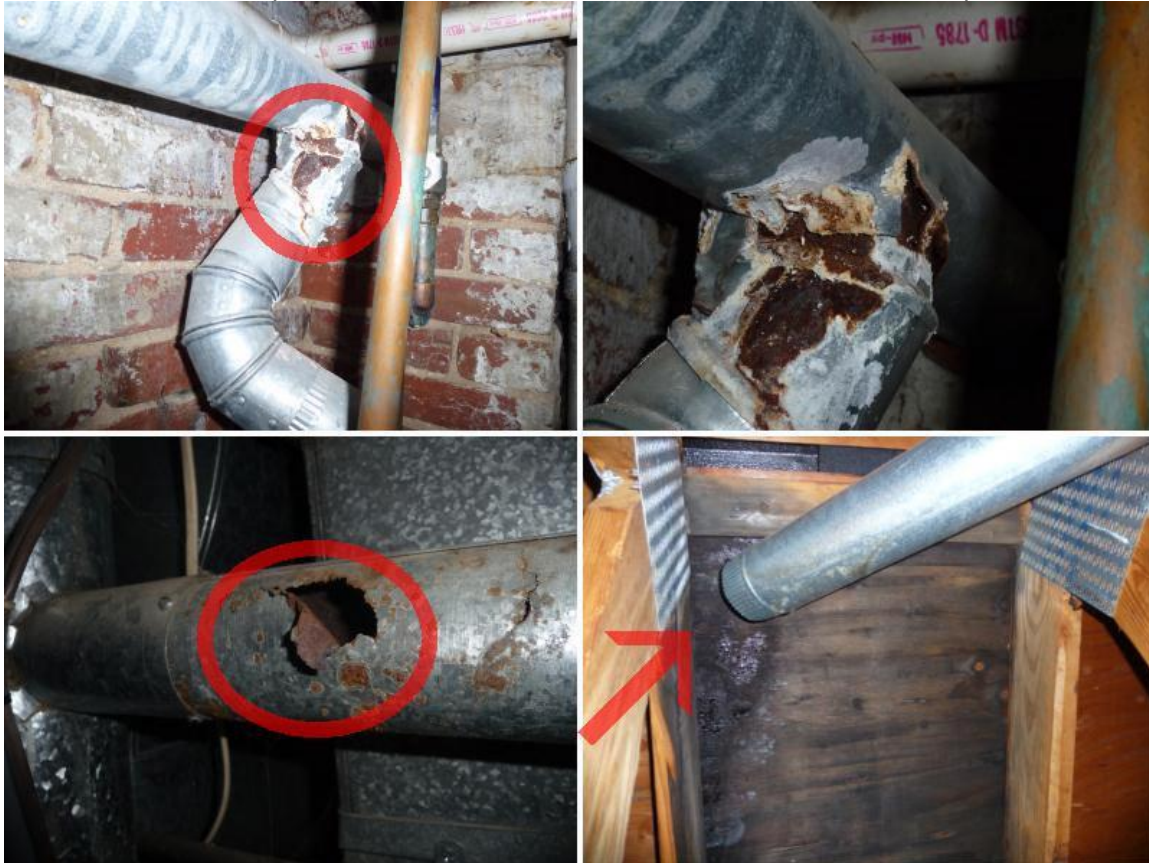
21. The following problems were noted at flue vent: Corrosion is noted at piping, not routed to the exterior, FIRE HAZARD!!! A licensed plumber should be called to make further evaluation and repairs as needed.

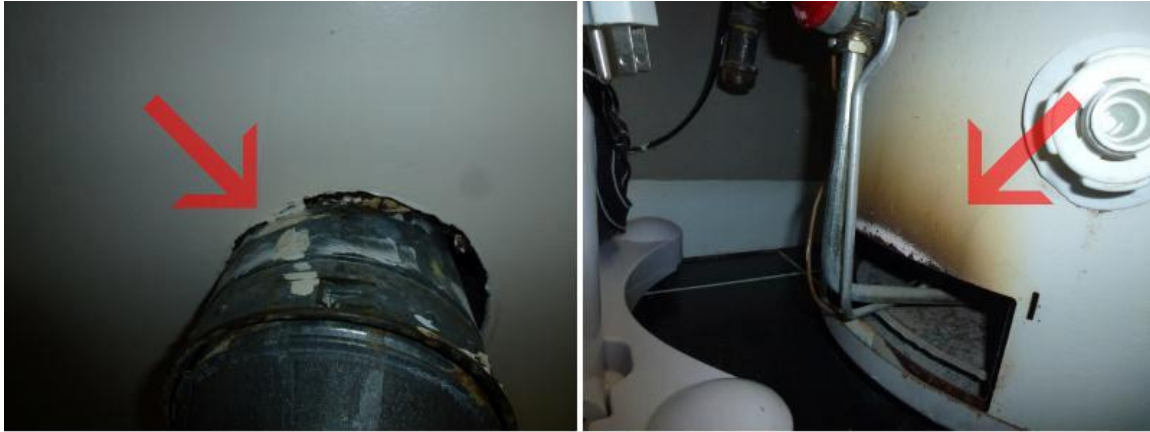
22. The following problems were noted at flue vent: Improper clearance to combustibles and corrosion is noted at piping. Backdrafting is noted, HAZARD CONDITIONS EXIST.

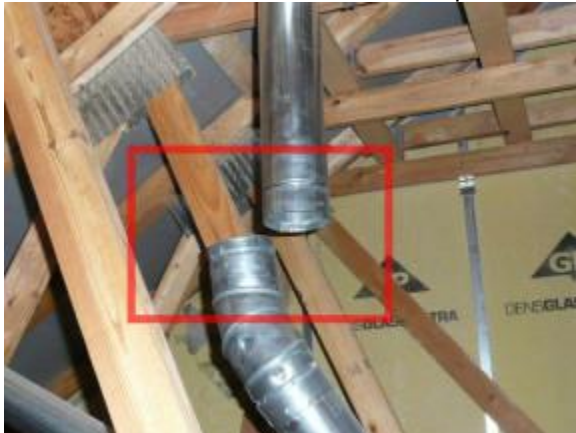
23. The following problems were noted at flue vent: disconnected in the attic. Contact a licensed heating contractor for further evaluation and repairs as needed.

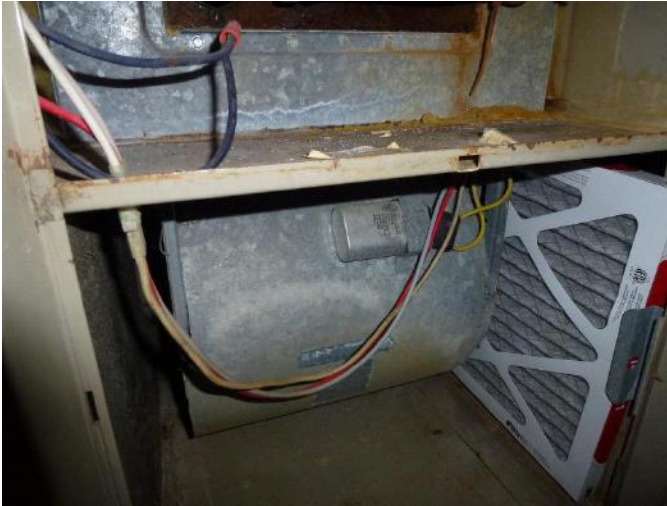
24. Blower door interlock is missing/not working properly. Contact a licensed heating contractor for further evaluation and repairs as needed.

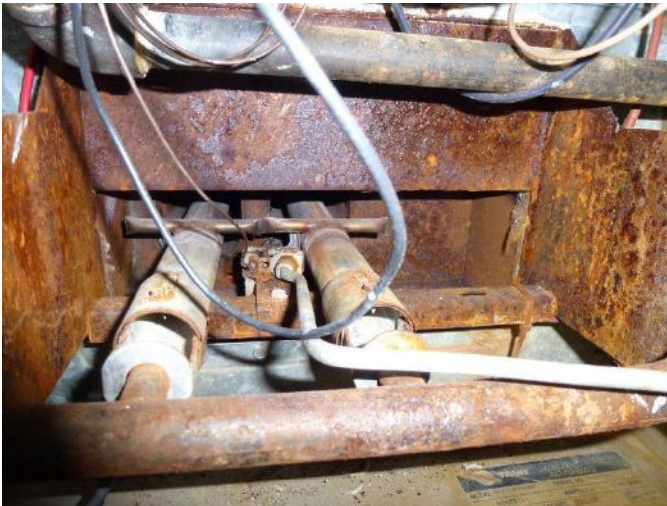
25. Excessive scale and corrosion is noted in the burn chamber.

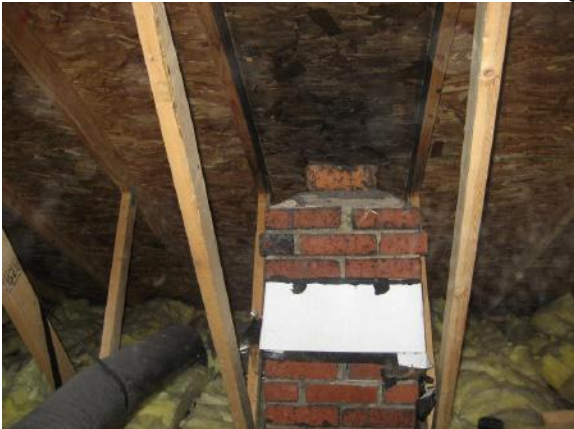
26. The following problems were noted at flue vent: Improperly terminated in the attic instead of penetrating the roof, FIRE HAZARD!!! Contact a licensed heating contractor for further evaluation and repairs as needed.

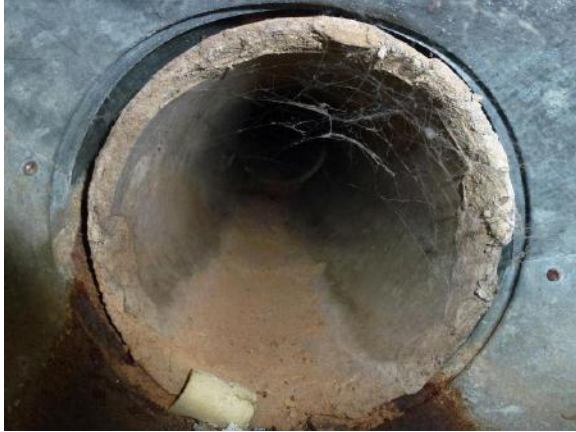
27. ASBESTOS-LIKE material noted! Possible health hazard. Evaluation by a licensed remediation contractor is recommended.

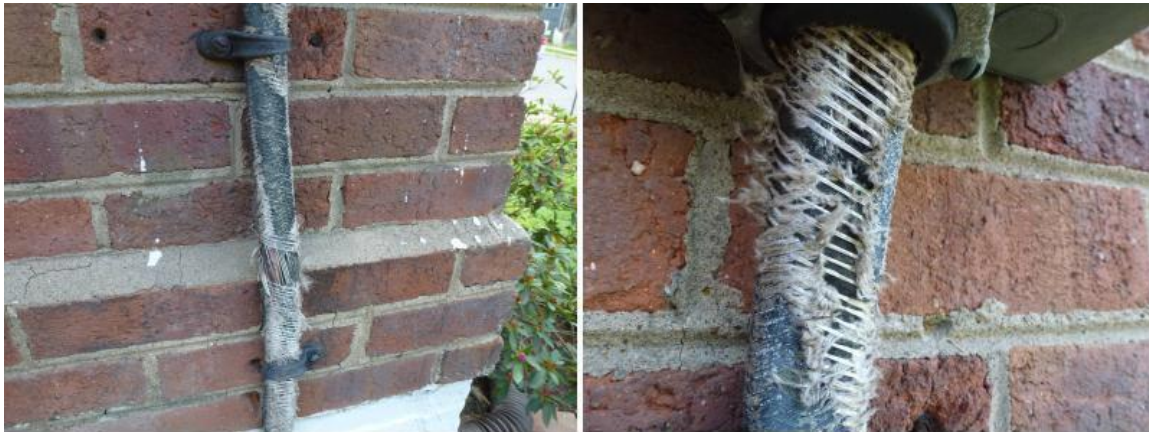
28. The following problems were noted at the SE cable: Service Entry cable is deteriorated/worn, Have a licensed electrician make further evaluation and corrections as needed.

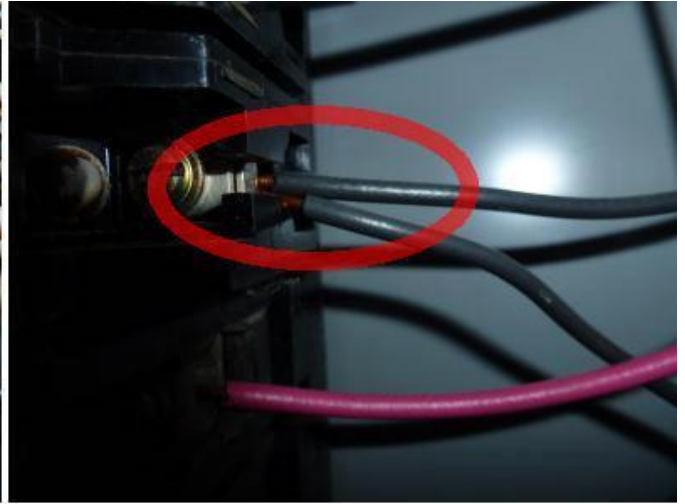
29. Multiple wires are connected to a single lug on a circuit breaker where only one wire should be connected, Have a licensed electrician make further evaluation and corrections as needed.

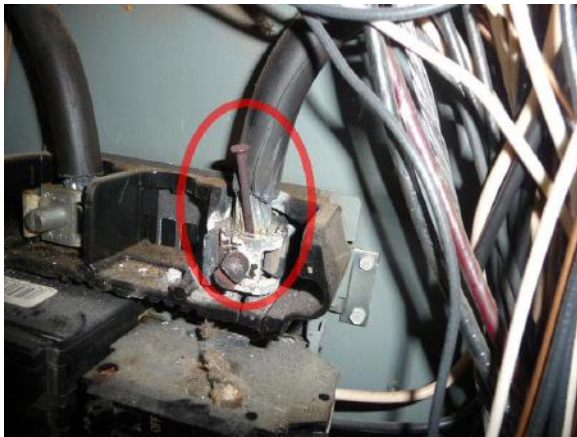
30. Nails are inserted at the SE cable. Potential fire hazard. Have a licensed electrician make further evaluation and corrections as needed.

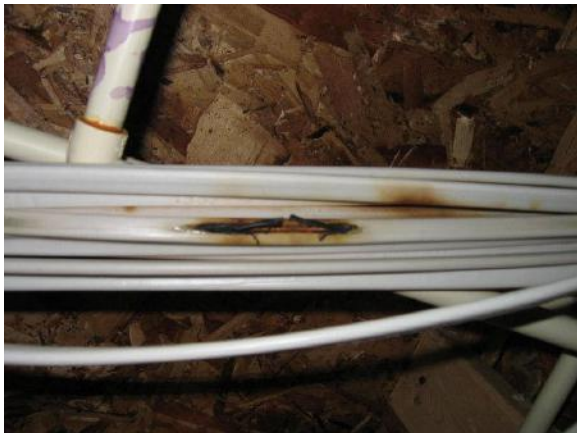
31. Melting wires noted in basement. Have a licensed electrician make further evaluation and corrections as needed.

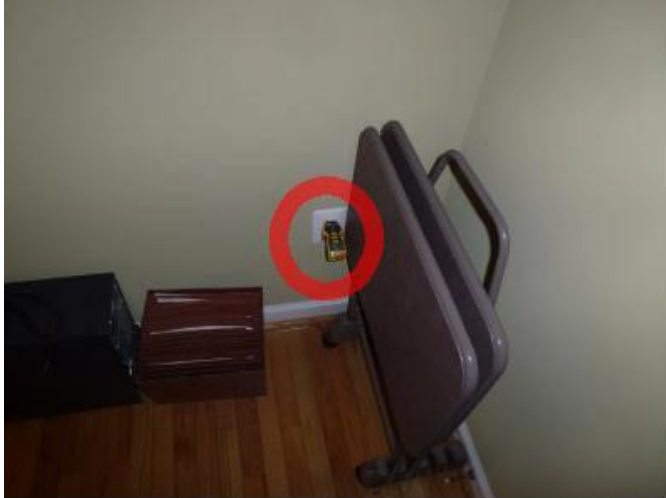
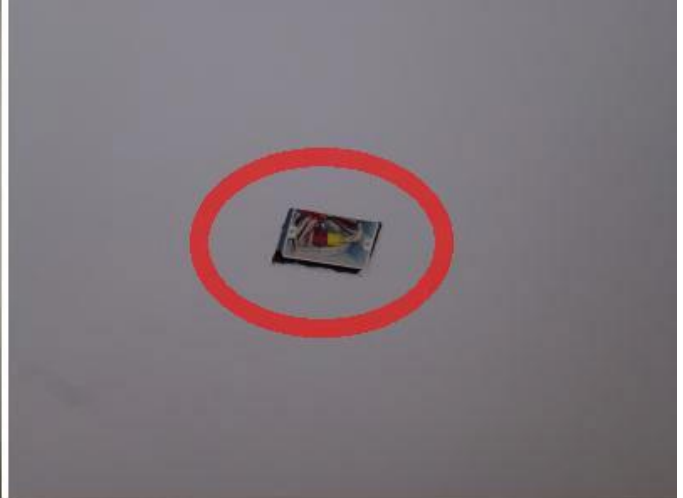
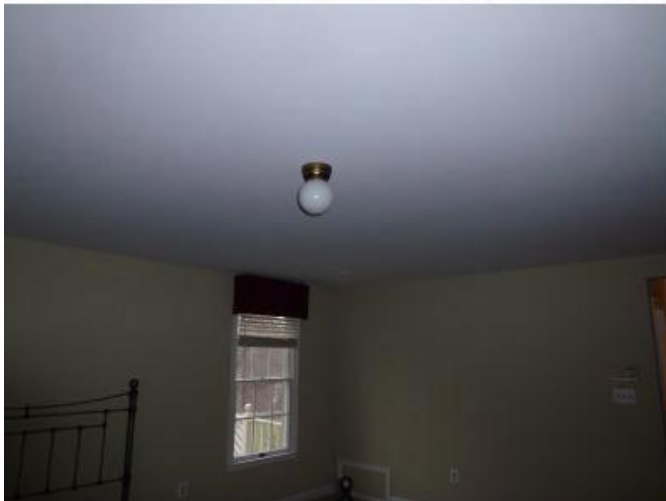
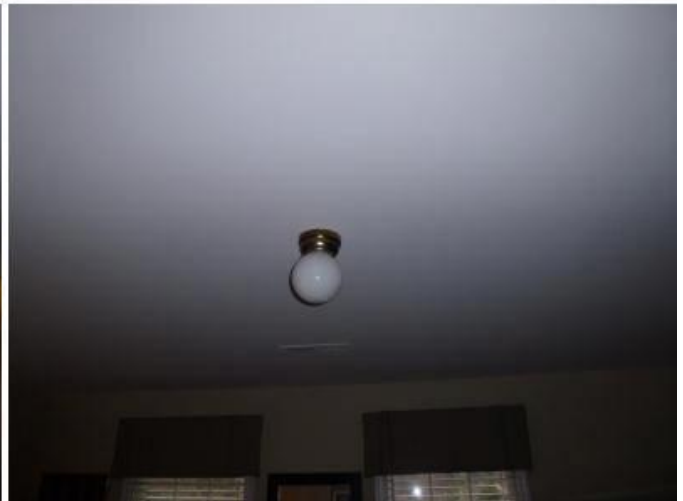
32. Reverse polarity is noted at garage door in kitchen. Junction box cover/s or light fixture missing in kitchen. Light/s not operational, possibly due to burned out / missing bulbs in MBR and front bedroom. Have a licensed electrician make further evaluation and corrections as needed.

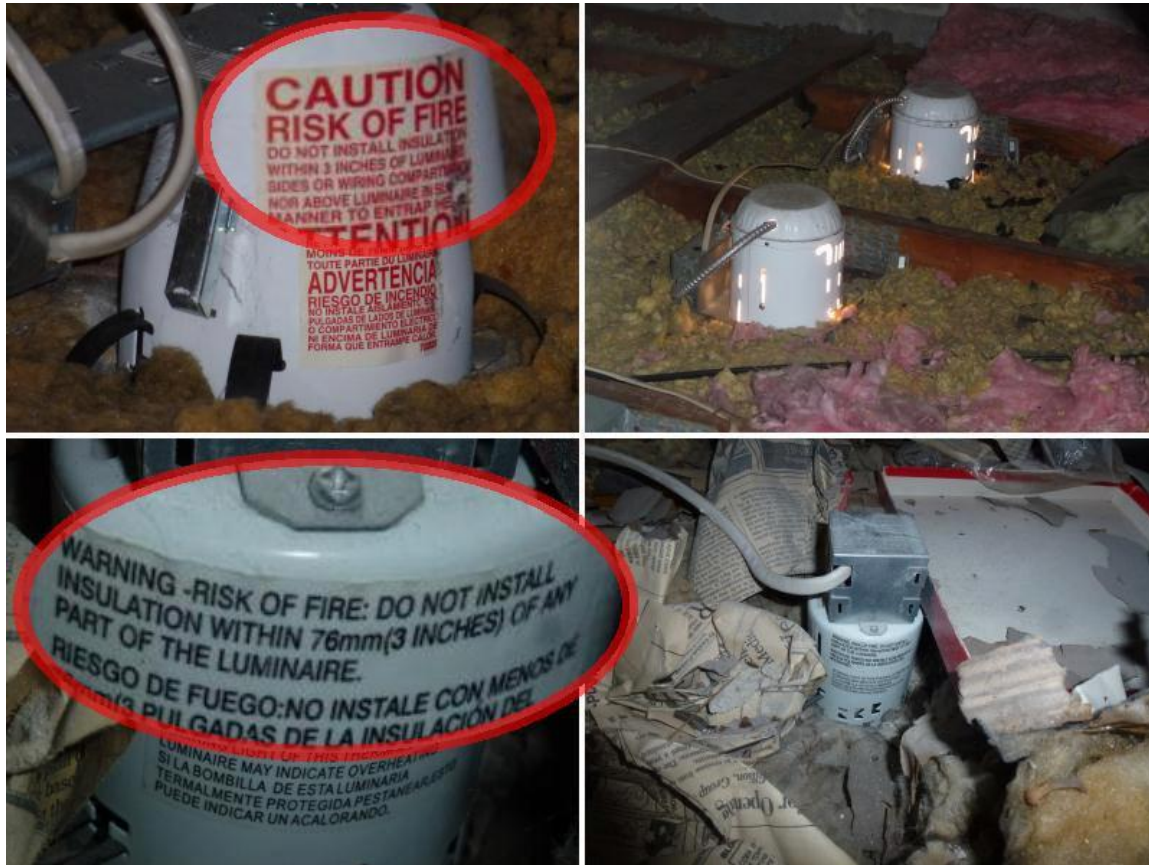
33. Recessed lights in the attic do not appear to be designed to be in direct contact with insulation or any combustible materials.
