**123 Main St
Fairfax, VA 22310**

**Prepared by
House Inspection Associates LLC
VA/MD/DC: 703 453-0442
www.HouseInspectionAssociates.com**

January 1, 2012

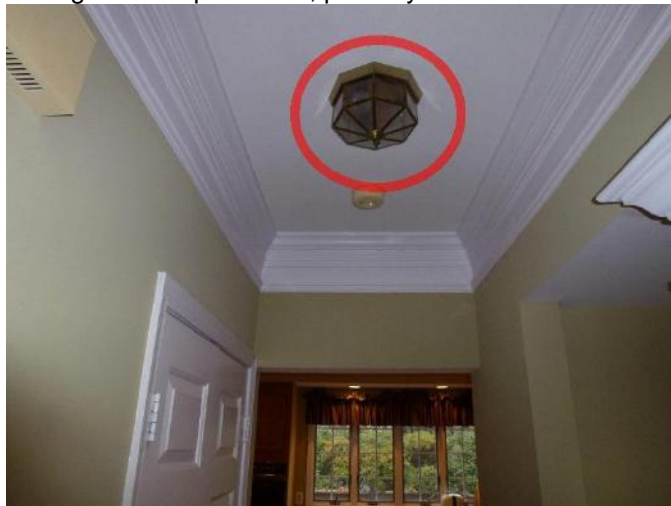
34. Light/s not operational, possibly due to burned out / missing bulbs in hallway on main level.

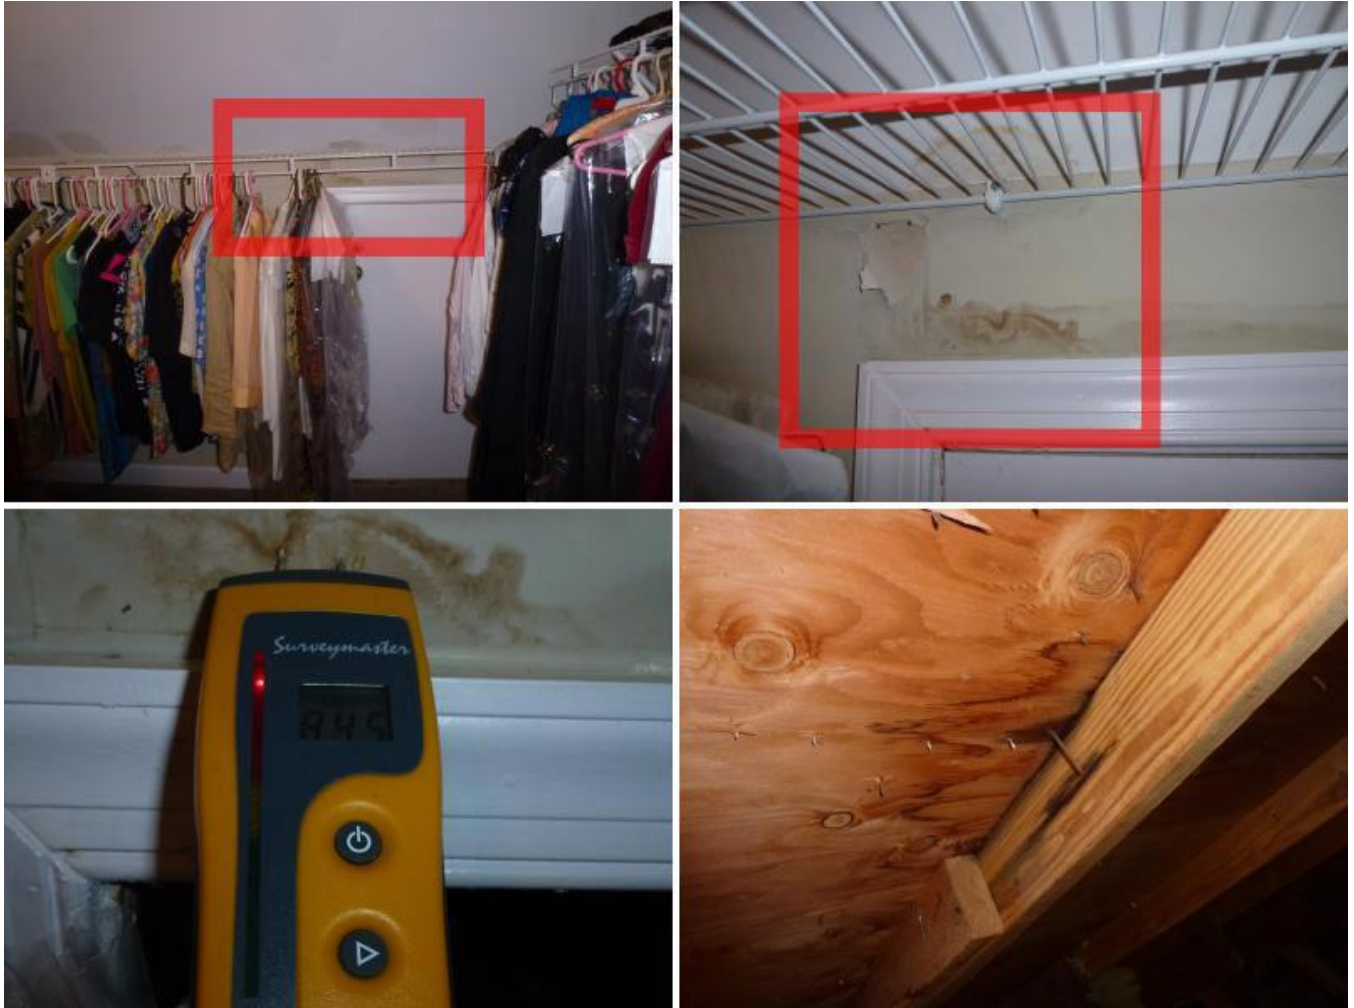
35. Active leak is noted at attic door in MBR closet and main attic, A licensed roofing contractor should be called to make further evaluation and repairs as needed.

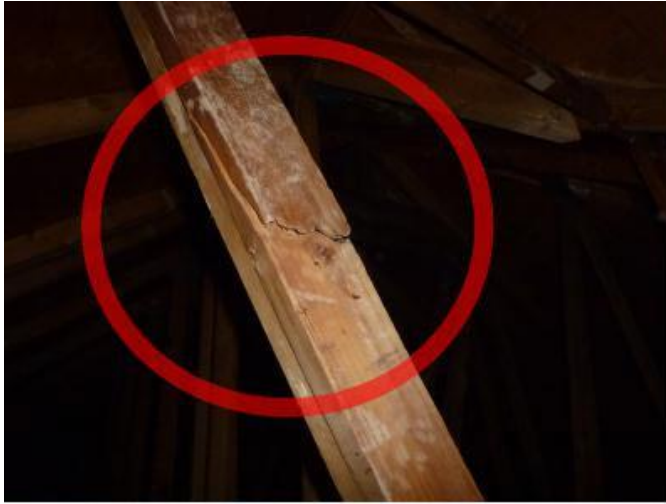
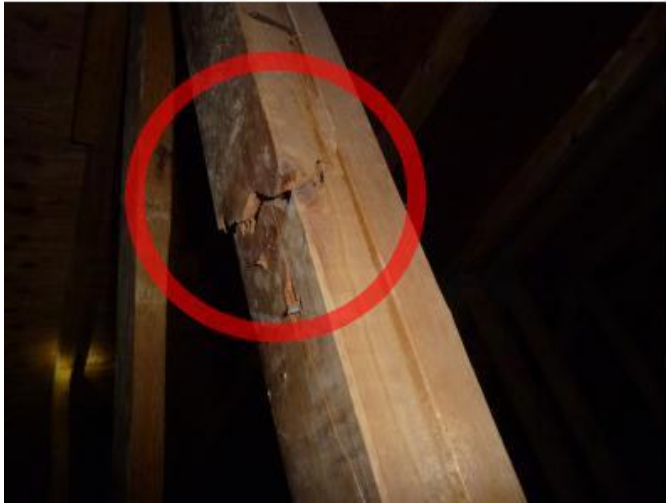
36. Truss/rafter/s cracked and repaired; however, unable to determine if the repairs have been performed correctly. Ask seller for documentation of this repair, A licensed structural engineer/architect should be called to make further evaluation and repairs as needed, including proper drawings.

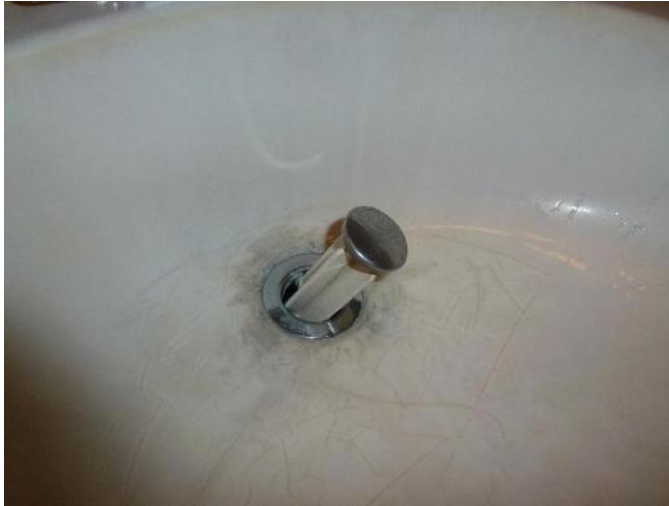
38. The following problems were noted at the drain: Stopper did not operate properly at right sink.

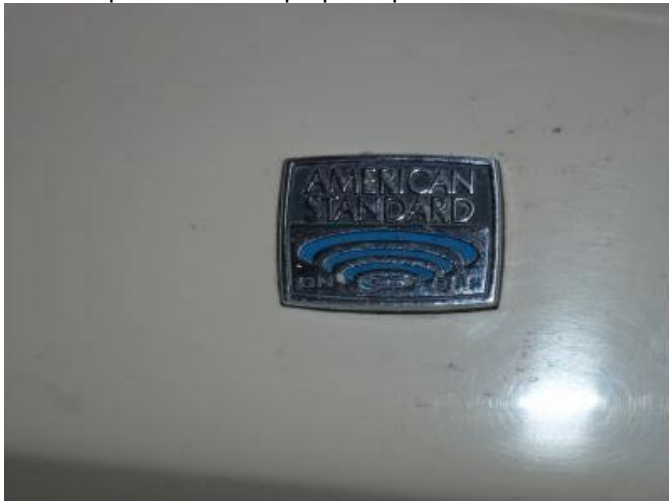
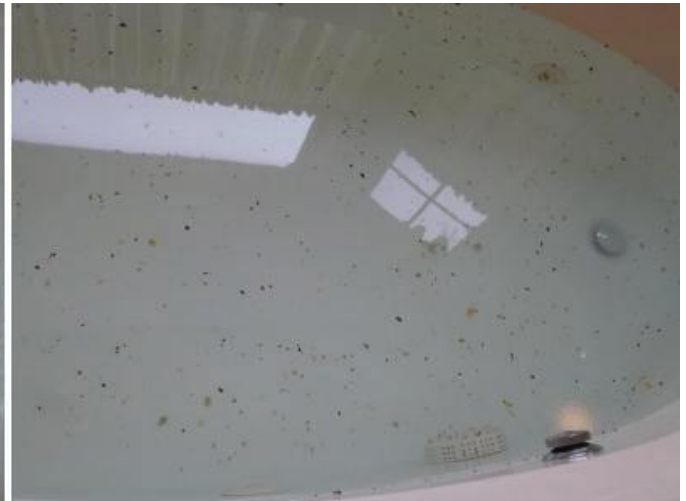
39. Did not respond to controls properly, stopped several times while running. Clean jets, hoses and pipes Have a licensed plumber make proper repairs as needed.

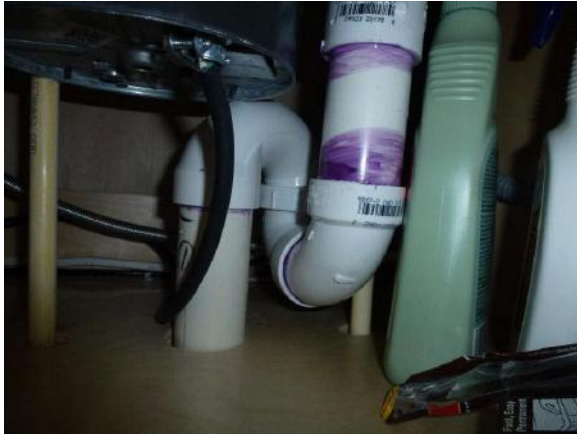
40. The following problems were noted at the drain: An improper S-trap drain line is installed. A licensed plumber should be called to make further evaluation and repairs as needed.

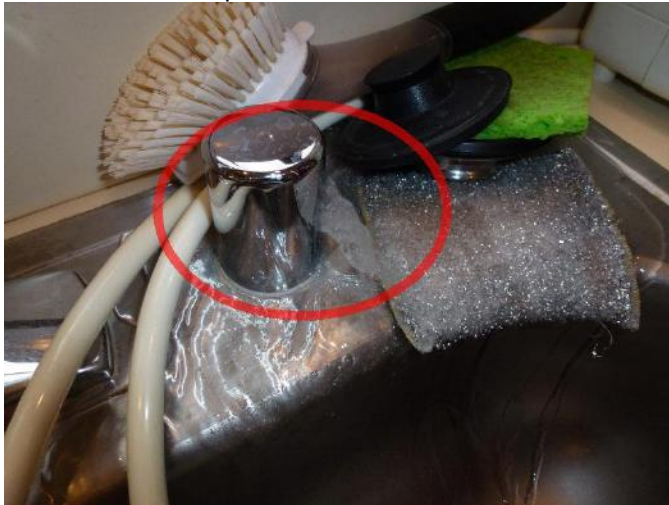
42. The following problems were noted at the air gap: The air gap is clogged and water is being discharged at top of sink, A licensed plumber should be called to make further evaluation and repairs as needed.

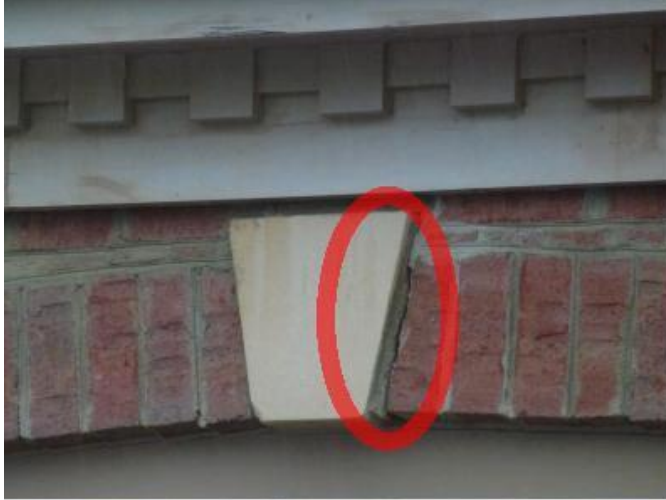
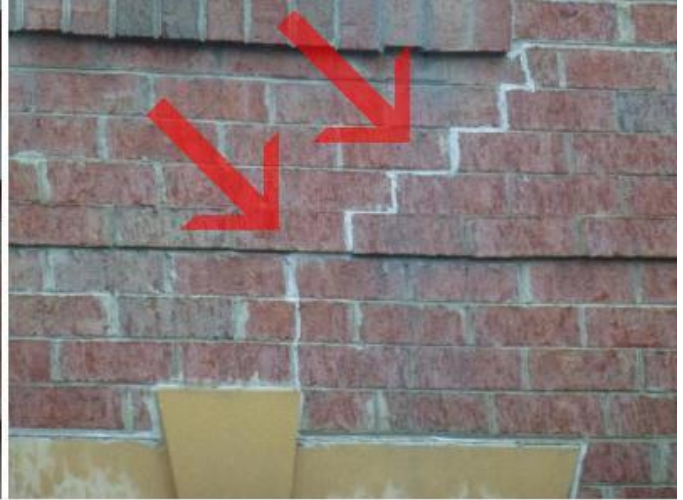
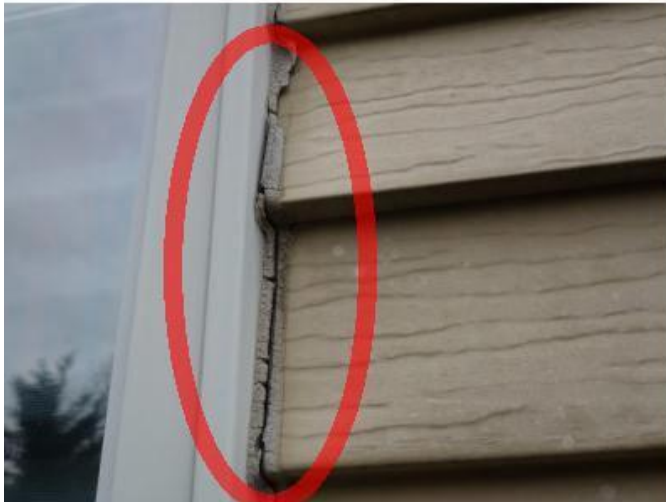
1. Cracks noted and deteriorated mortar is noted at garage, repaired crack noted at front window. Caulk gaps/cracks at window/s. The potential for water entry and damage is present.

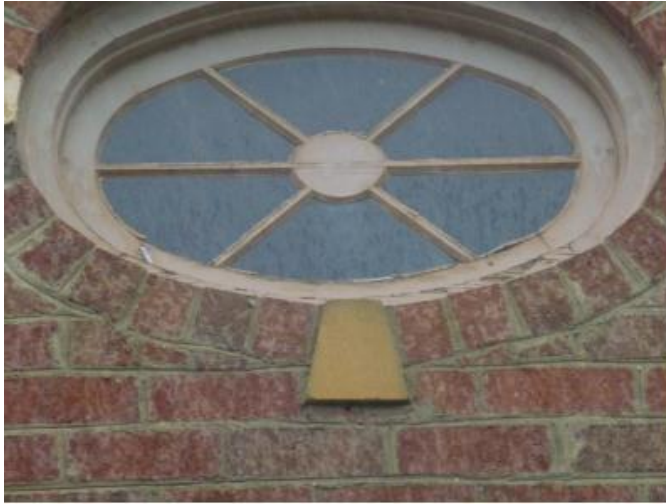
2. Peeling paint is noted at window/s throughout. Paint/finish needed.

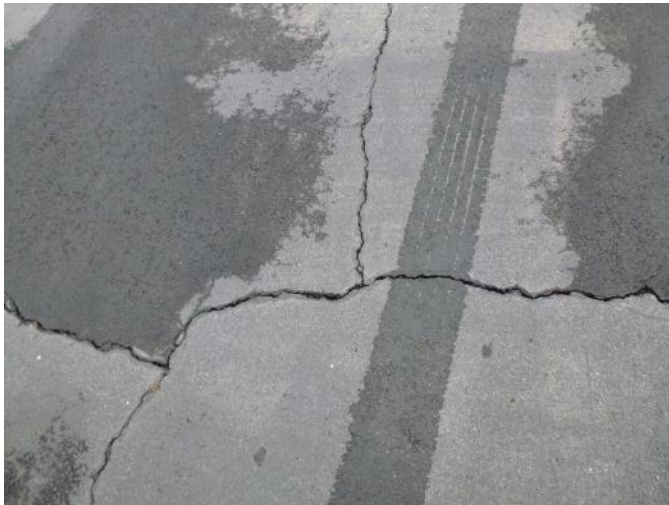
3. Cracks noted.

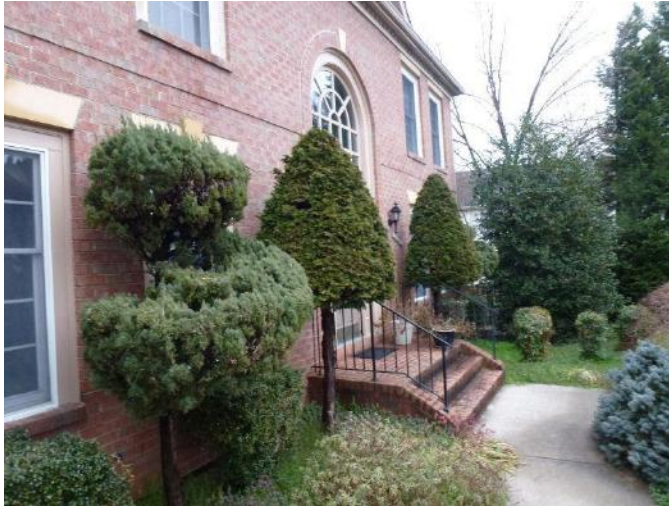
4. Trim plants /trees away from structure.

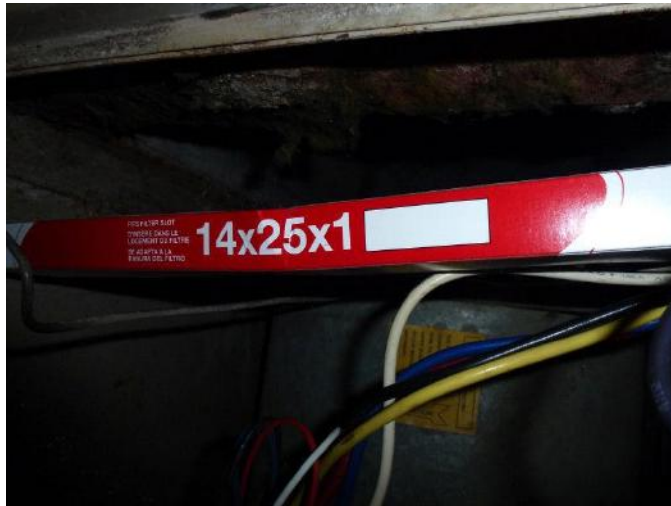
9. Filter size: 14x25x1: we recommend disposable "pleated" style filter. Filters should be changed/cleaned once a month or as needed. Filters are located at air handler.

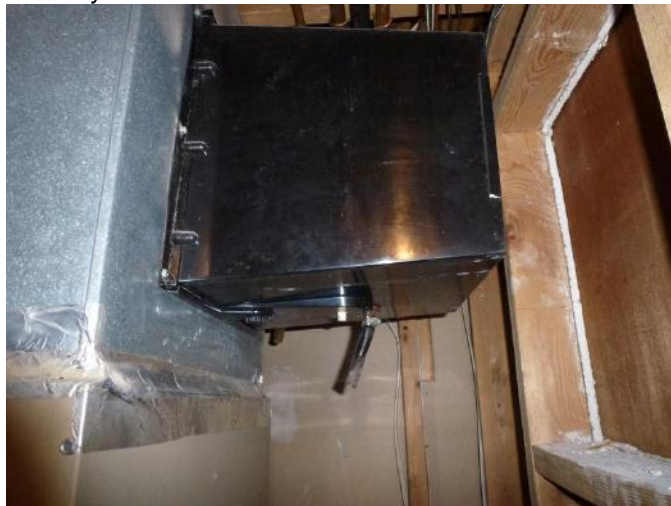
10. NOTE: Humidifiers are beyond the scope of this inspection. Service/replace humidifier evaporator pad annually or as needed.

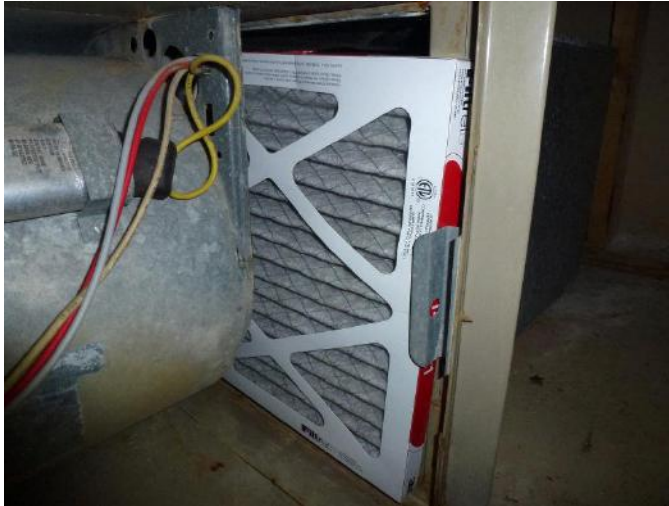
14. Filter size: 14x24x1: we recommend disposable "pleated" style filter. Filters should be changed/cleaned once a month or as needed.

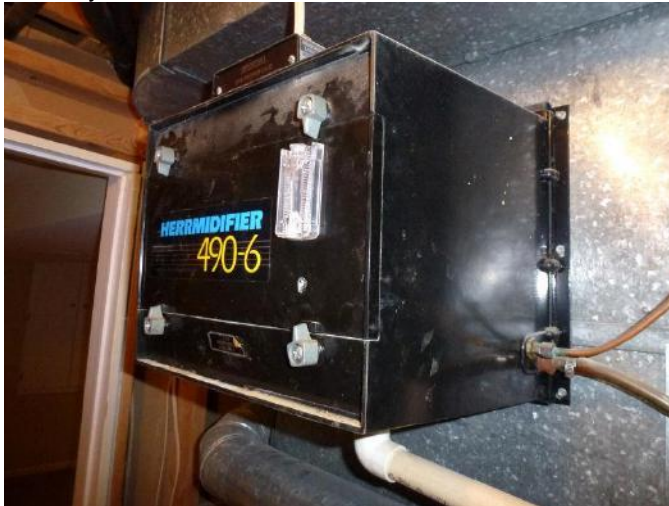
15. NOTE: Humidifiers are beyond the scope of this inspection. Service/replace humidifier evaporator pad annually or as needed.

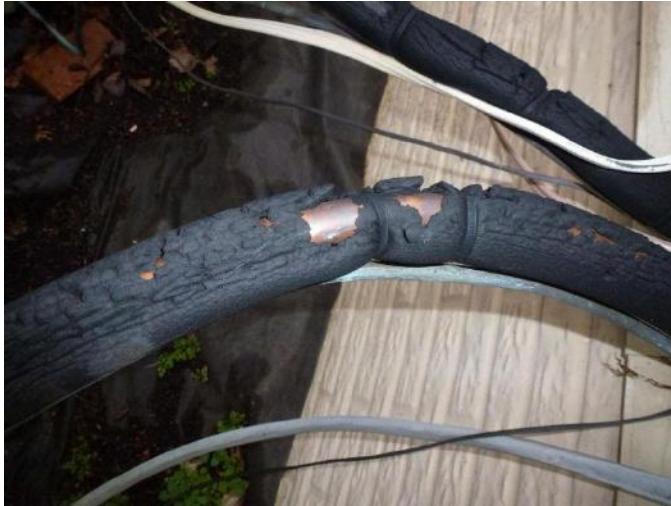
17. The following problems were noted at the compressor/outdoor unit: Insulation is damaged / missing on refrigerant line.

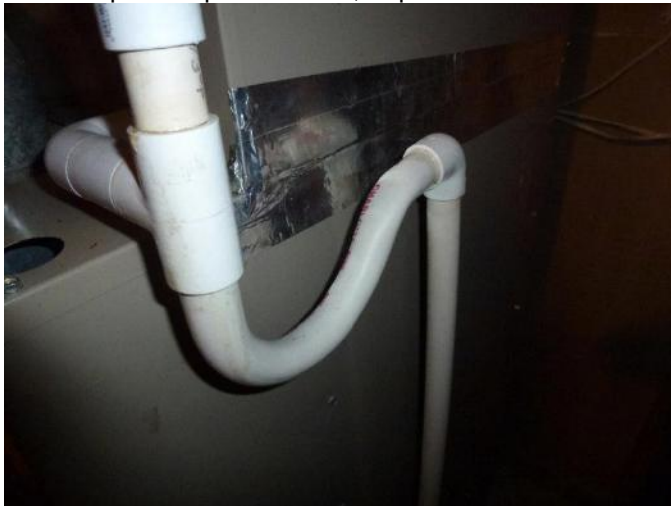
18. For optimum performance, trap should be cleaned at regular intervals, particularly in the summer.

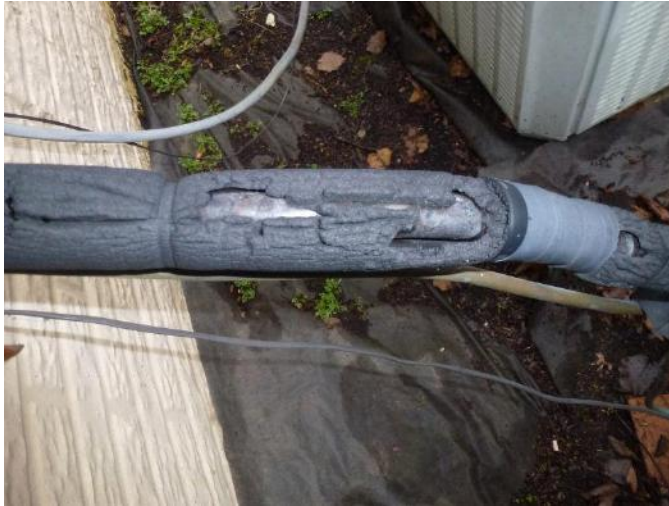
19. The following problems were noted at the compressor/outdoor unit: Insulation is damaged / missing on refrigerant line.

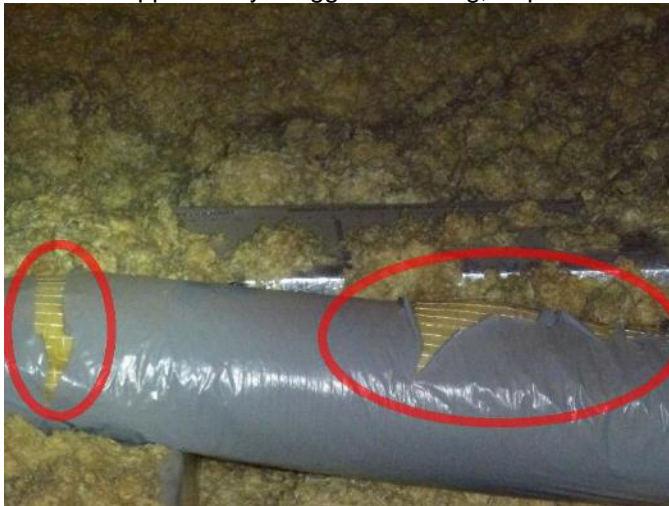
20. Ducts appear dirty. Suggest cleaning, Vapor barrier at flexible round ductwork is loose/deteriorated in the attic.

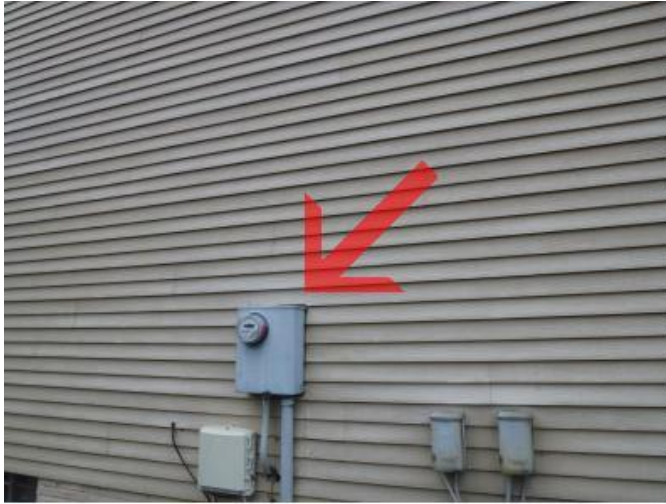
21. Gaps are noted at the meter SE cable entry / electrical meter. The potential of water entry is present, seal/caulk as needed.

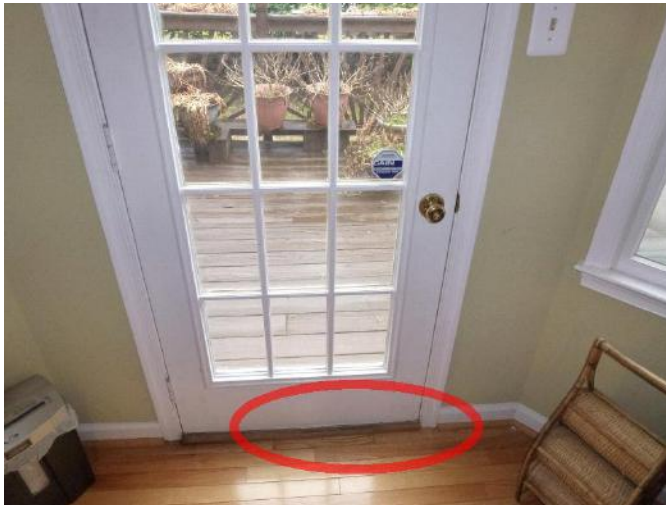
22. Doors rub/stick at deck.

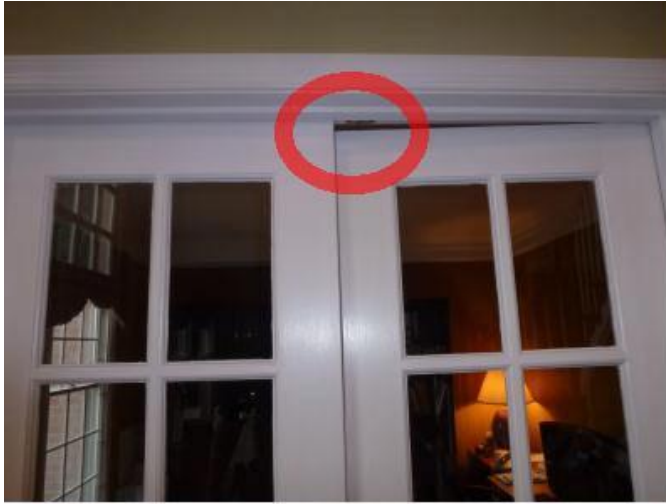
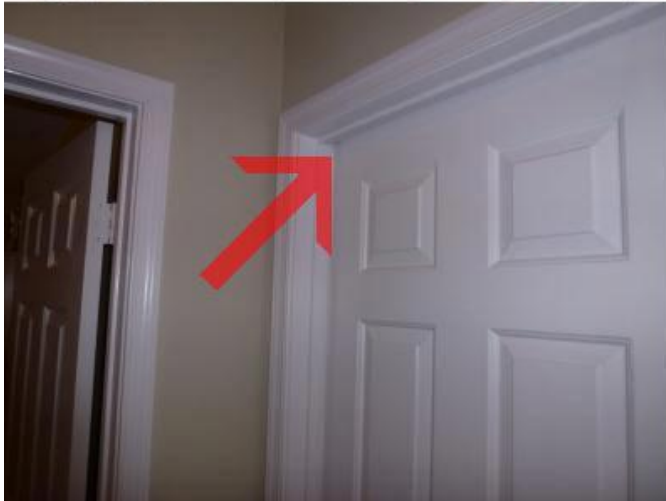
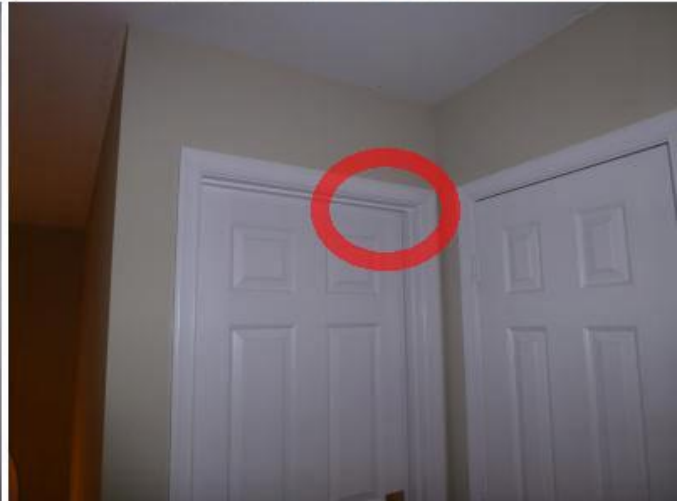
23. Doors don't latch at office and hallway closet on main level. Doors rub/stick at front bedrooms.

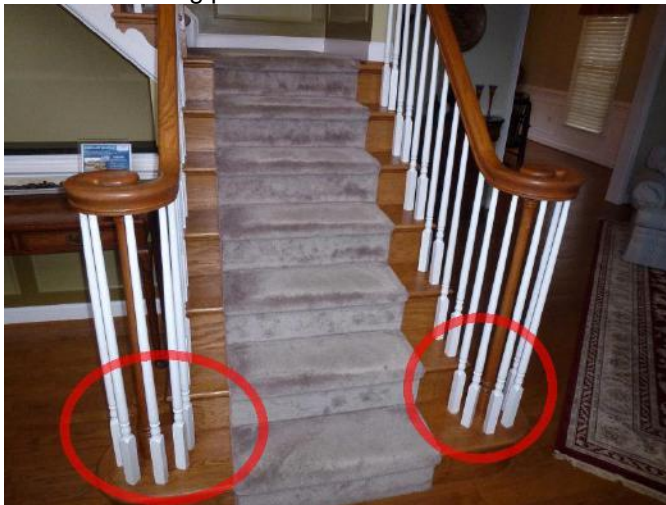
24. The following problems were noted at the handrail: loose in foyer.

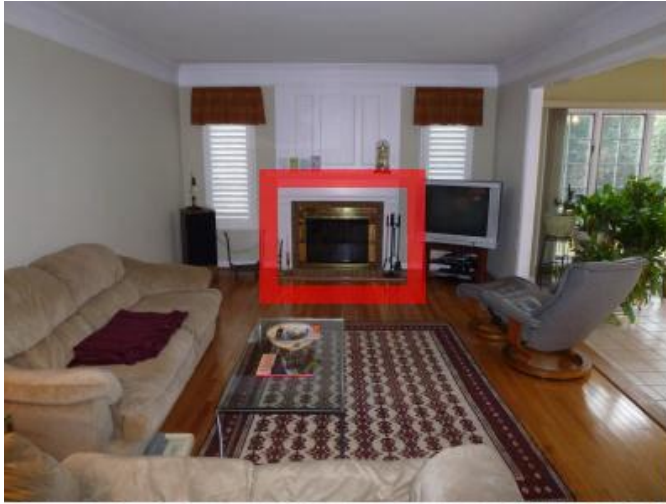
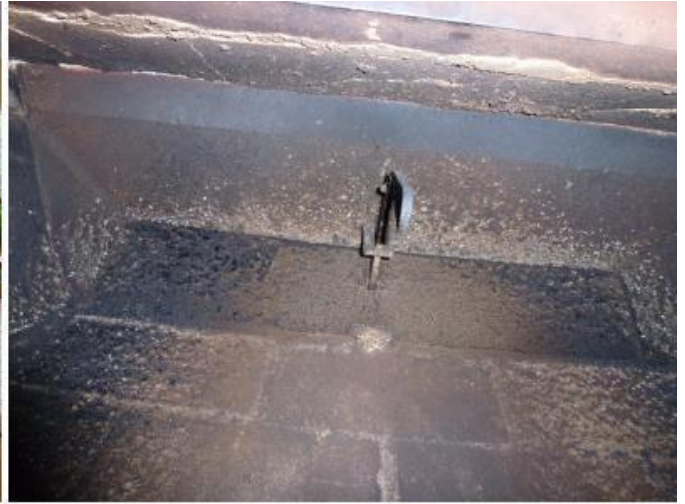
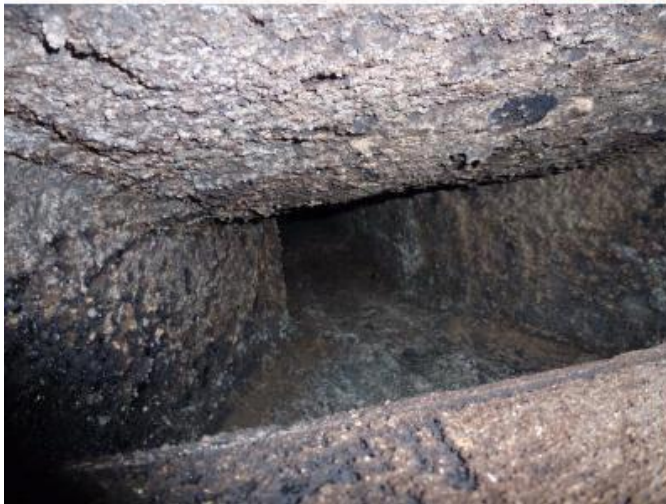
25. Recommend cleaning and inspection. As a rule of thumb, chimney should be swept after burning 2 - 3 cords of wood.

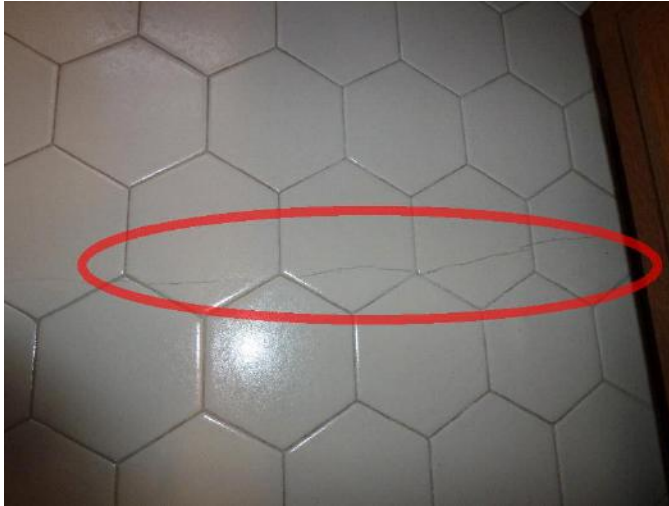
26. The following problems were noted at the floor: tile/s are cracked.

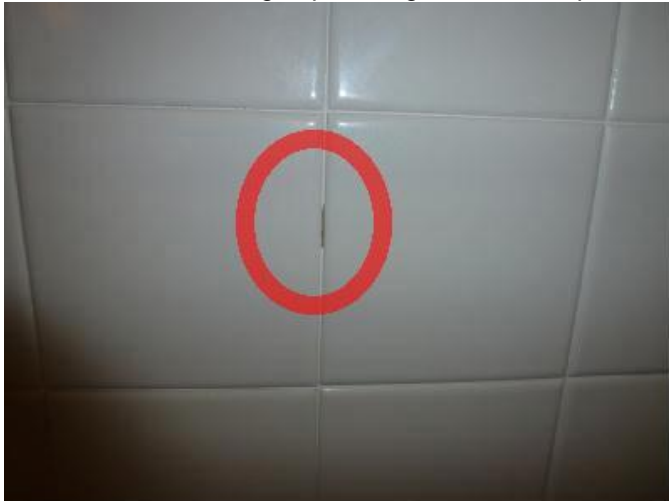
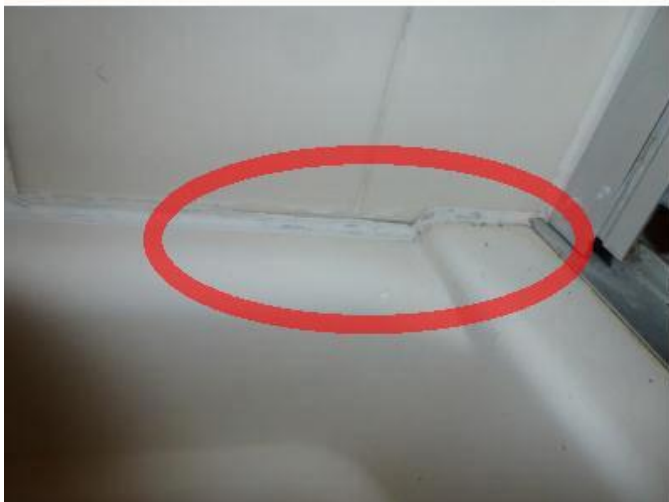
27. Grout is missing/deteriorated - re-grouting is needed to prevent water intrusion, Caulk and seal all tub and shower areas including at plumbing fixtures as a precaution.

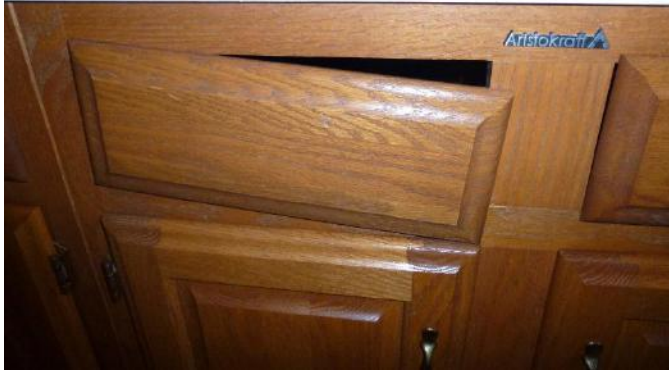
28. The following problems were noted: vanity is damaged.

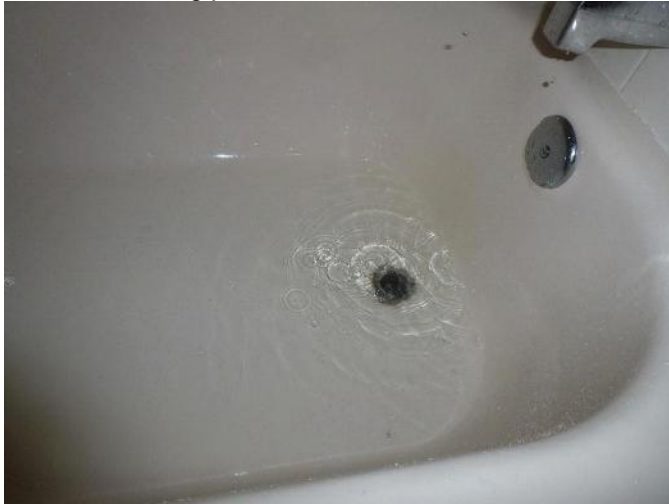
29. The following problems were noted at the drain: drain is slow at tub.

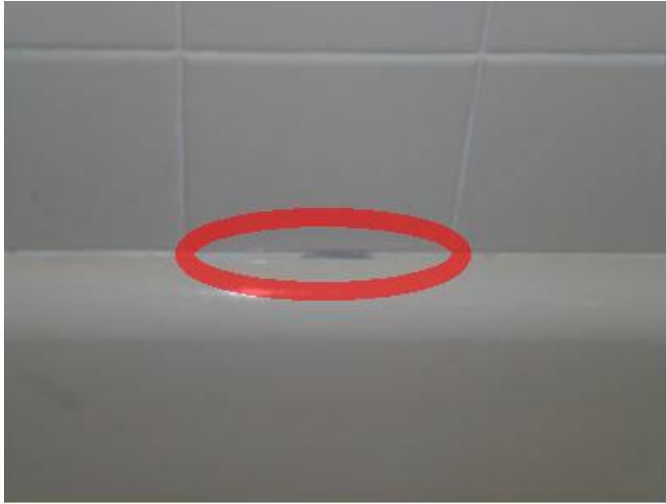
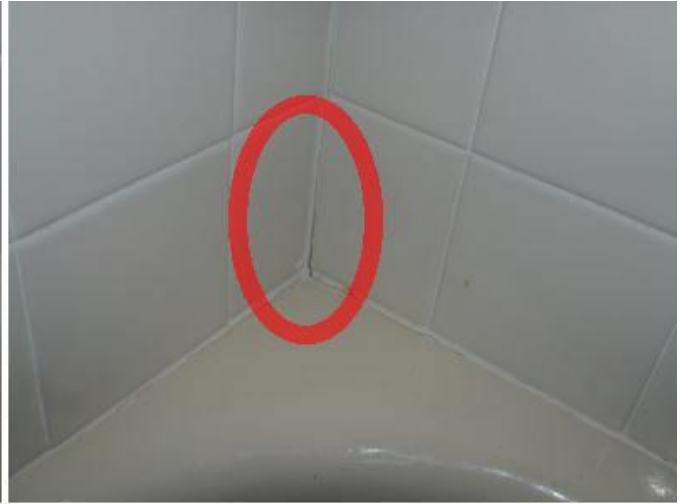
30. Caulk and seal all tub and shower areas including at plumbing fixtures as a precaution.

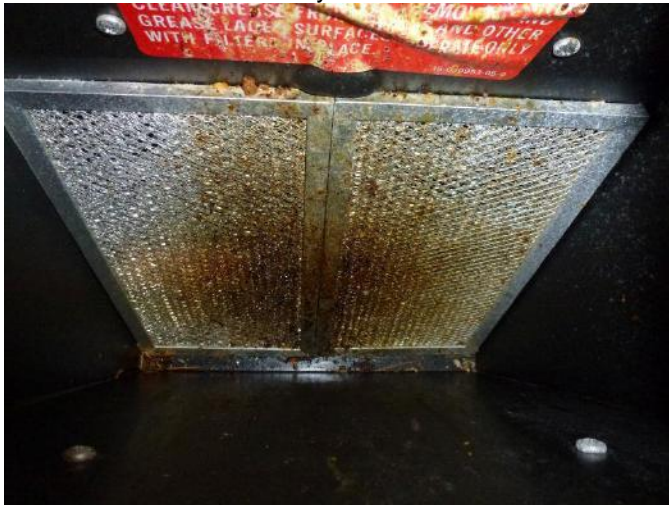
31. Exhaust fan/filter is dirty.

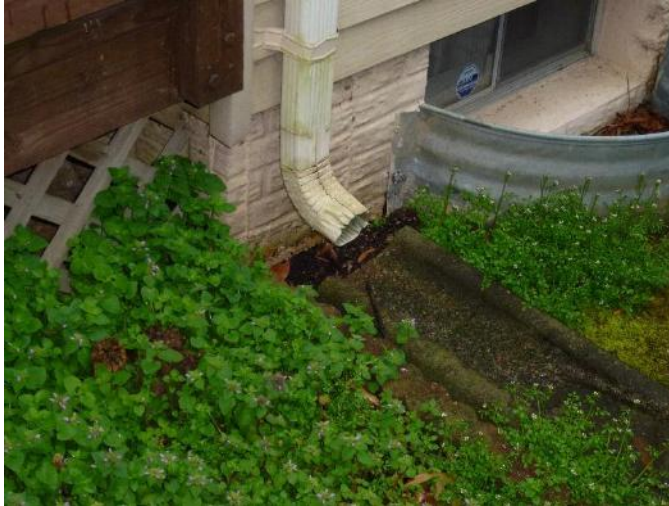
1. Route downspouts away from the building.

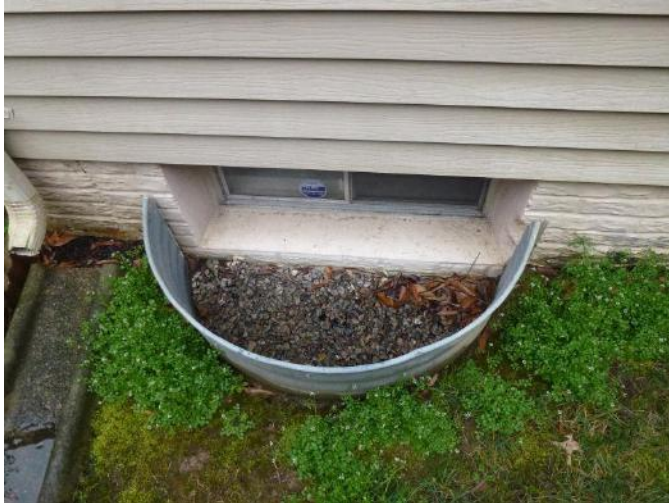
2. Consider installing a window well cover to prevent water intrusion.

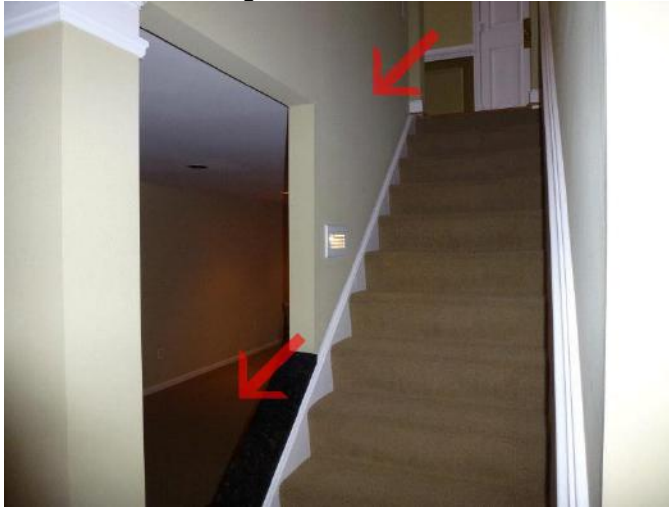
4. Handrail is missing. Correction is recommended.

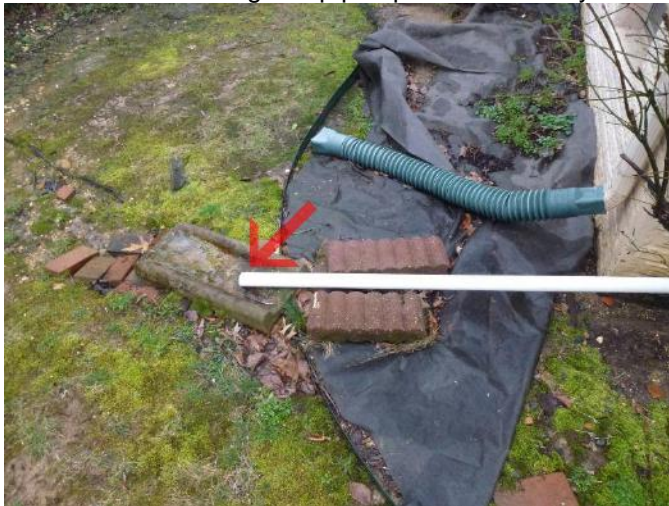
5. Consider extending sump pump drain line away from foundation.

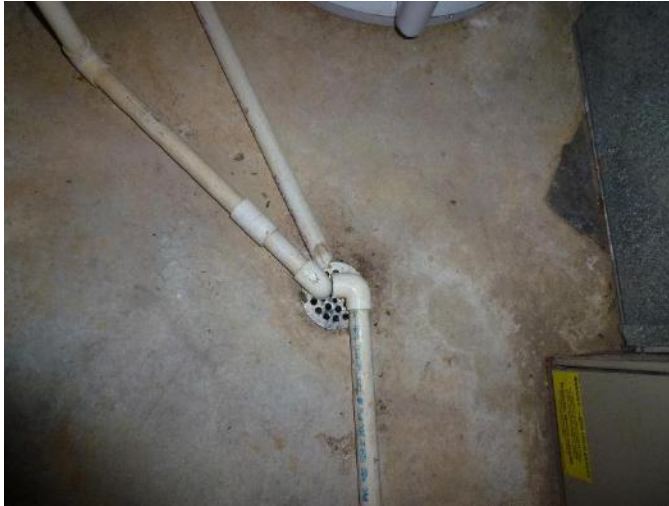
6. Subsurface drains noted. Adequacy of this drainage system is not determined due to the underground nature. Consider having the drain "scoped" / inspected by a licensed plumber.

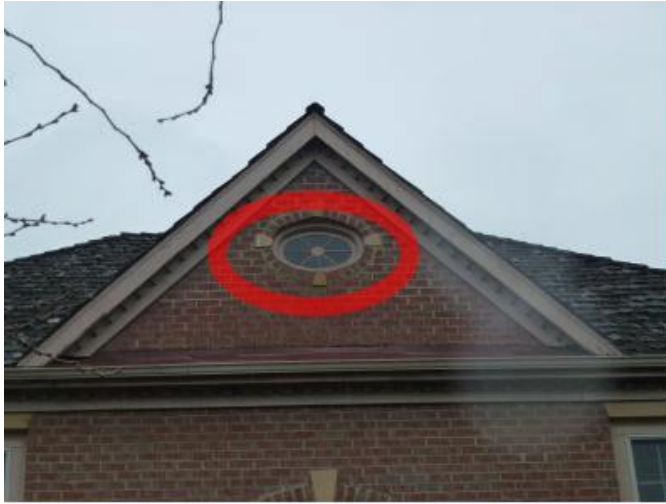
12. Flexible ducts should not be exposed to direct sunlight. UV rays can damage the vapor barrier. Consider covering windows in the attic.

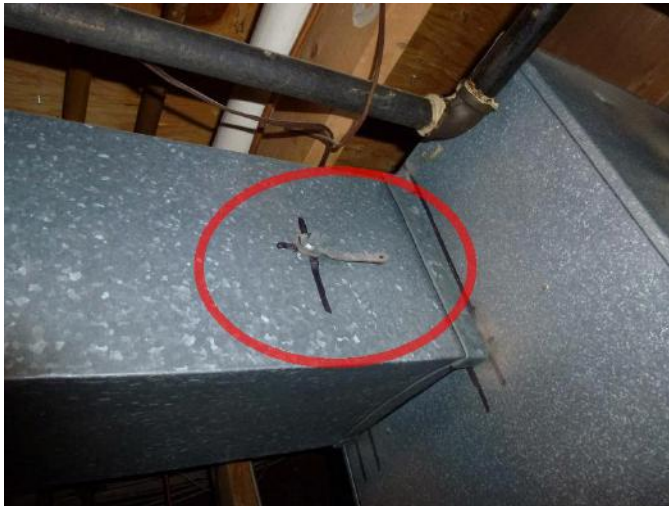
13. Ask HVAC contractor to mark dampers "winter" and "summer", in order to better balance air flow during different seasons.

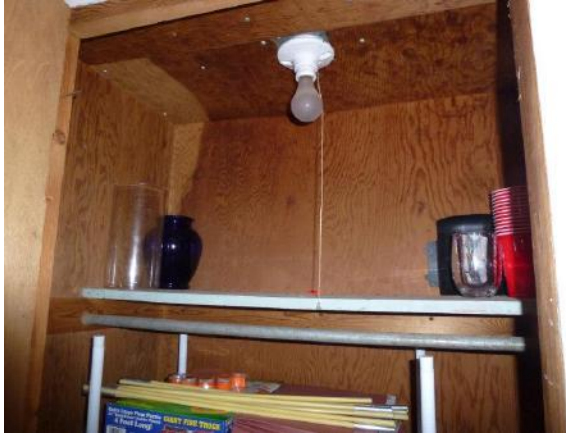
14. Ground Fault Circuit Interrupter (GFCI) receptacles are recommended for kitchens. Consider removing incandescent light bulb from the vicinity of shelving. Potential fire hazard. You can also replace existing incandescent light bulb with a fluorescent bulb/light fixture

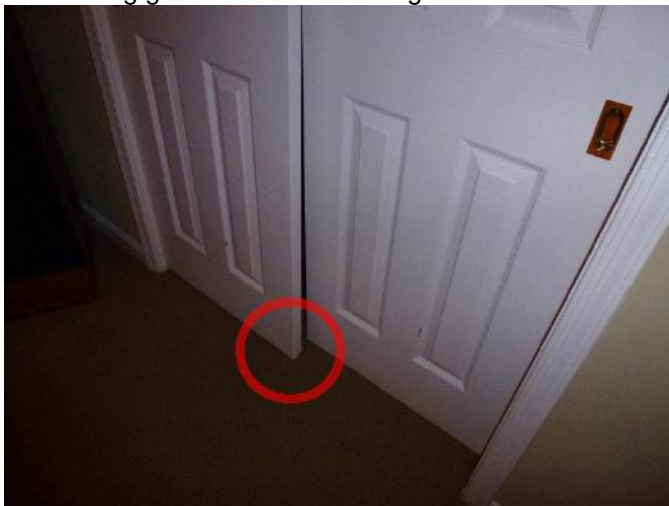
15. Missing guide is noted at sliding doors in basement.

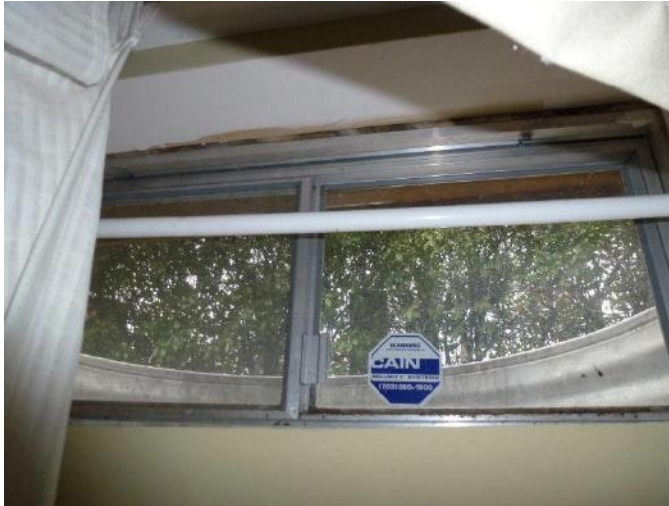
16. Single pane in basement. Consider installing double pane, insulated windows for better energy efficiency.

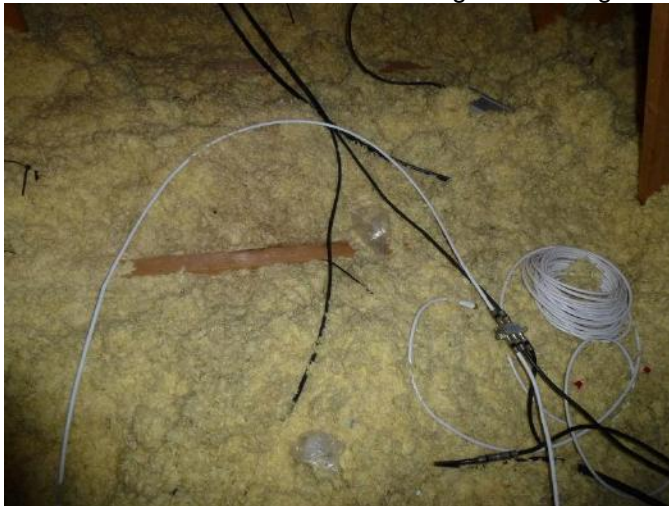
17. Insulation has been disturbed and good coverage is no longer present.

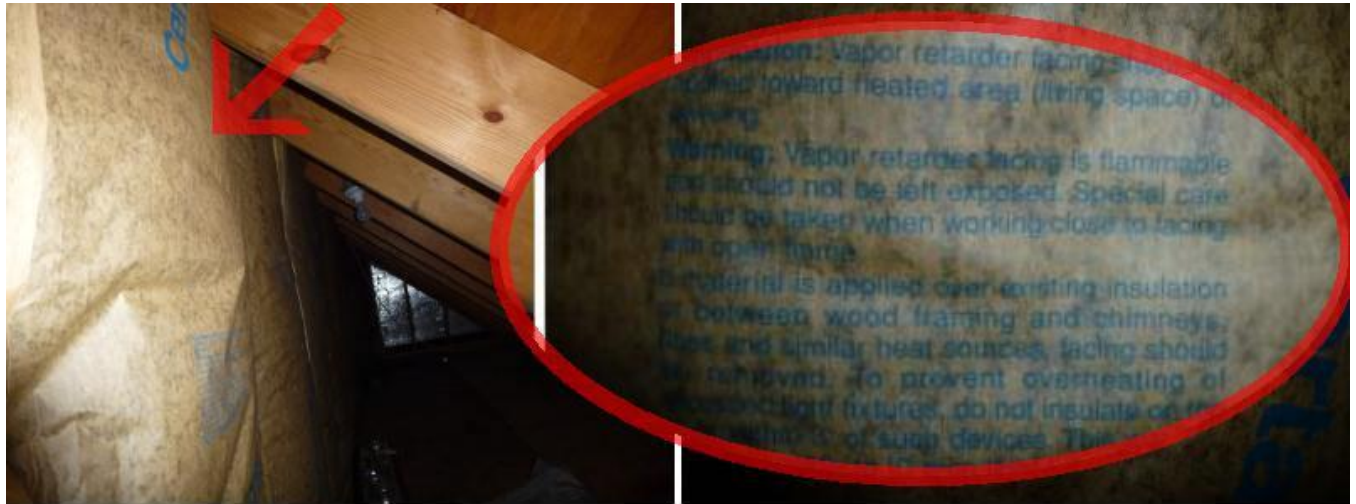
18. Insulation is installed upside down/backwards. Vapor barrier should be installed toward conditioned space. If another layer of insulation is added on top of existing layer, unfaced insulation should be used.

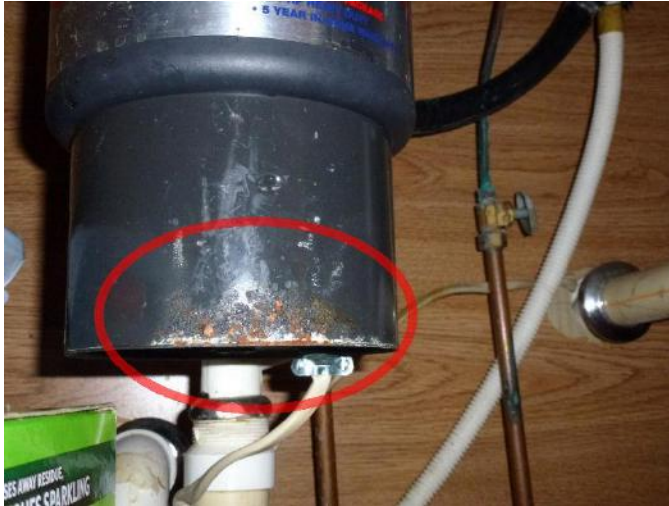
24. Unit is an older model. Unit is near the end of its useful life. Rusting is noted on body of the disposal.

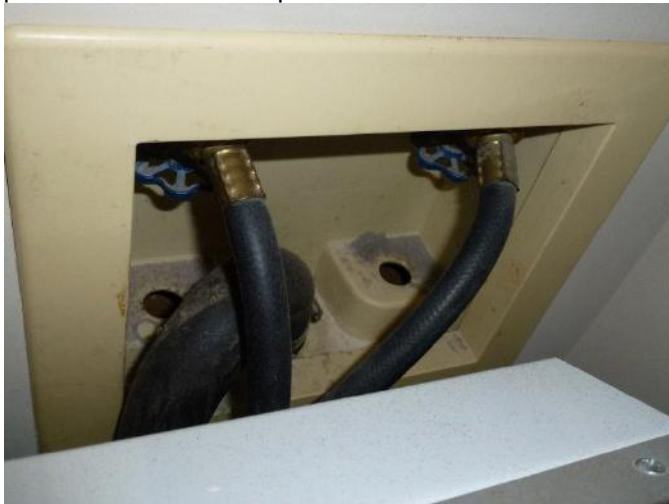
25. Washing machine is an older model. Unit is nearing the end of its useful life, Consider installing burst-proof supply hoses. Our recommendation is to check hoses frequently and replace them every 3-5 years as part of a proactive maintenance plan.

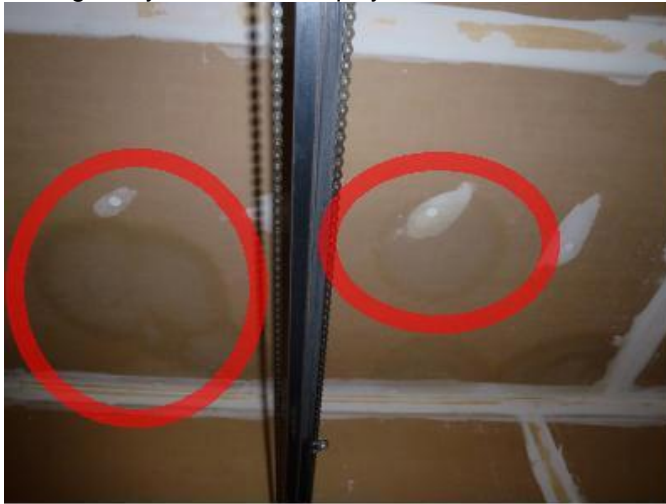
2. Stains noted at ceiling. Unable to determine if active leakage exists, not wet today, monitor in the future. Hidden damage may exist. Make inquiry with the seller as to the history of leaks.

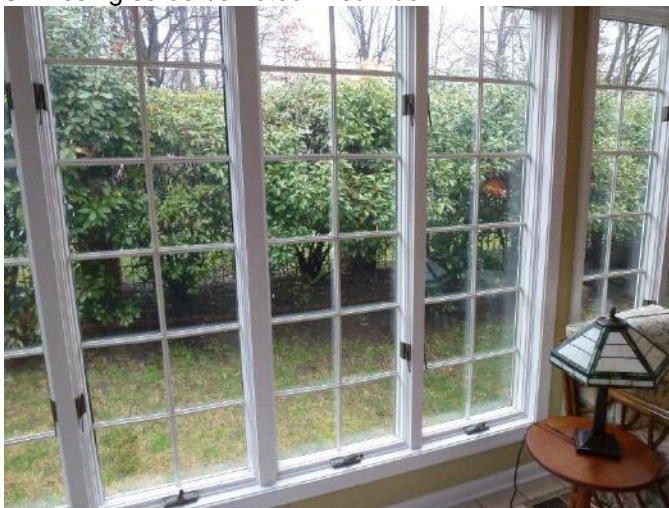
3. Missing screen/s noted in sunroom.

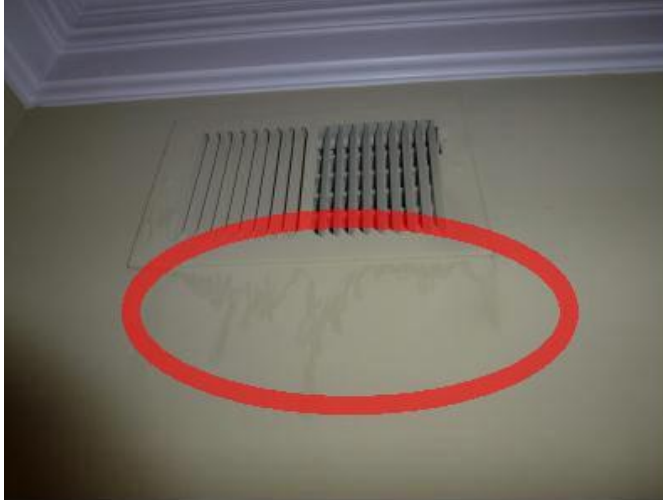
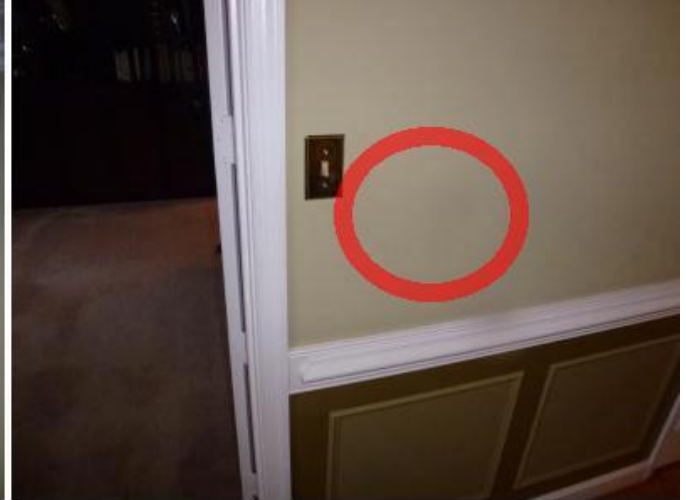
4. Stains noted in foyer. Unable to determine if active leakage exists, not wet today, monitor in the future. Hidden damage may exist. Make inquiry with the seller as to the history of leaks.

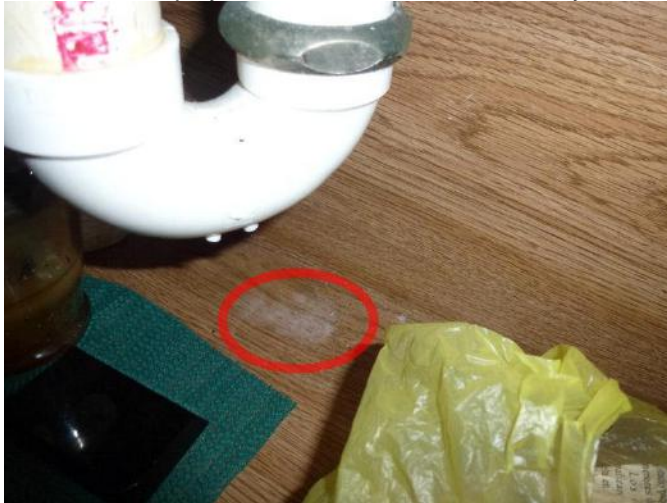
5. Stains noted under the sink. Unable to determine if active leakage exists, not wet today. Hidden damage may exist. Make inquiry with the seller as to the history of leaks.

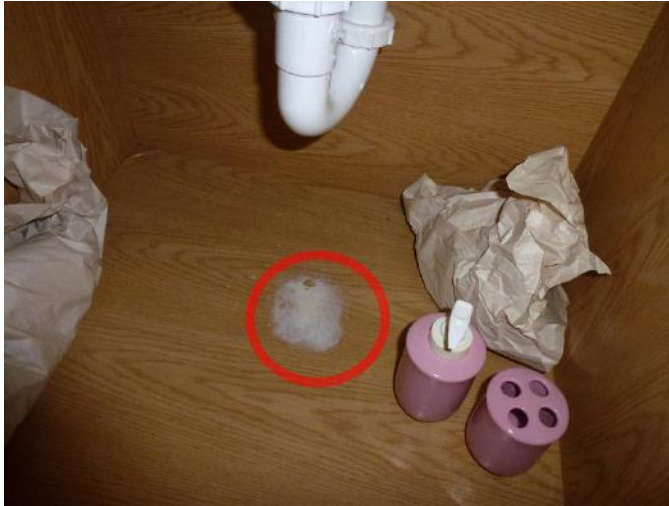
6. Stains noted under the sink. Unable to determine if active leakage exists, not wet today. Hidden damage may exist. Make inquiry with the seller as to the history of leaks.
