**123 Main St
Fairfax, VA 22310**

**Prepared by
House Inspection Associates LLC
VA/MD/DC: 703 453-0442
www.HouseInspectionAssociates.com**

January 1, 2012

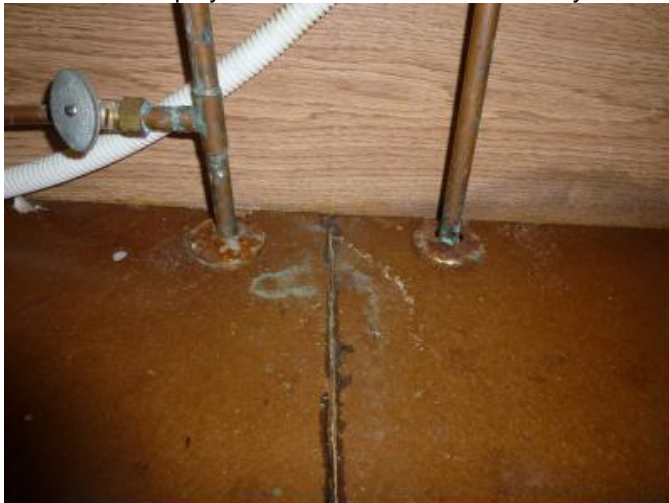
7. Stains noted under the sink. Unable to determine if active leakage exists, not wet today. Hidden damage may exist. Make inquiry with the seller as to the history of leaks.

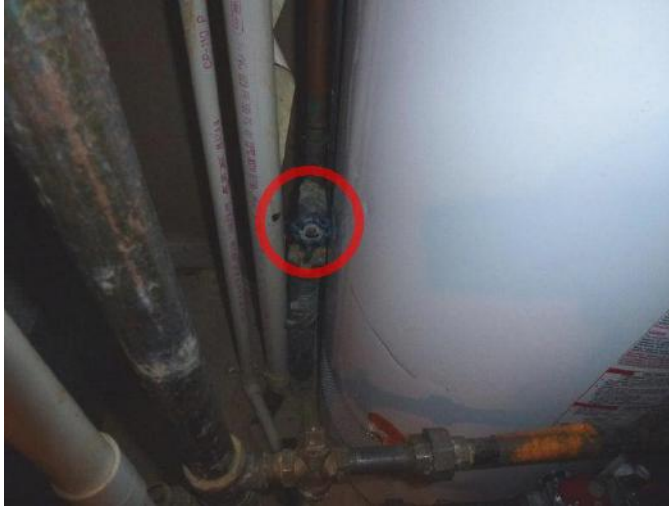
1. Basement, At water heater.

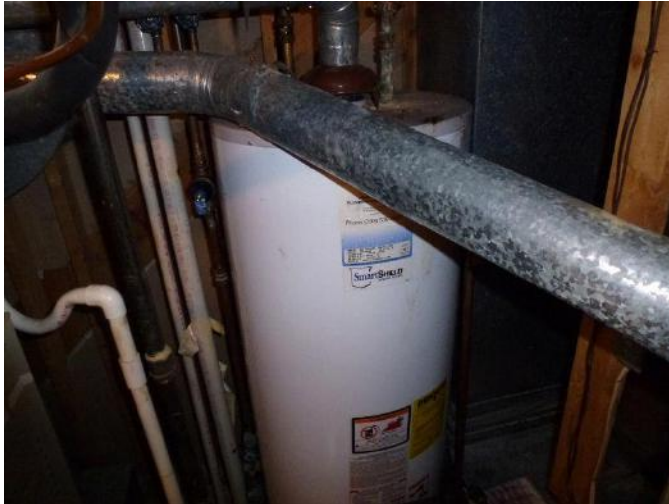
2. Access to the water heater is restricted.

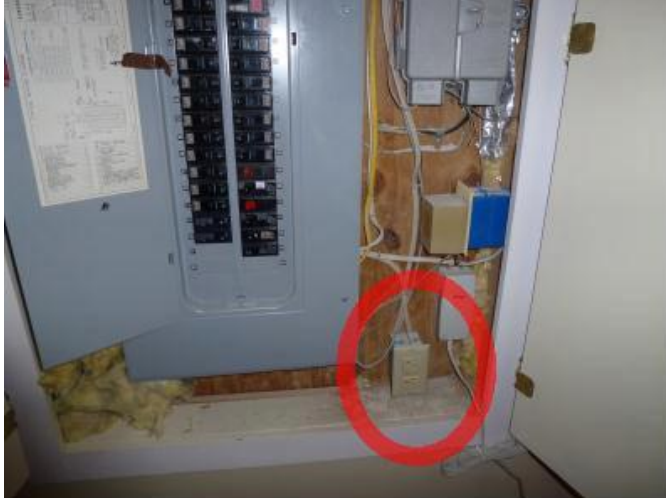
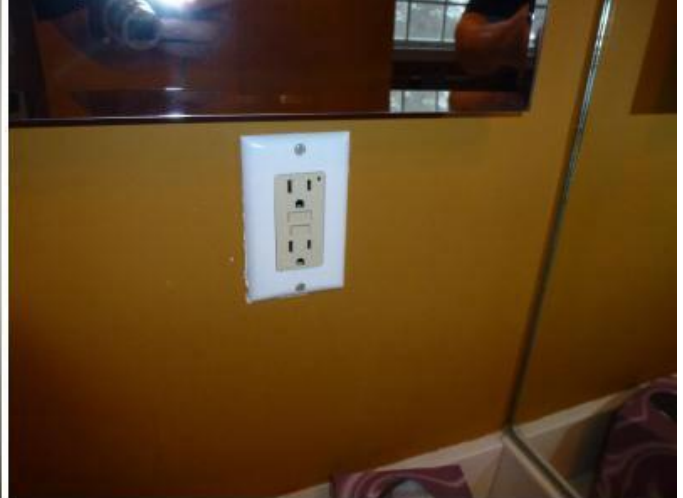
5. Exterior GFCI receptacles reset at main electrical panel, Bathroom GFCI receptacles reset in hall bathroom.

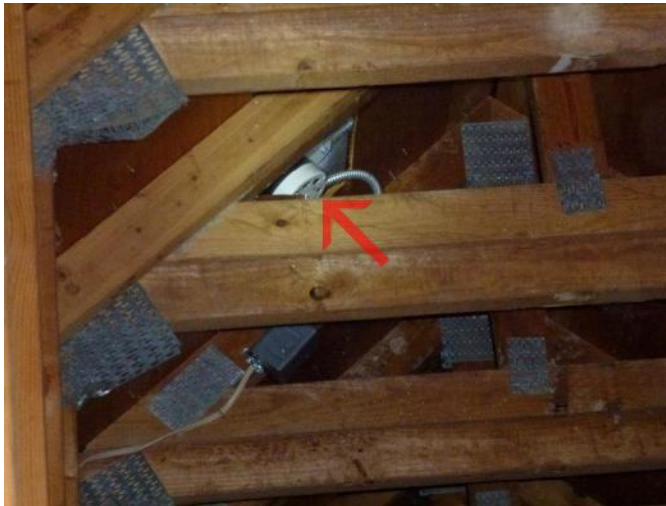
6. Attic fan is installed, not tested. controls / thermostat was difficult to reach or the temperature was too low for the thermostat to activate.

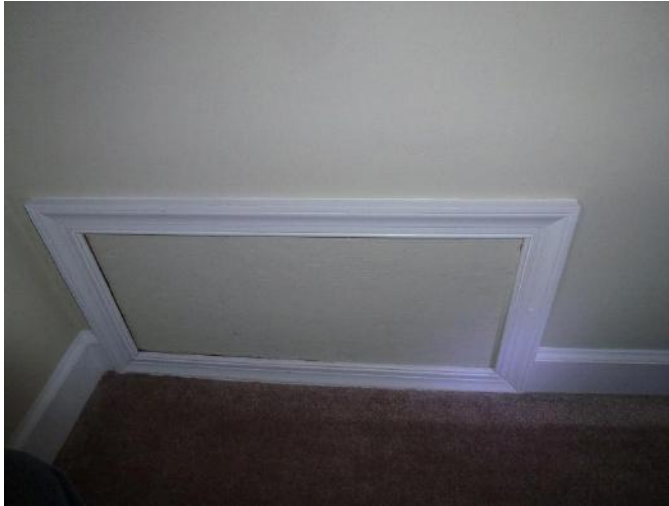
7. Unable to inspect electrical wiring, motor & hoses because access door is sealed shut.

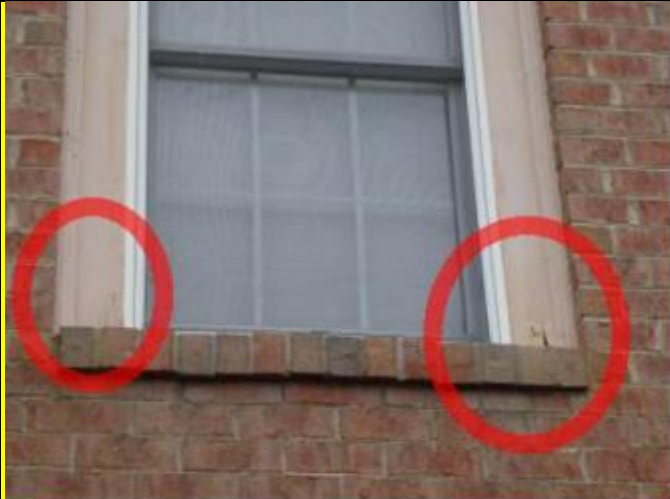
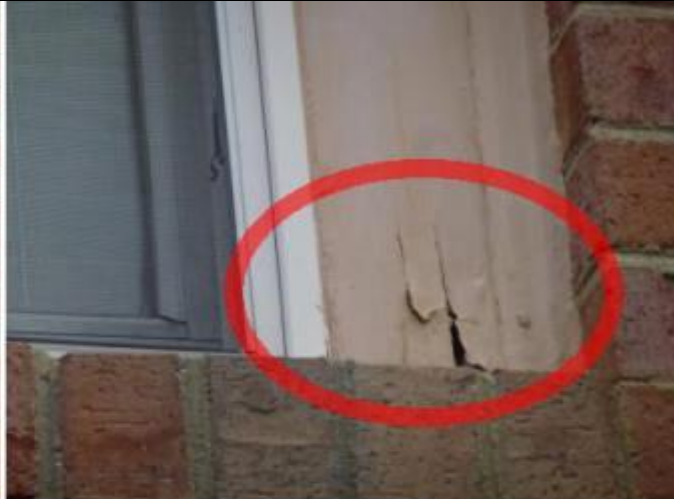
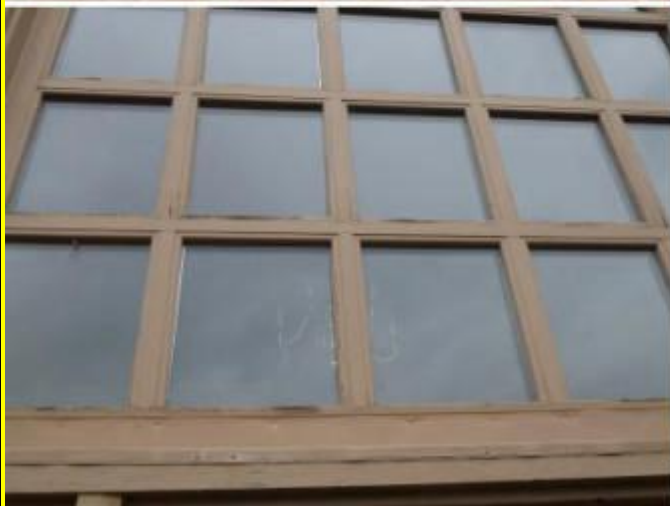
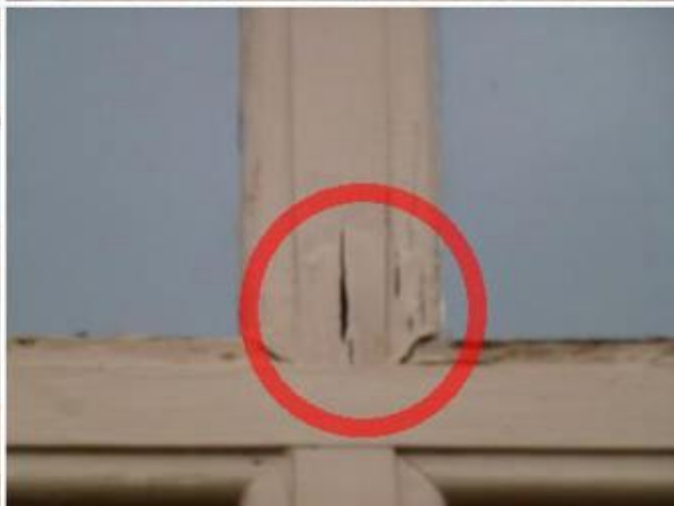
Soft spots/Rot noted at window/s throughout. Hidden damage may exist.

Soft spots/Rot noted at door trim throughout.

Soft spots/Rot noted at bay window/s, corner/s, and rake board/s.

Peeling paint is noted at window/s throughout. Paint/finish needed.

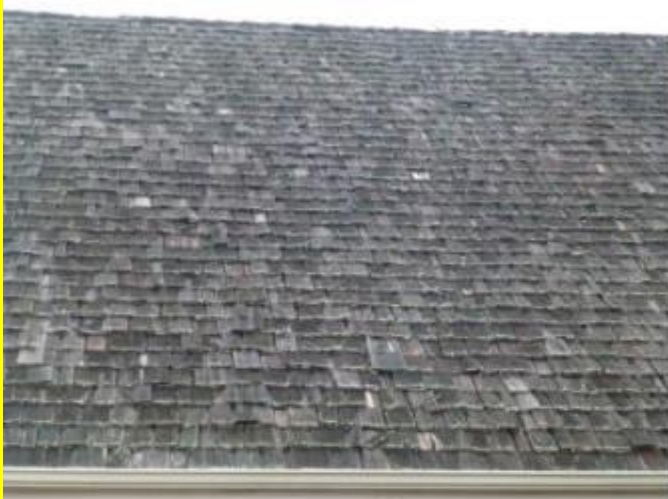
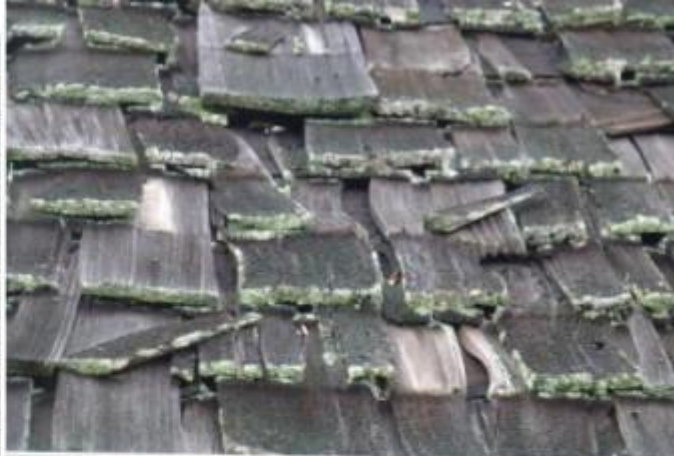
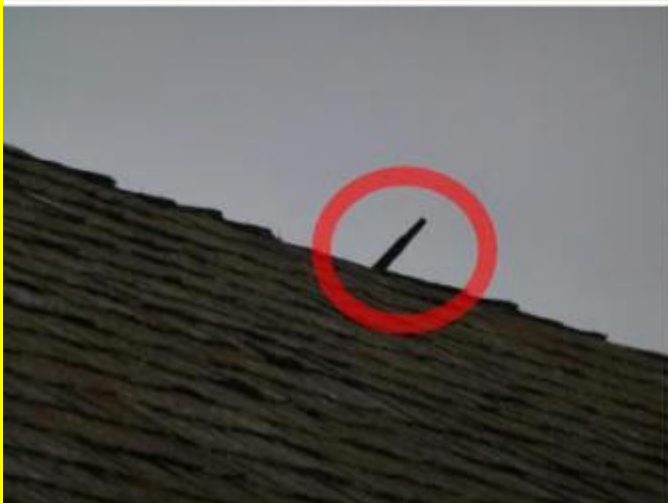
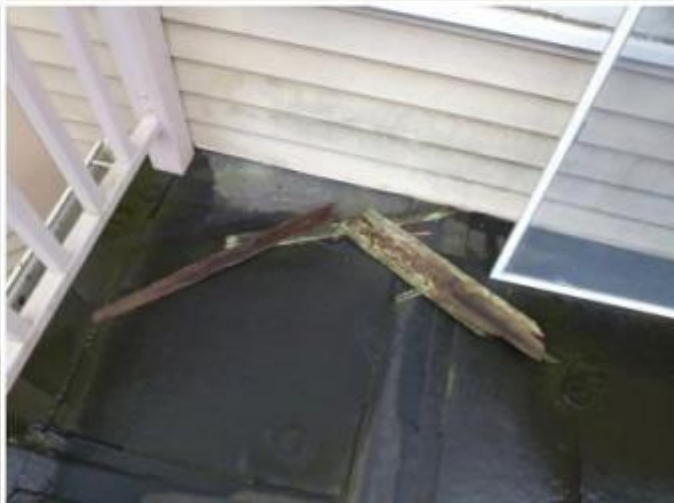
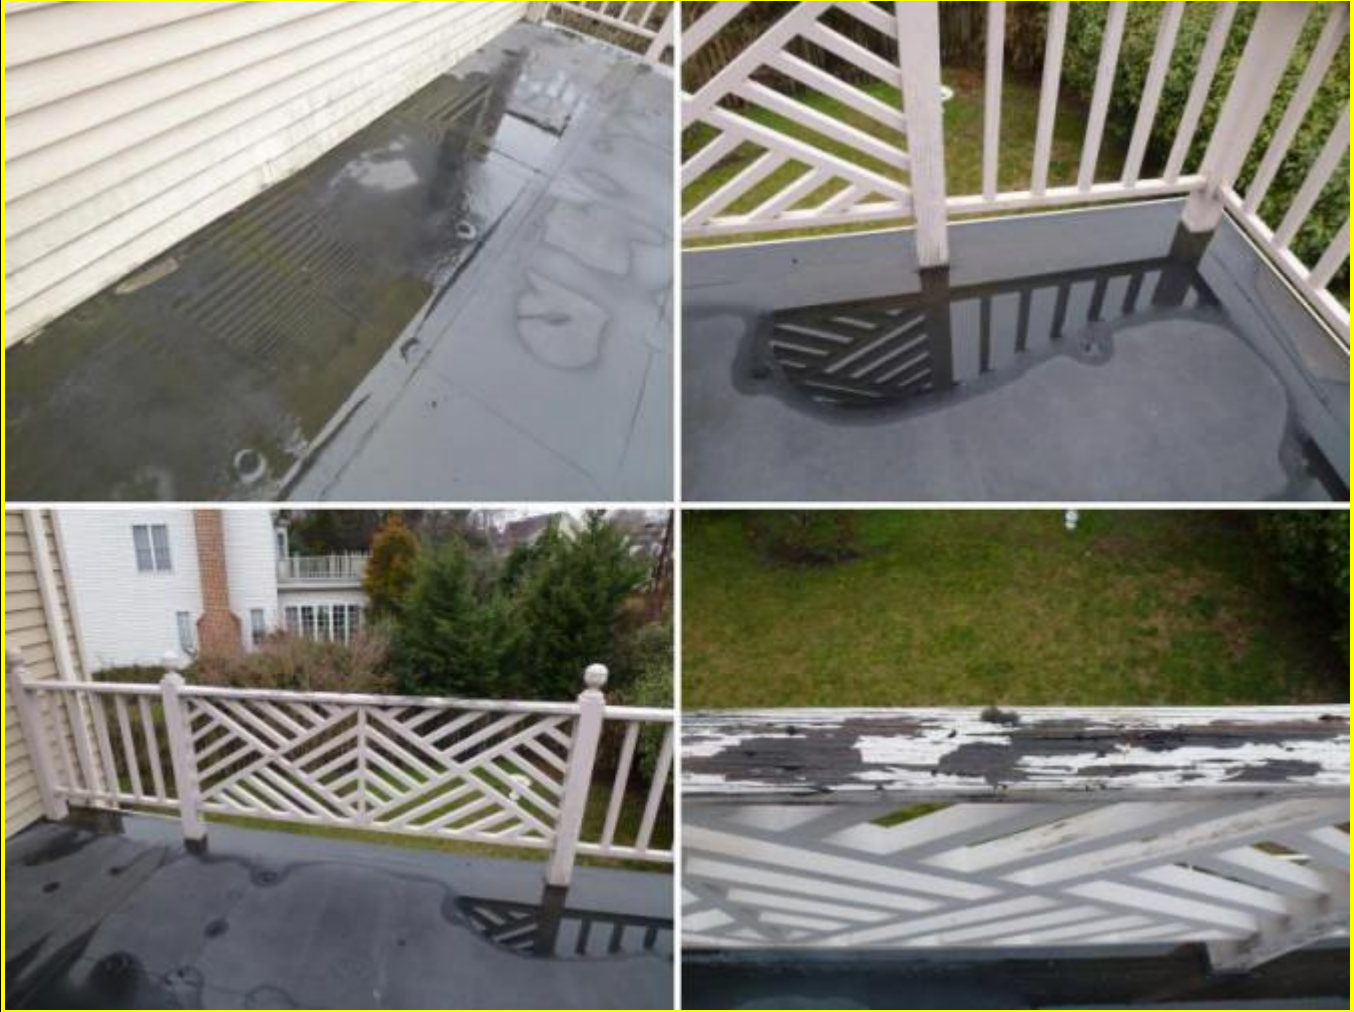
Damaged or missing shingles noted throughout. Roof is past the end of its useful life, A licensed roofing contractor should be called to make further evaluation and repairs as needed.

Evidence of ponding/poor drainage, The potential for water entry is present. Handrail is loose and rotted. A licensed roofing contractor should be called to make further evaluation and repairs as needed.

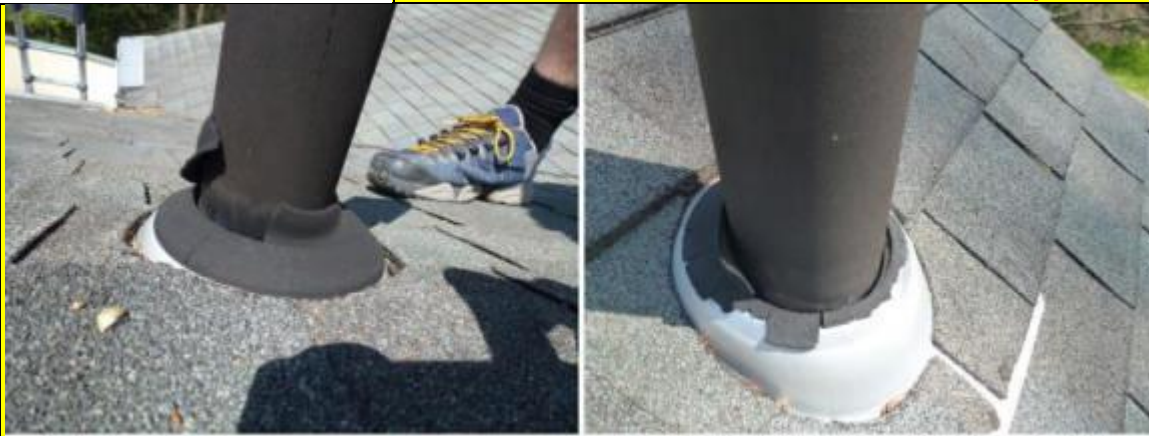
Separated/Deteriorated flashing noted at vent pipe/s. The potential for water entry and damage is present. Hidden damage may exist. A licensed roofing contractor should be called to make further evaluation and repairs as needed.

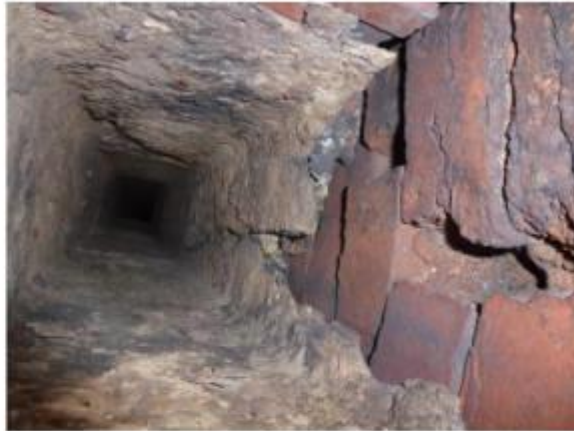
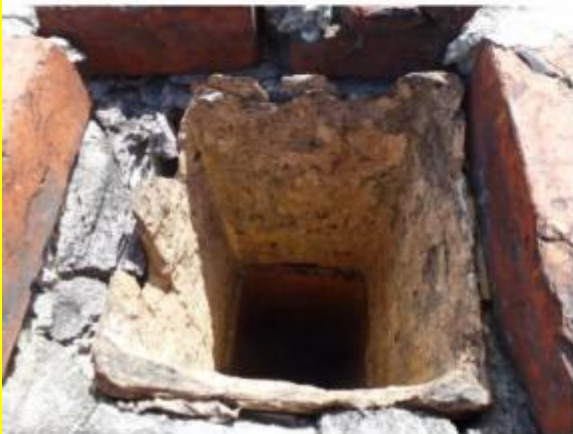
Chimney is separated. The flue is damaged/deteriorated, A licensed contractor should be called to make further evaluation and repairs as needed.

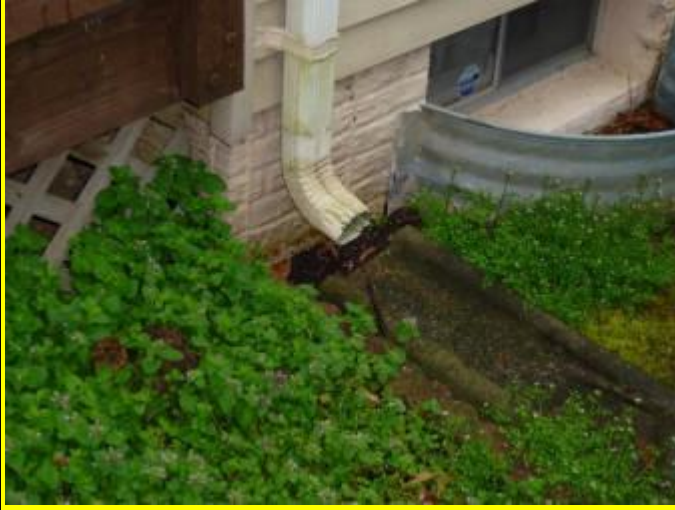
Route downspouts away from the building.

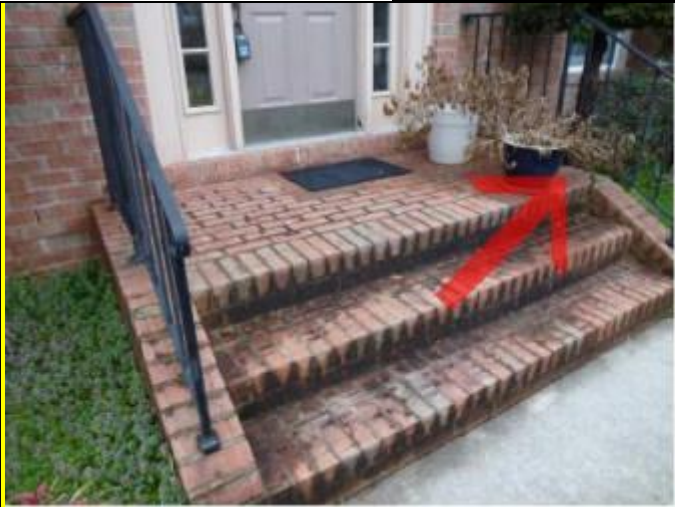
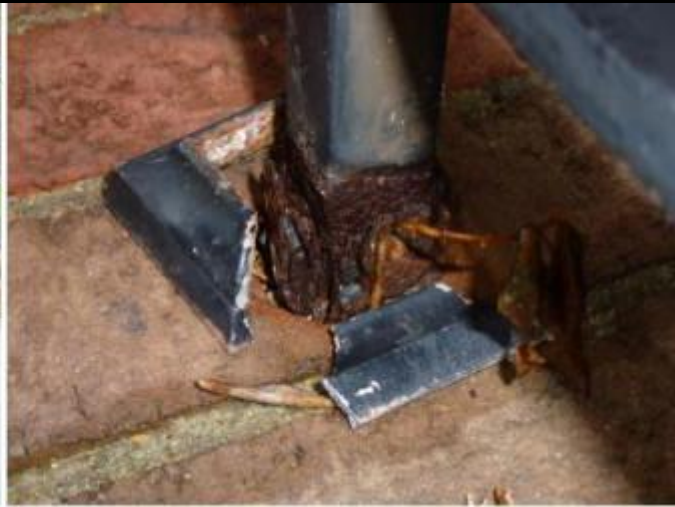
Appears serviceable, Stairs are serviceable, Cracks noted are typical

The following problems were noted at the handrail: damaged.

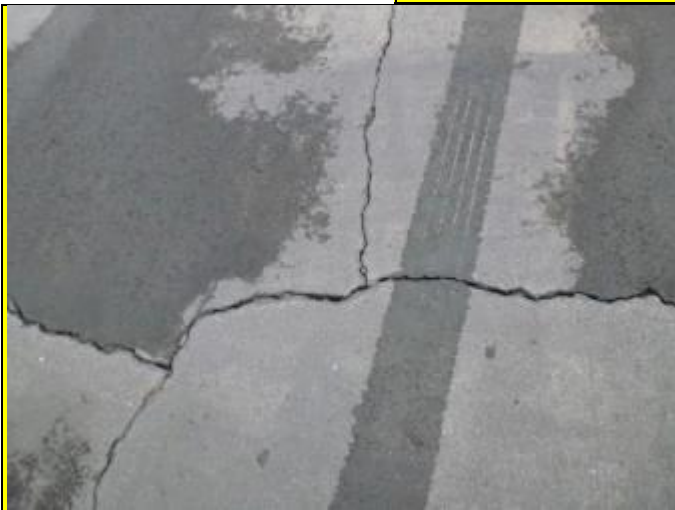
Cracks noted.

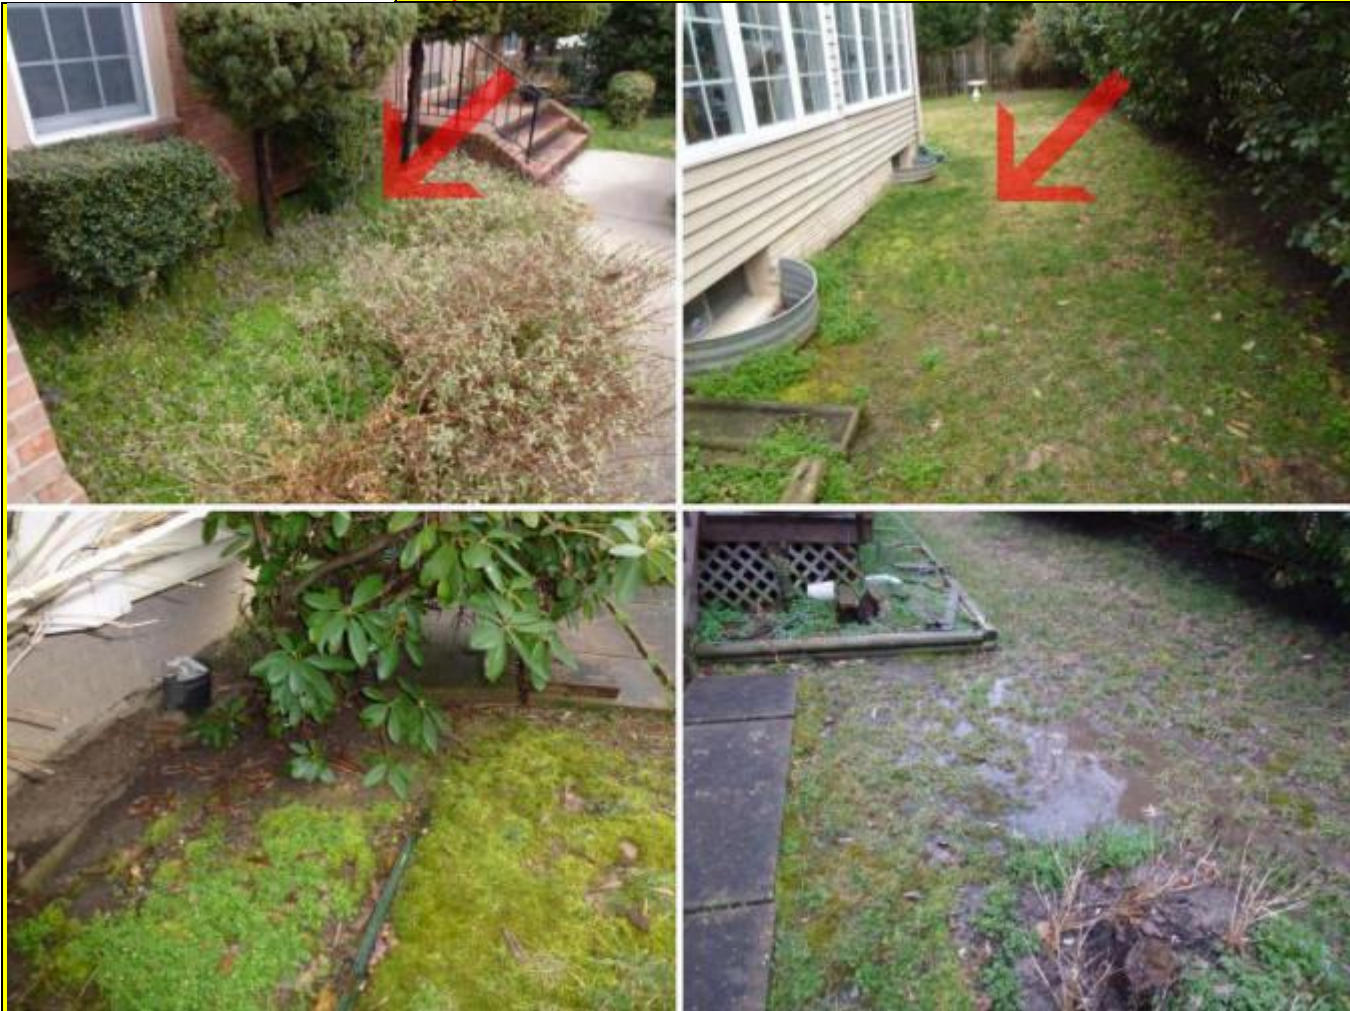
SITE & CONDITION:	Gentle slope, Pitch slope of soils away from foundation. Slope should fall away from the foundation at a minimum of 1/2 inch per foot and extend at least 10 feet away from the foundation
-------------------	--

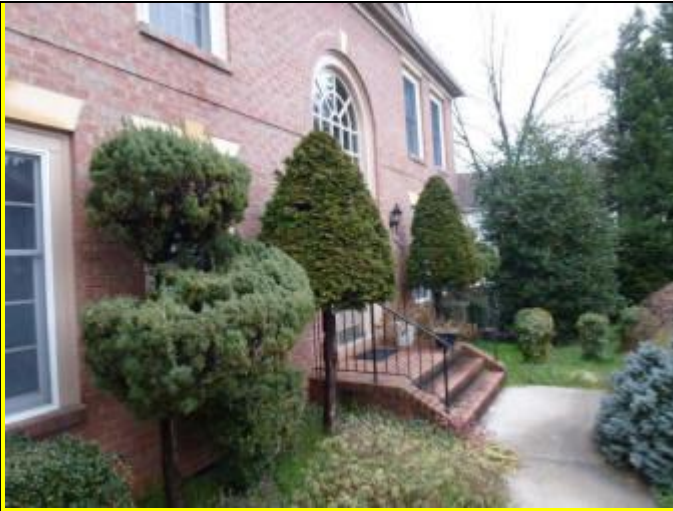
CONDITION:	Trim plants /trees away from structure.
------------	---

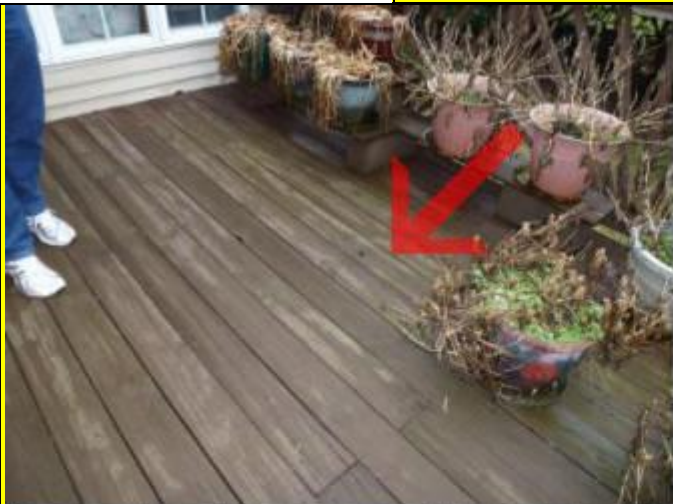
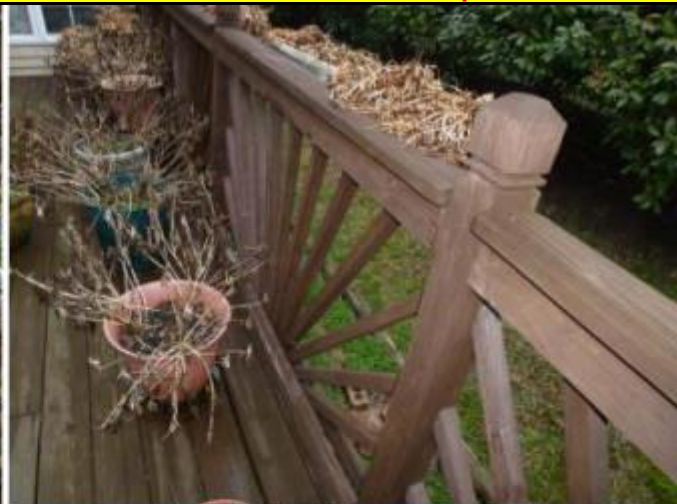
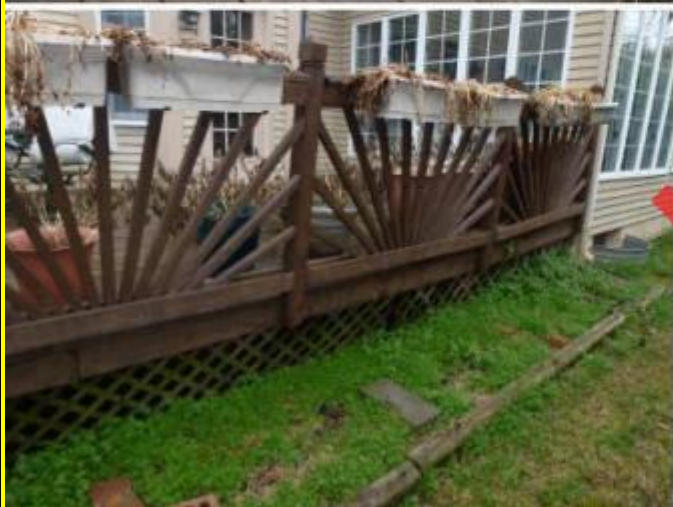
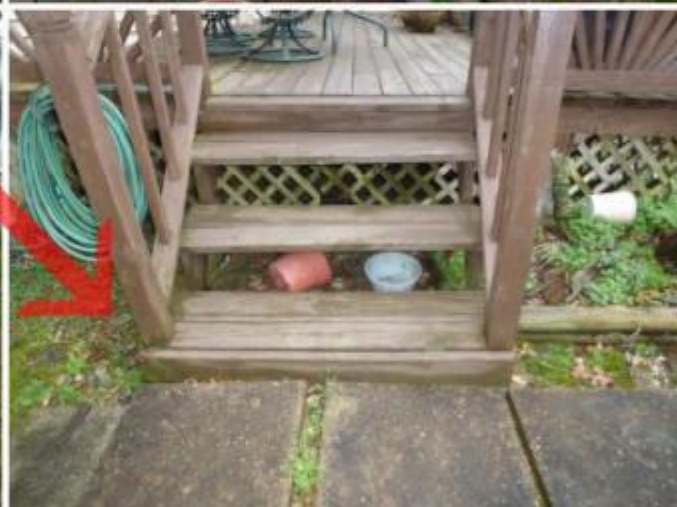
Improper conditions viewed, deck is sagging, handrail is loose, stairs have sunk.
Contact a licensed contractor for further evaluation and repairs as needed.

Maintain deck surface (pressure wash and seal annually)

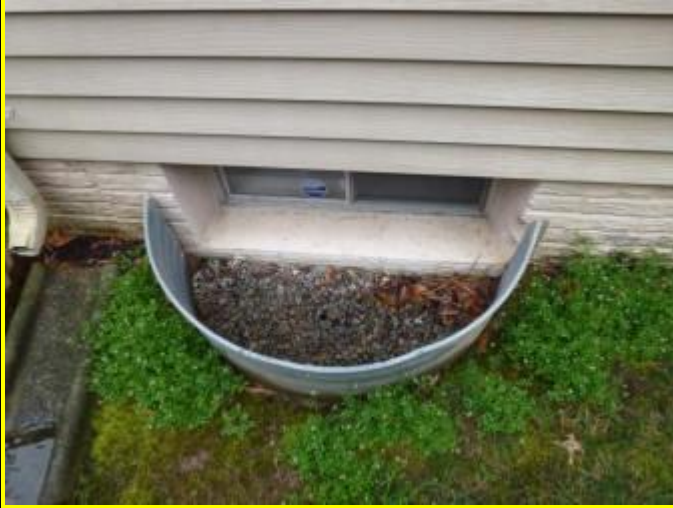
Consider installing a window well cover to prevent water intrusion.

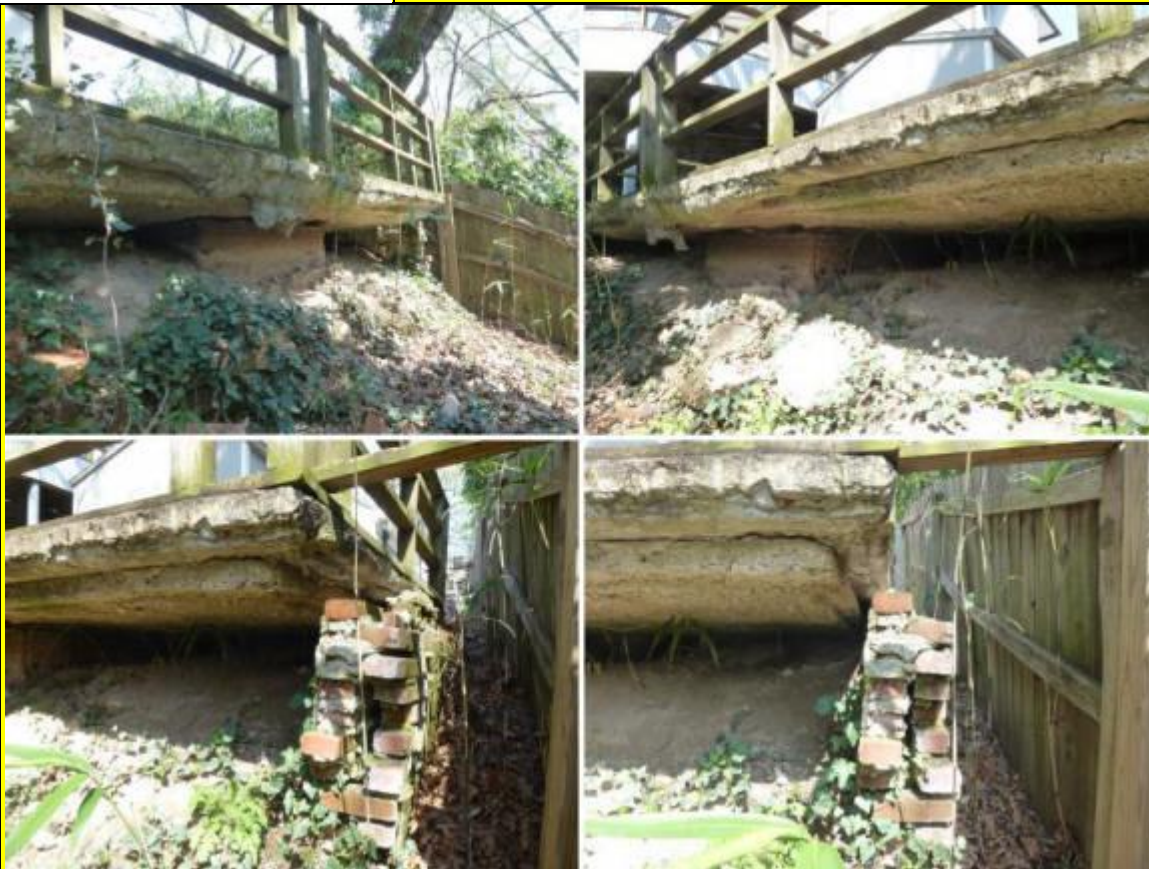
Damage/Displacement is noted, wall has collapsed. A structural engineer should be consulted.

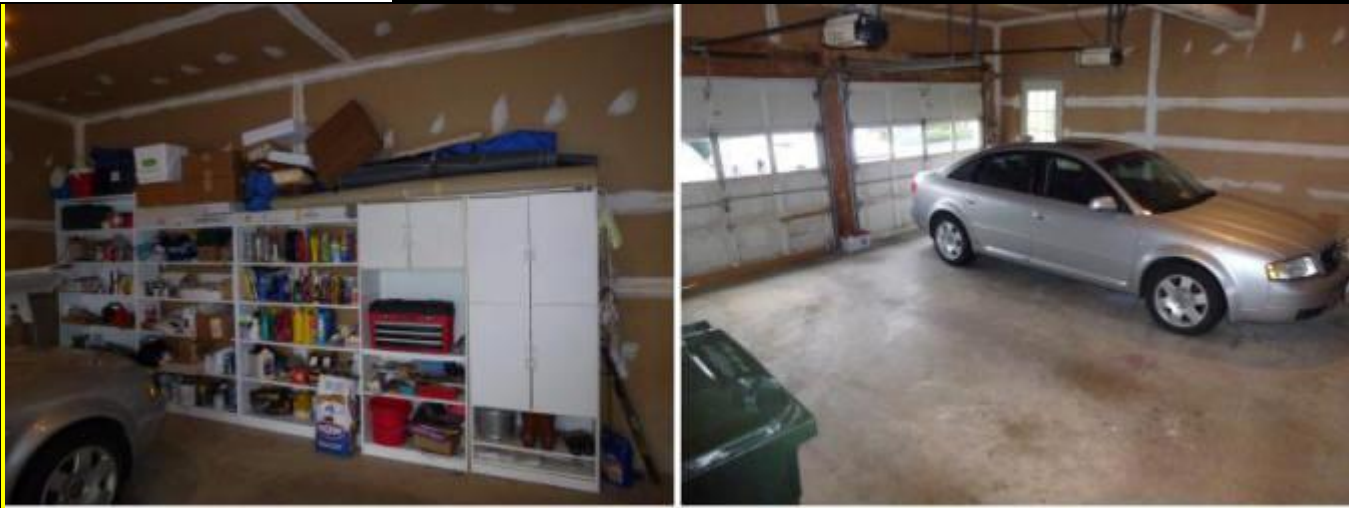
CONDITION: Appears serviceable, Typical cracks noted, Floor is not fully visible, due to stored items/cars.

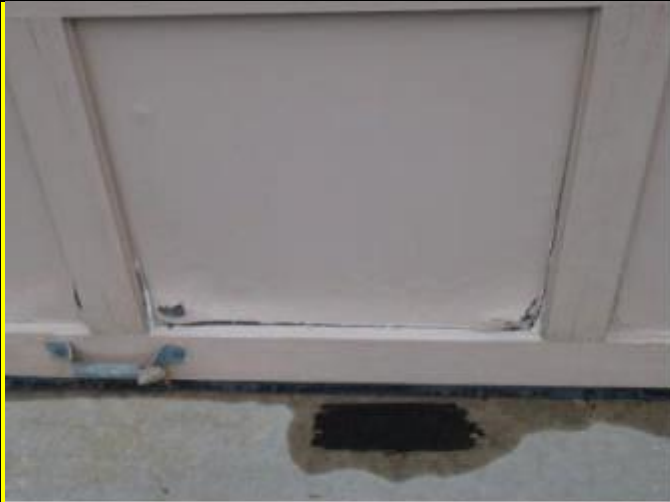
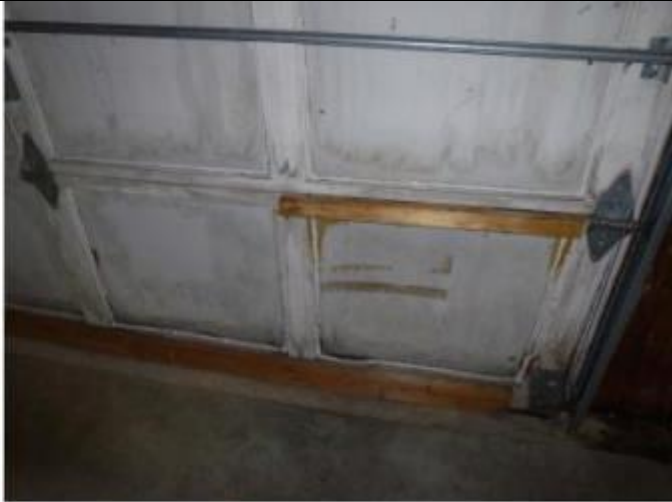
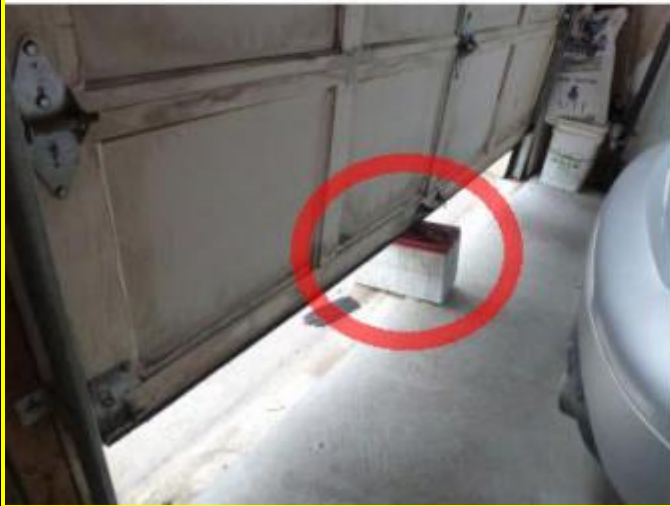
Soft spots/Rot and temporary repairs noted. The following problems were found at the automatic reverse feature: not operational at left door. Note: All overhead doors should have fully operational auto-reverse function.

Consider adding electronic sensors for safer operation of automatic reverse feature.

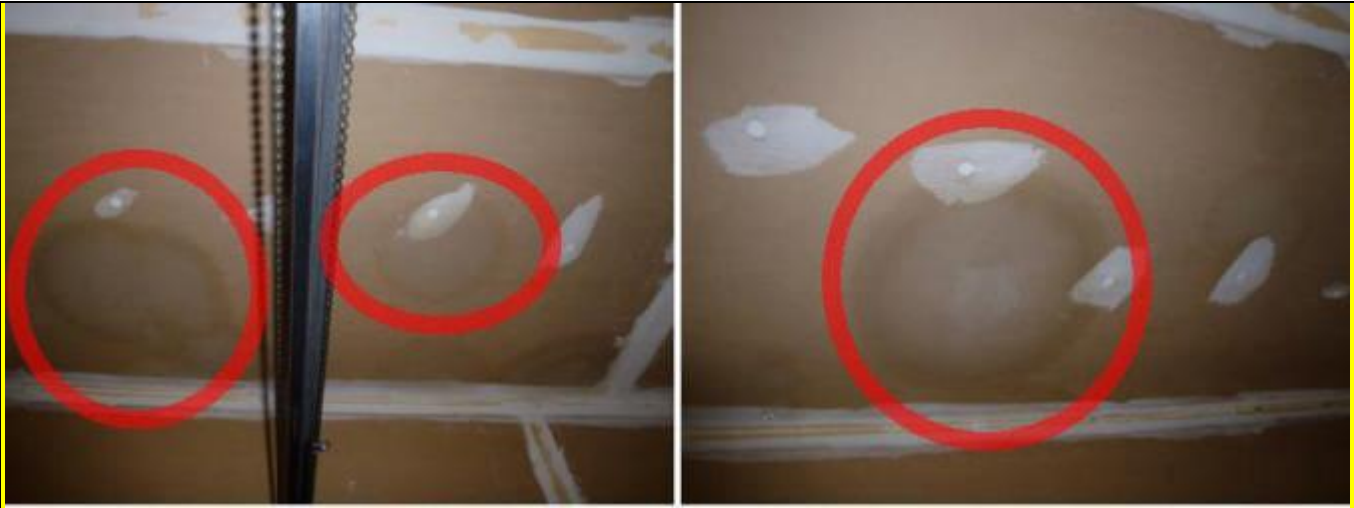
Stains noted at ceiling. Unable to determine if active leakage exists, not wet today, monitor in the future. Hidden damage may exist. Make inquiry with the seller as to the history of leaks.

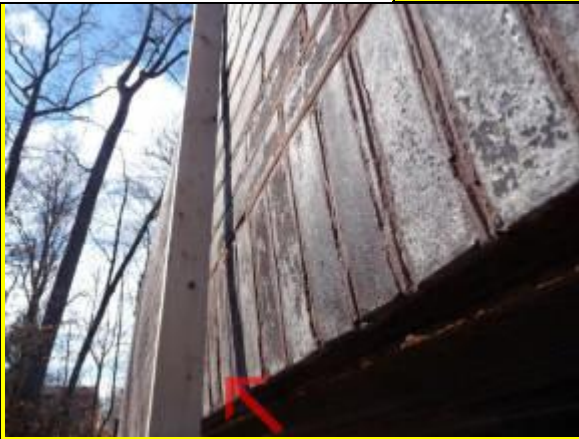
Bricks are bowed out above door, possible collapse, A licensed contractor should be called to make further evaluation and repairs as needed.

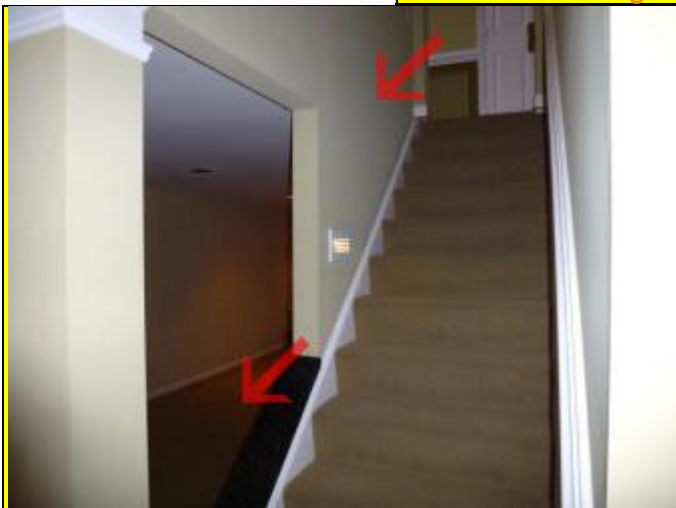
Viewing was restricted by wall coverings, Basement is finished, Stairs are serviceable, **Handrail is missing. Correction is recommended.**

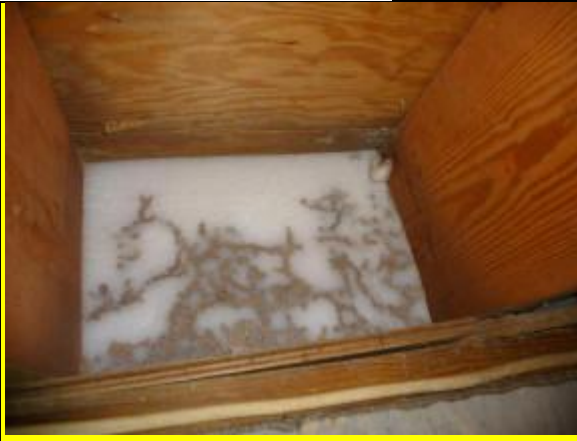
Signs of Wood Destroying Organisms in furnace room, consult a licensed Pest control company.

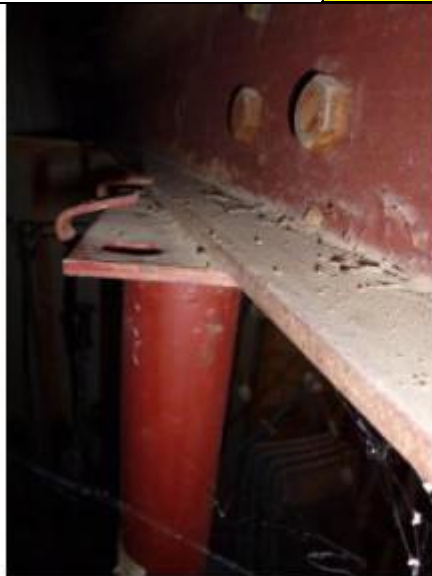
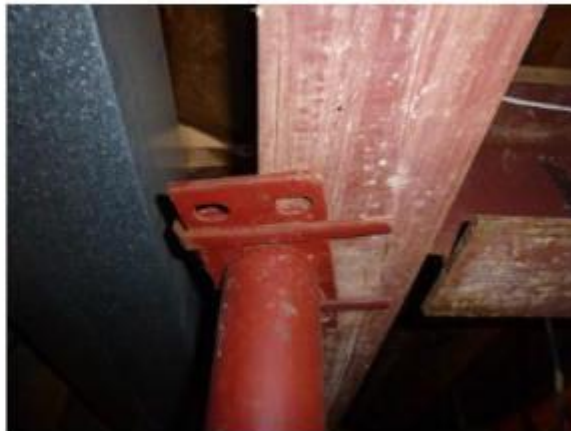
Metal, Post is not properly secured, Further evaluation and repair is needed by a foundation contractor.

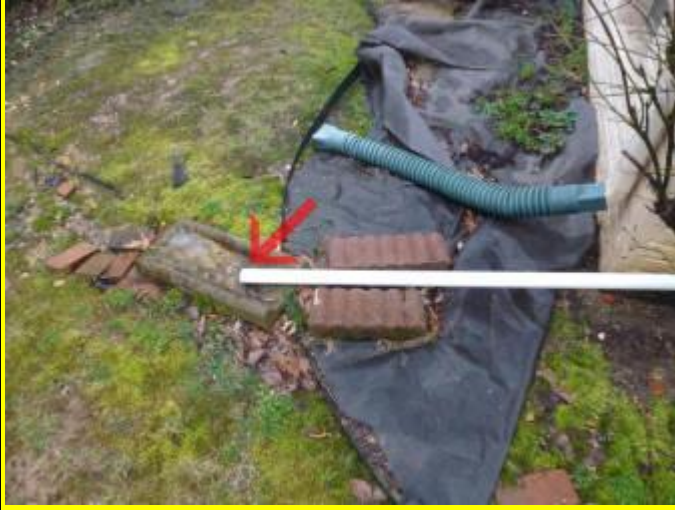
Slab appears serviceable but is not visible due to floor covering, Sump pump appears serviceable, A french drain is present. Adequacy of basement drainage system is not determined due to the underground nature of the system, **Consider extending sump pump drain line away from foundation.**

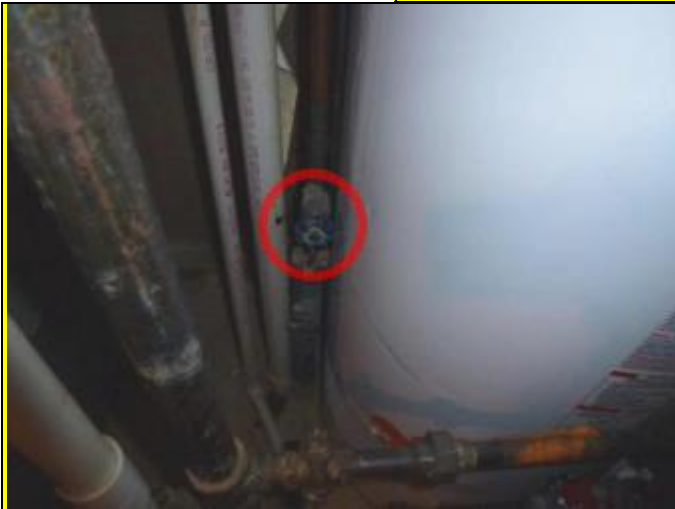
Copper, Basement, At water heater.

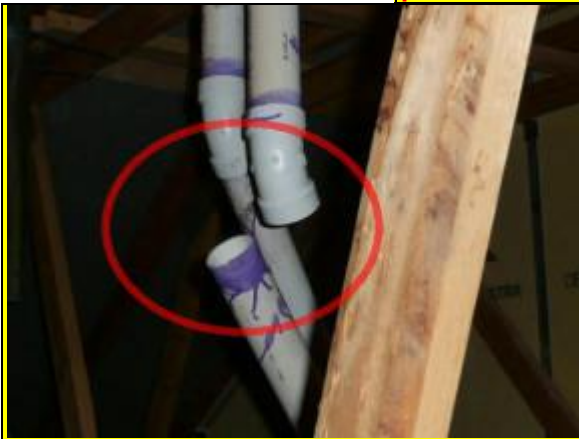
MATERIAL: PVC.
CONDITION: Appears serviceable, Lines not fully visible. **Vents are separated in attic, A licensed plumber should be called to make further evaluation and repairs as needed.**

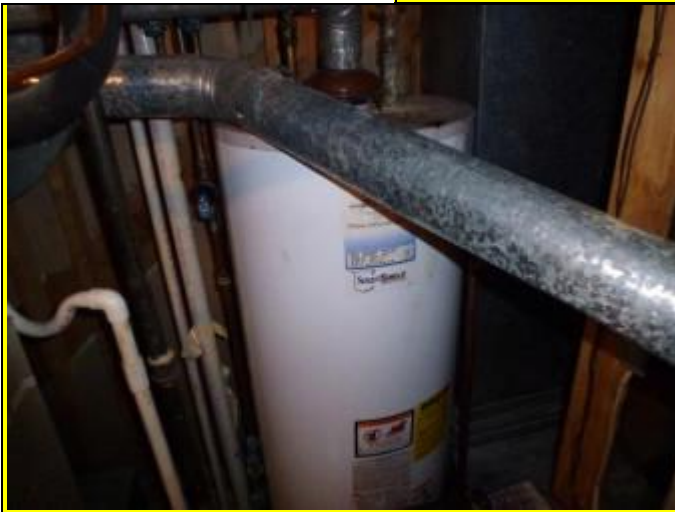
WATER HEATER #1:

TYPE - SIZE - LOCATION: Gas, 50 Gallons, Basement, **Access to the water heater is restricted.**

CONDITION: A water shutoff valve is installed, not tested/operated, Pressure relief valve noted, not tested
The following problems were noted at flue vent: Corrosion is noted at piping, not routed to the exterior, FIRE HAZARD!!! A licensed plumber should be called to make further evaluation and repairs as needed.

The following problems were noted at flue vent: Improper clearance to combustibles and corrosion is noted at piping. Backdrafting is noted, HAZARD CONDITIONS EXIST.

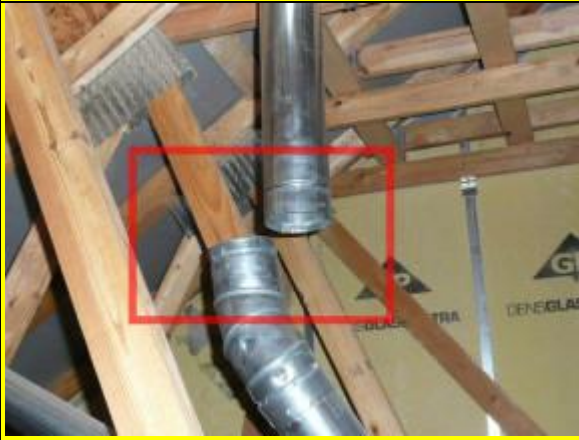
HEATING SYSTEM #1:

LOCATION :	Basement.
SYSTEM TYPE:	Forced Air.
FUEL TYPE & NOTES:	Natural Gas.
CAPACITY OF UNIT:	80,000 BTU.
APPROXIMATE AGE:	Older model - past the end of its useful life. 20+ years.
CONDITION OF UNIT:	System has been neglected, with no signs of recent servicing. Suggest cleaning/servicing.
BURNERS/HEAT EXCHANGERS:	Burner Flame(s) appear typical, The heat exchanger portion of a gas or oil fired heater is difficult to access without disassembly, and cannot be adequately checked during a visual inspection. We recommend a service contract be placed on the unit and a heating contractor called to verify the condition of the heat exchanger prior to settlement date.
PUMP/BLOWER FAN:	System lacks cleaning. Fan compartment is dirty.
COMBUSTION AIR:	Appears serviceable.
VENTING:	The following problems were noted at flue vent: disconnected in the attic. Contact a licensed heating contractor for further evaluation and repairs as needed.

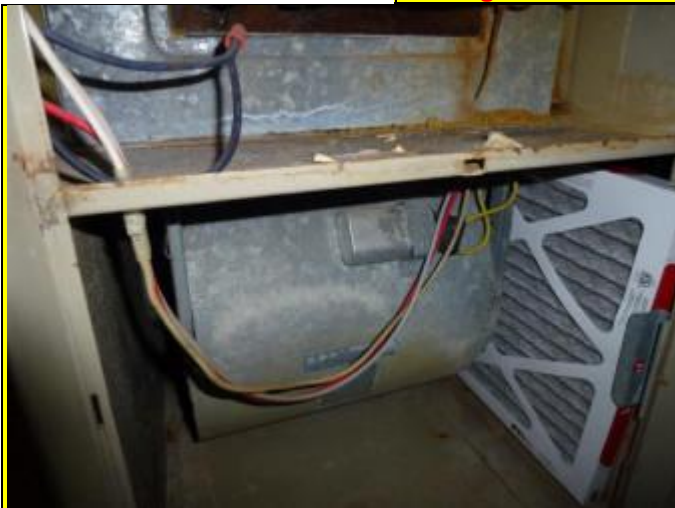
Basement.
Forced Air.
Natural Gas.
56,000 BTU.
Older model - past the end of its useful life. 20+ years.
System has been neglected, with no signs of recent servicing. Suggest cleaning/servicing.
Blower door interlock is missing/not working properly. Contact a licensed heating contractor for further evaluation and repairs as needed.

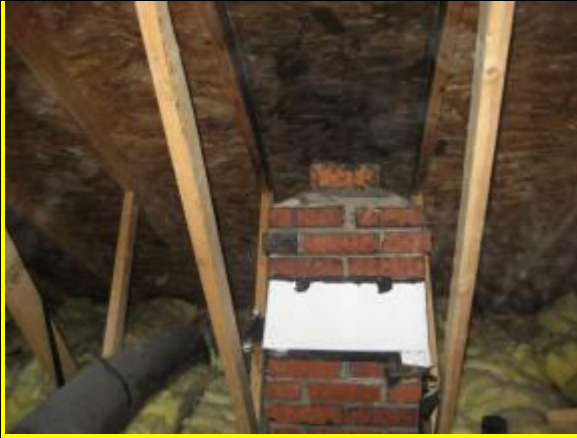
The following problems were noted at flue vent: Improperly terminated in the attic instead of penetrating the roof, FIRE HAZARD!!! Contact a licensed heating contractor for further evaluation and repairs as needed.

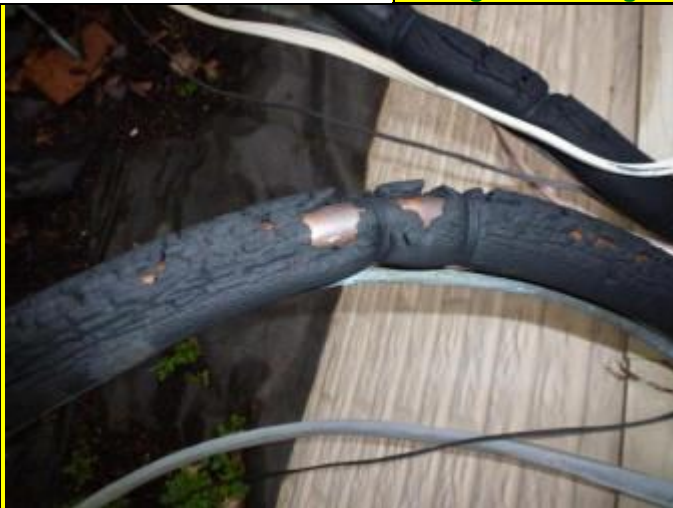
AIR CONDITIONING #1:

LOCATION :	Right side of house.
TYPE & CONDITION:	Condensing (outdoor) unit, Outside air temperature was below 65 degrees. Unable to test system at this time.
	The following problems were noted at the compressor/outdoor unit: Insulation is damaged / missing on refrigerant line.

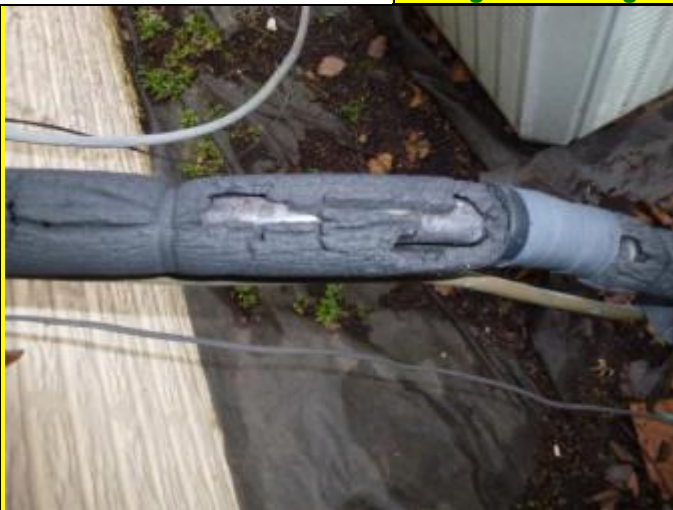
AIR CONDITIONING #2:

Right side of house.
Condensing (outdoor) unit, Outside air temperature was below 65 degrees. Unable to test system at this time.
The following problems were noted at the compressor/outdoor unit: Insulation is damaged / missing on refrigerant line.
