**123 Main St
Fairfax, VA 22310**

**Prepared by
House Inspection Associates LLC
VA/MD/DC: 703 453-0442
www.HouseInspectionAssociates.com**

January 1, 2012

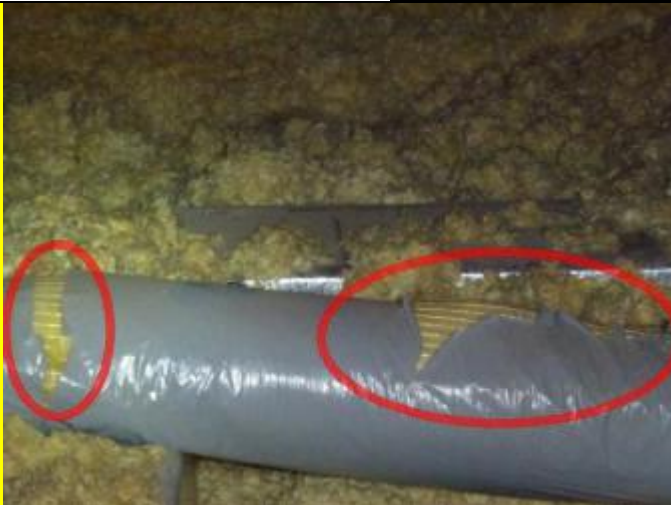
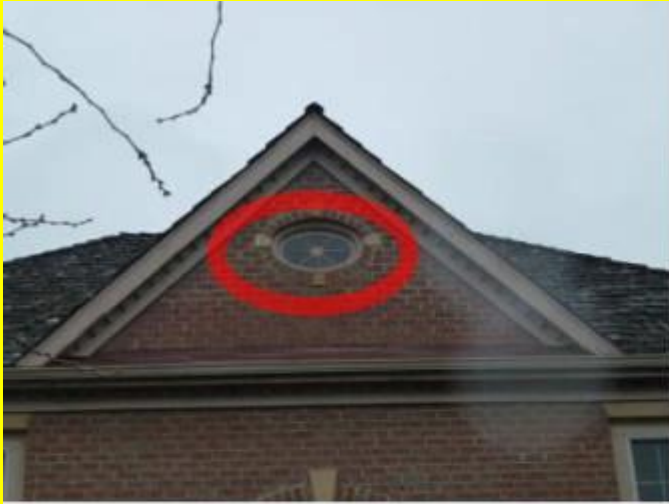
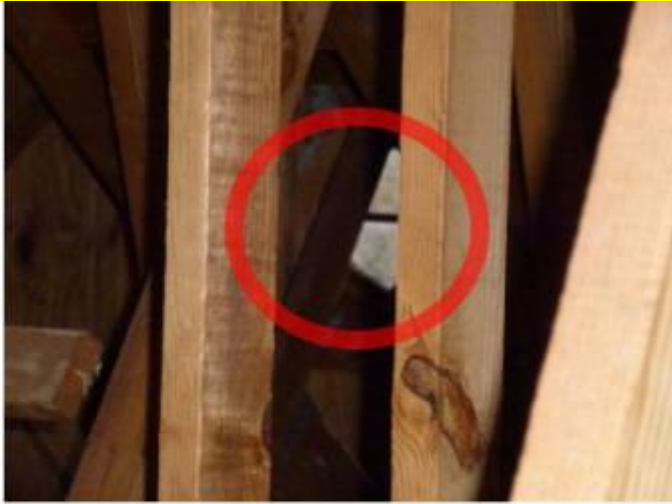
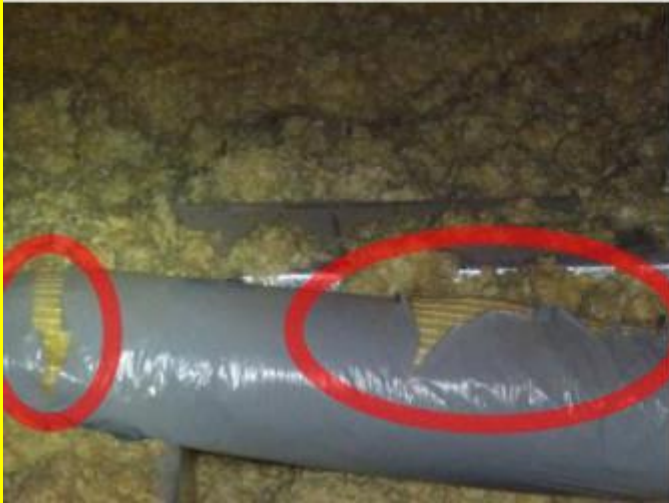
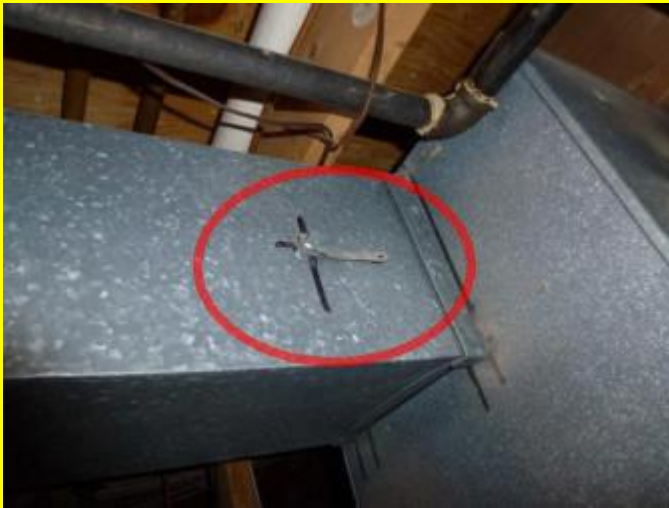
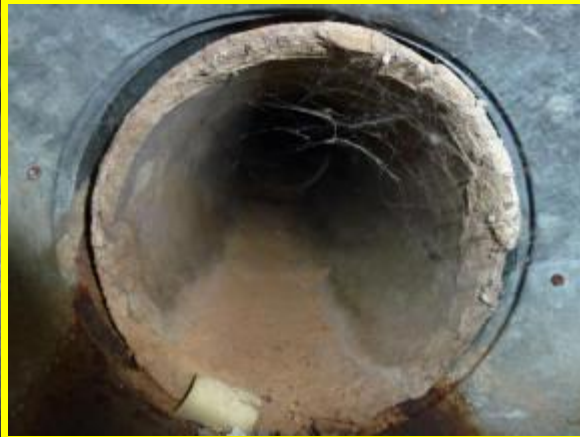
DUCTWORK:

TYPE:	Sheet metal, Flexible Round. Ducts are installed beneath concrete slab floor.
CONDITION:	Ducts appear dirty. Suggest cleaning, Vapor barrier at flexible round ductwork is loose/deteriorated in the attic.
	Flexible ducts should not be exposed to direct sunlight. UV rays can damage the vapor barrier. Consider covering windows in the attic.
	Ask HVAC contractor to mark dampers "winter" and "summer", in order to better balance air flow during different seasons.
	ASBESTOS-LIKE material noted! Possible health hazard. Evaluation by a licensed remediation contractor is recommended.

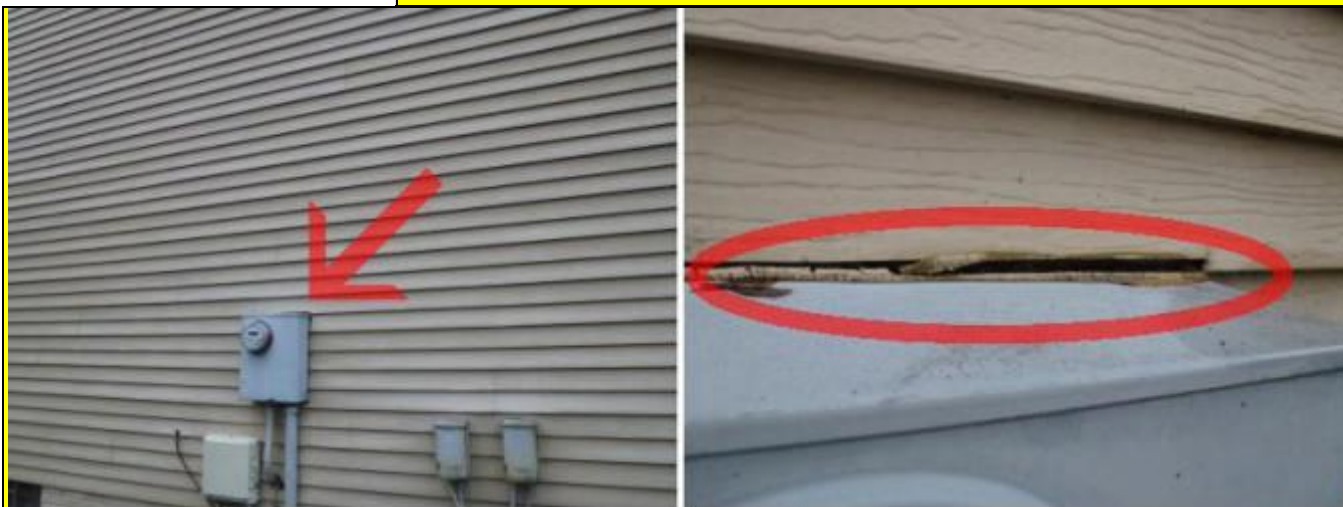
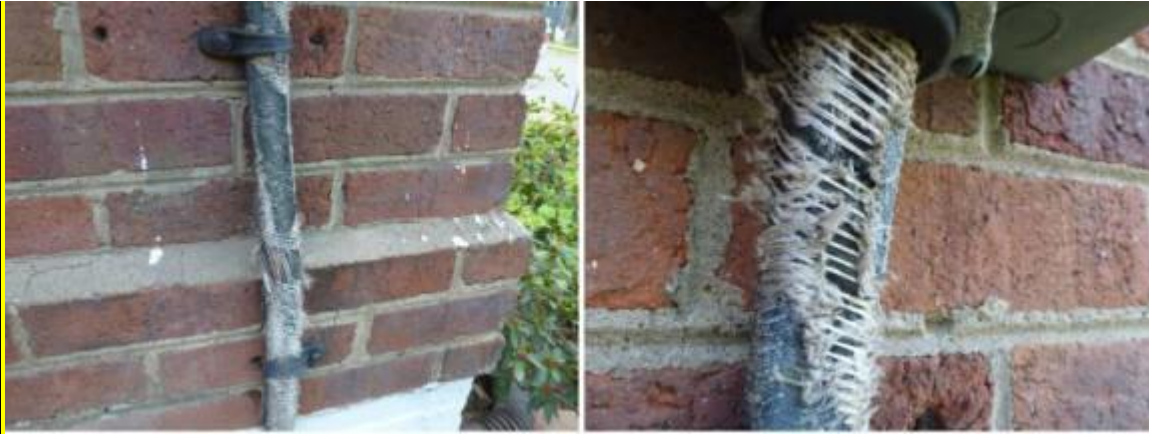
The following problems were noted at the SE cable: Service Entry cable is deteriorated/worn, Have a licensed electrician make further evaluation and corrections as needed.

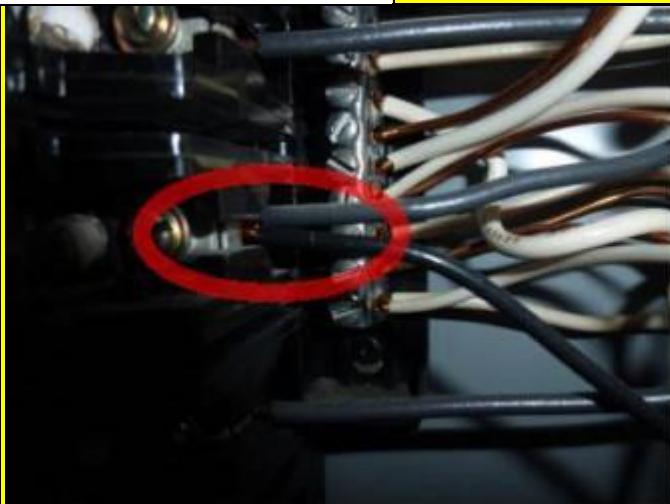
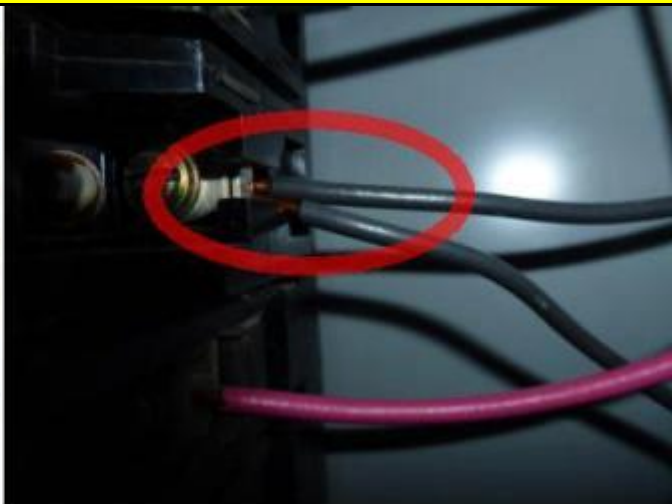
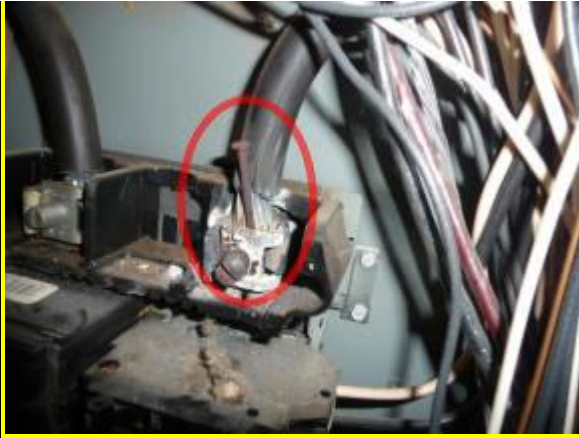
Multiple wires are connected to a single lug on a circuit breaker where only one wire should be connected, Have a licensed electrician make further evaluation and corrections as needed.

Nails are inserted at the SE cable. Potential fire hazard. Have a licensed electrician make further evaluation and corrections as needed.

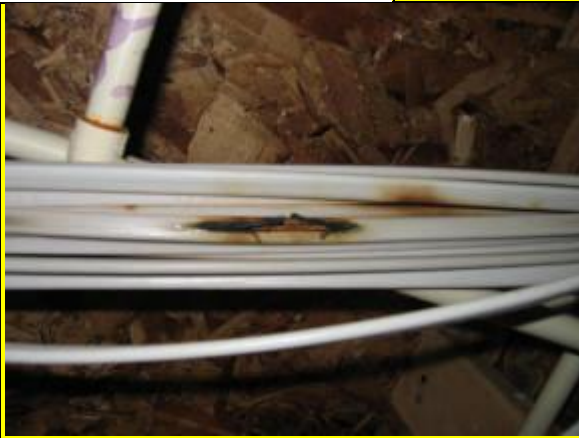
Melting wires noted in basement. Have a licensed electrician make further evaluation and corrections as needed.

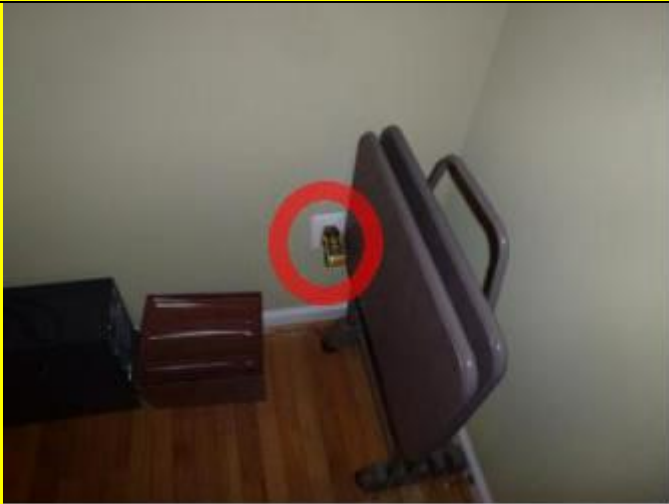
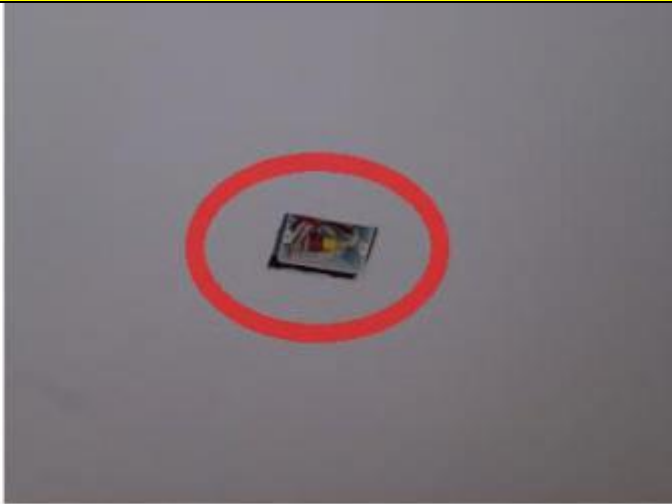
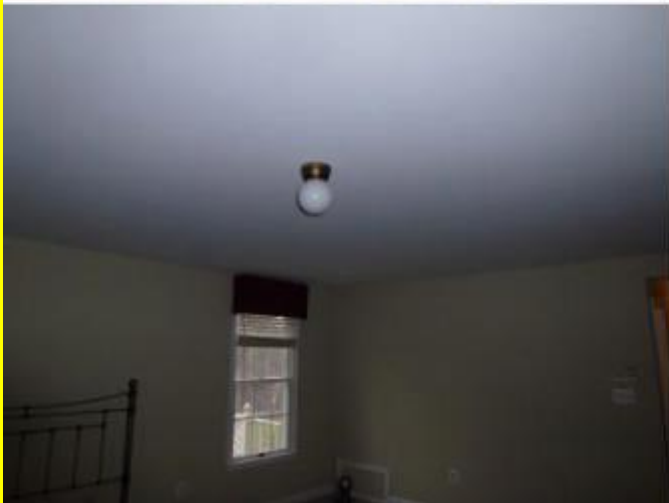
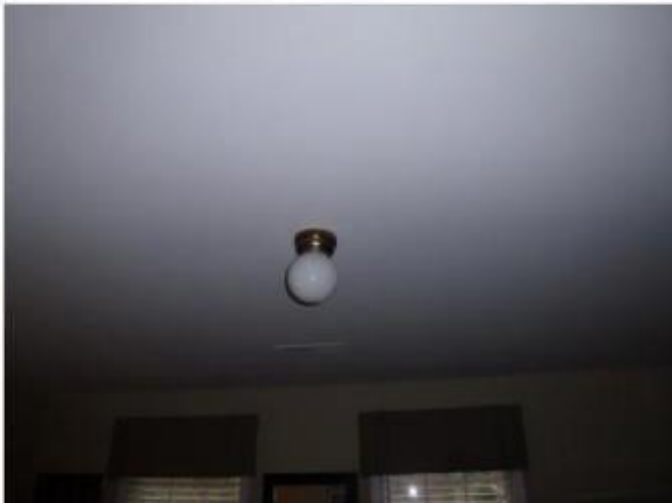
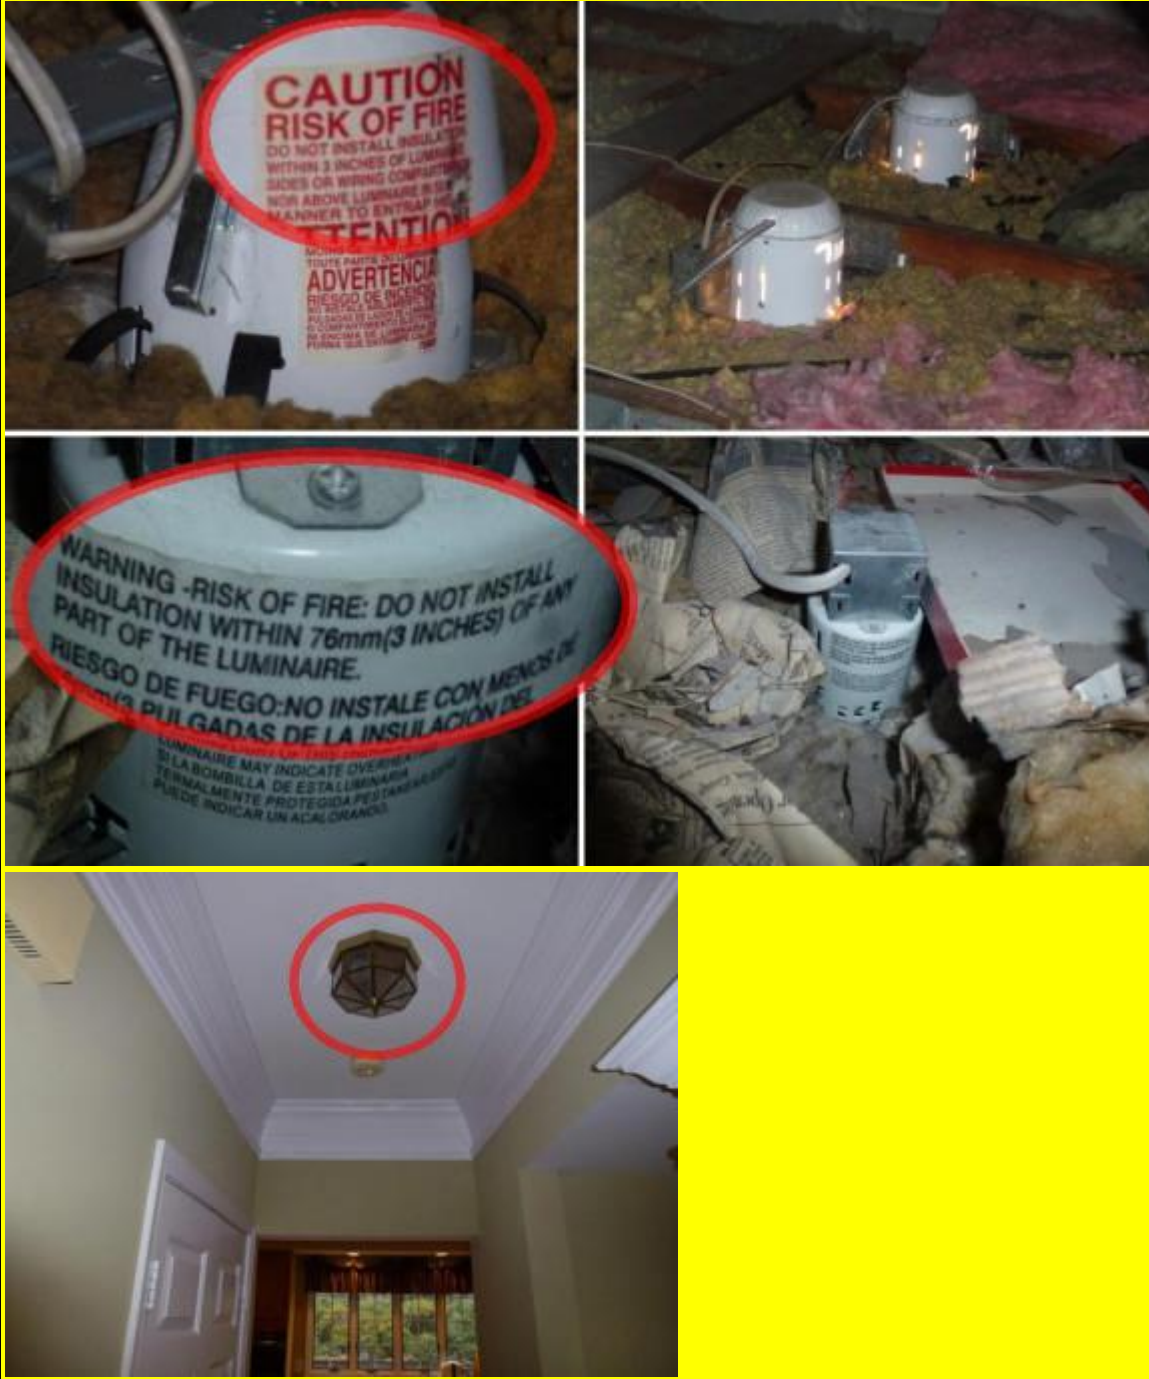
DEFECTS:

Reverse polarity is noted at garage door in kitchen. Junction box cover/s or light fixture missing in kitchen. Light/s not operational, possibly due to burned out / missing bulbs in MBR and front bedroom. Have a licensed electrician make further evaluation and corrections as needed.

Recessed lights in the attic do not appear to be designed to be in direct contact with insulation or any combustible materials.

Light/s not operational, possibly due to burned out / missing bulbs in hallway on main level.

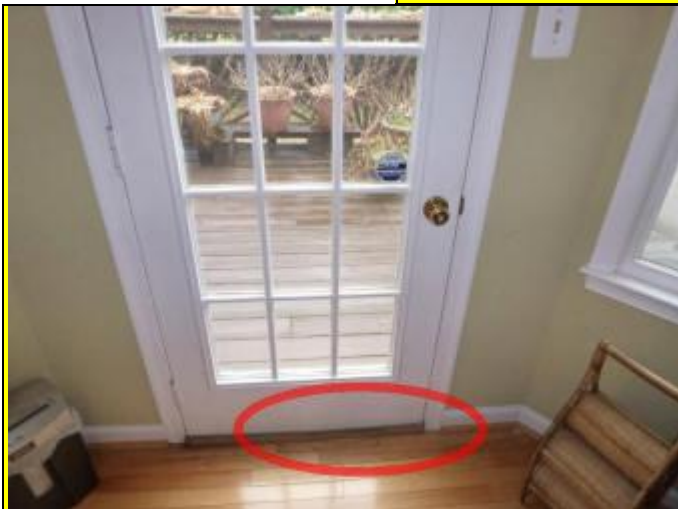
Doors rub/stick at deck.

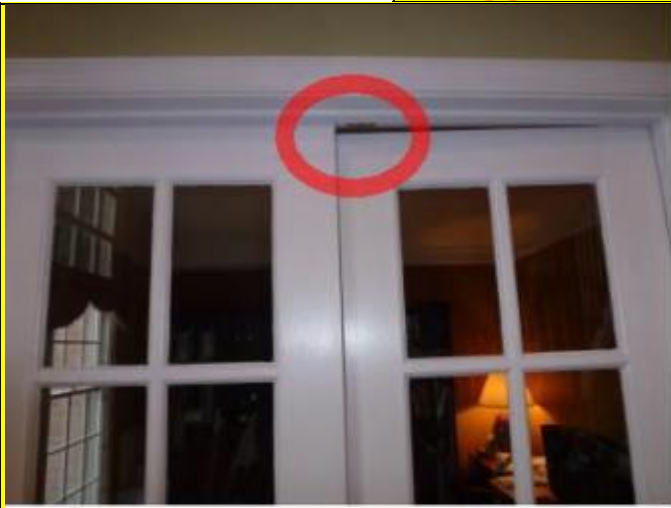
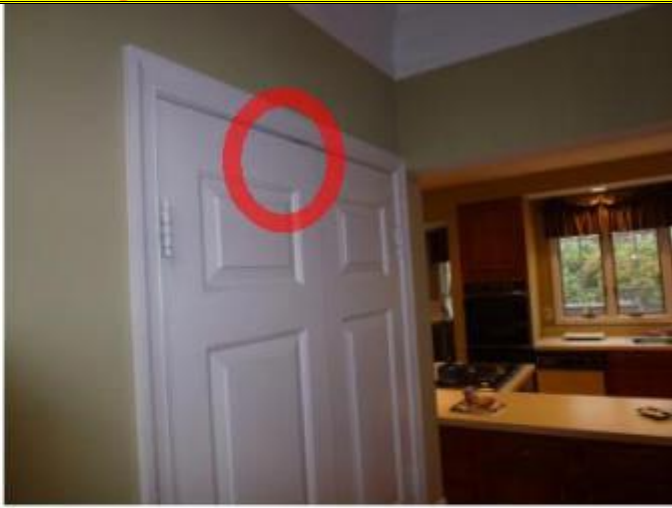
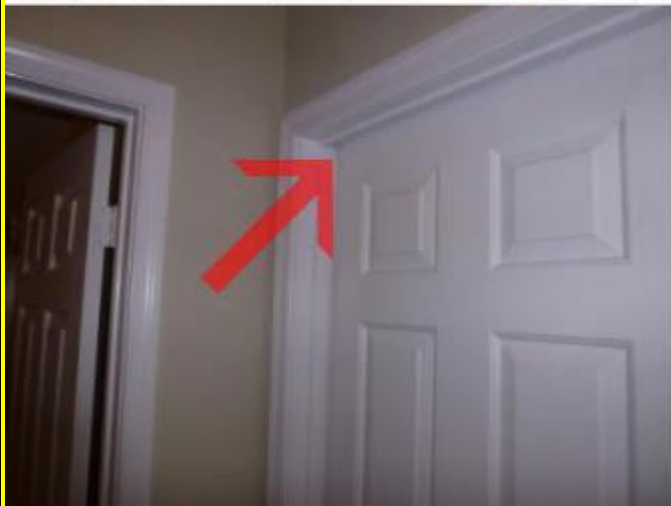
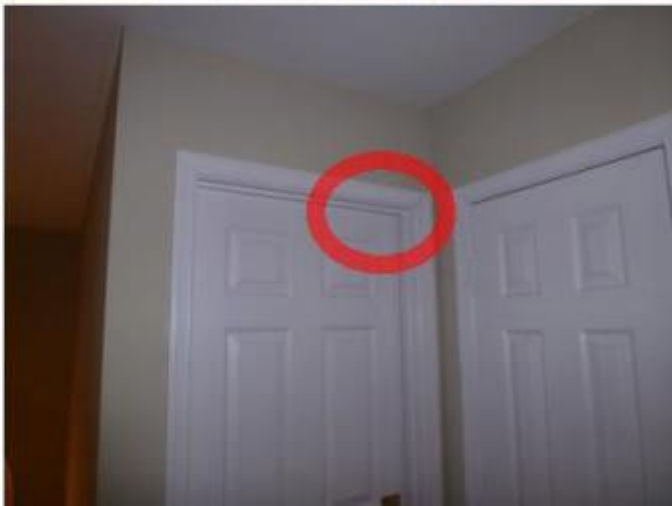
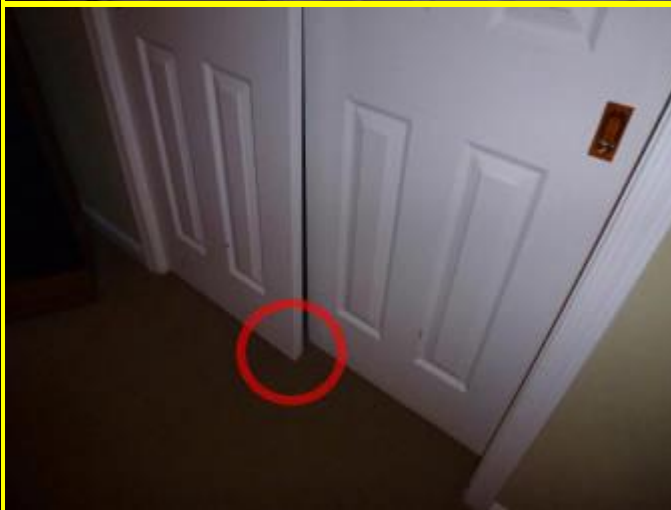
INTERIOR DOORS:

Appears serviceable, Doors don't latch at office and hallway closet on main level.
Doors rub/stick at front bedrooms.

Missing guide is noted at sliding doors in basement.

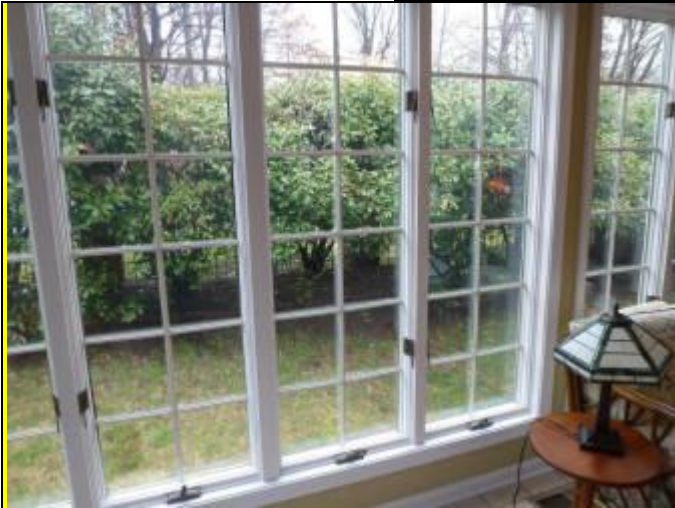
A representative sampling was taken. Windows as a grouping are generally operational. **Missing screen/s noted in sunroom.**

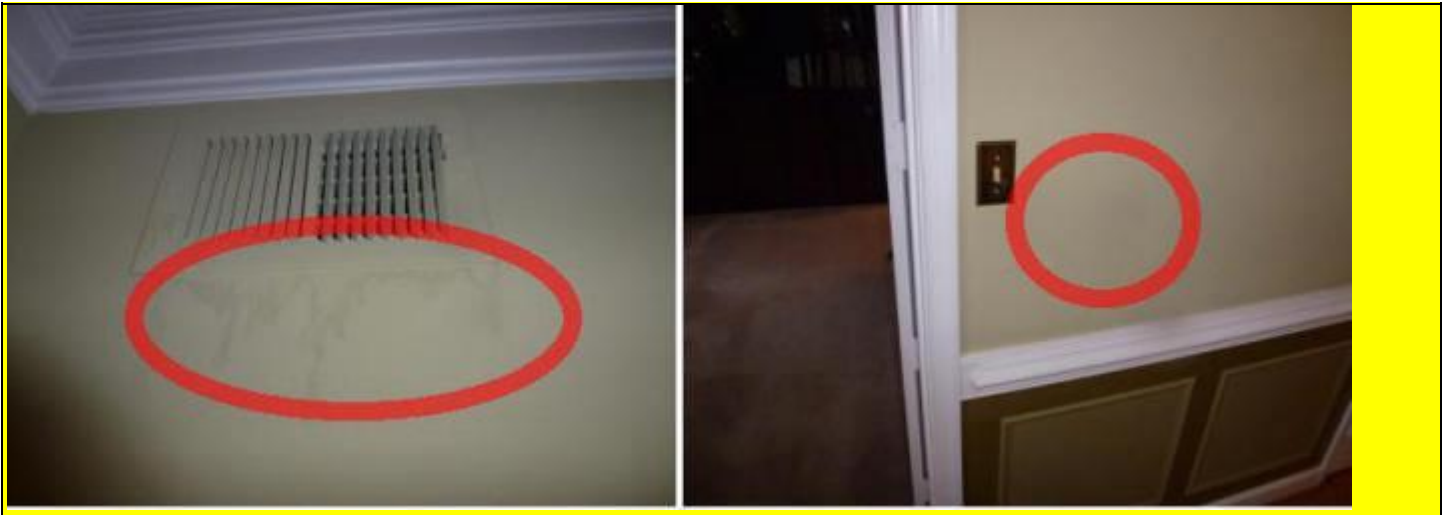
General condition appears serviceable, Stored items or furnishings prevent full inspection, Typical cracks noted
Stains noted in foyer. Unable to determine if active leakage exists, not wet today, monitor in the future. Hidden damage may exist. Make inquiry with the seller as to the history of leaks.

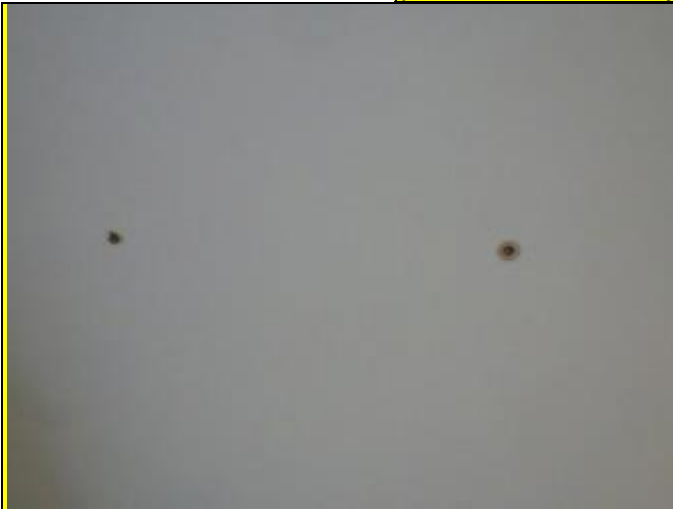
General condition appears serviceable, Typical cracks noted, Nail pops noted (nail head protrudes outside of drywall)

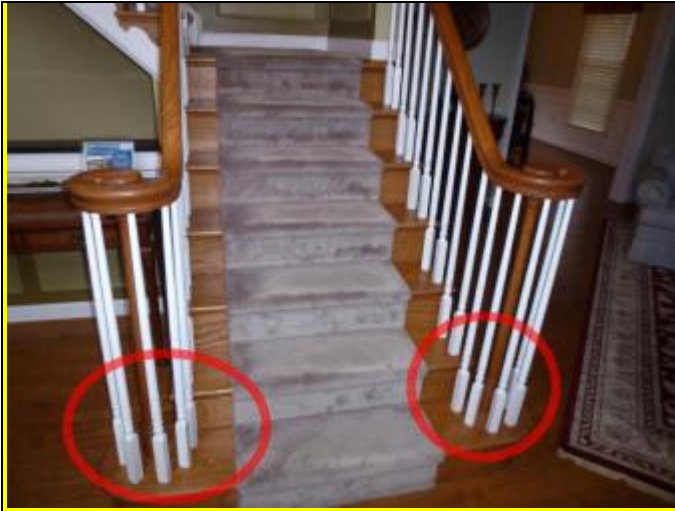
Stairs are serviceable, **The following problems were noted at the handrail: loose in foyer.**

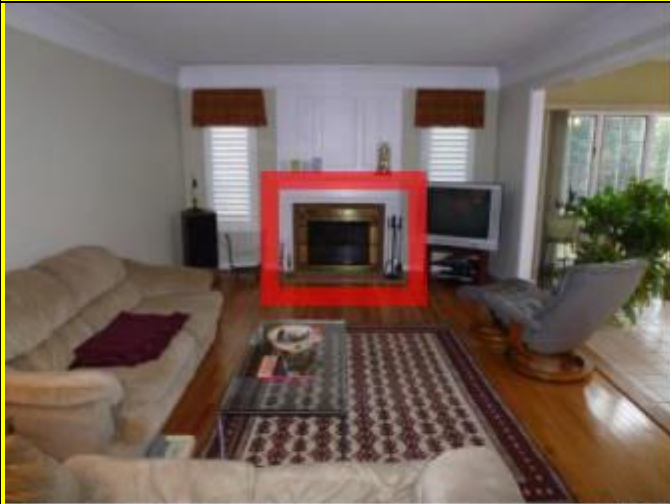
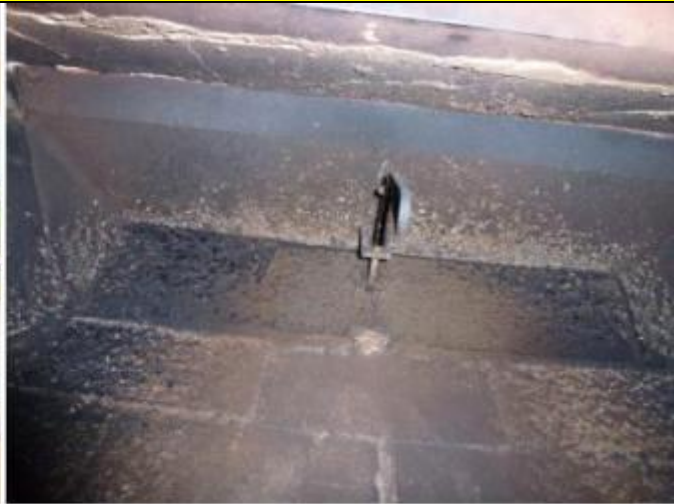
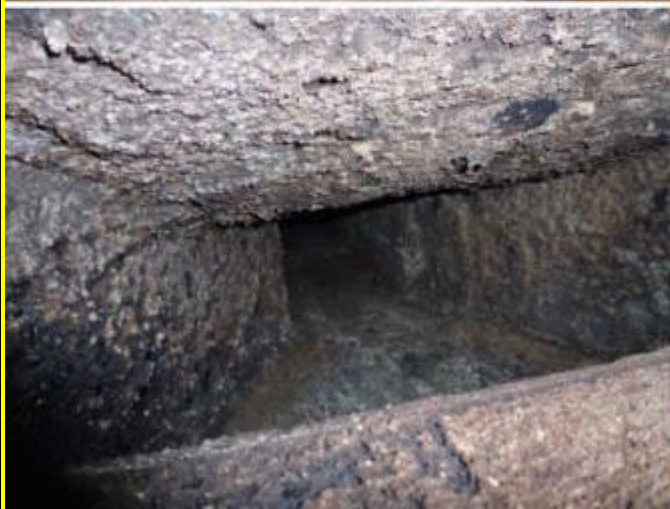
Masonry, Appears serviceable, THE INTERIORS OF FLUES AND CHIMNEYS CAN NOT BE ADEQUATELY CHECKED DURING A VISUAL INSPECTION AND ARE NOT PART OF THIS INSPECTION, Mortar joints appear serviceable, Damper is operational
Recommend cleaning and inspection. As a rule of thumb, chimney should be swept after burning 2 - 3 cords of wood.

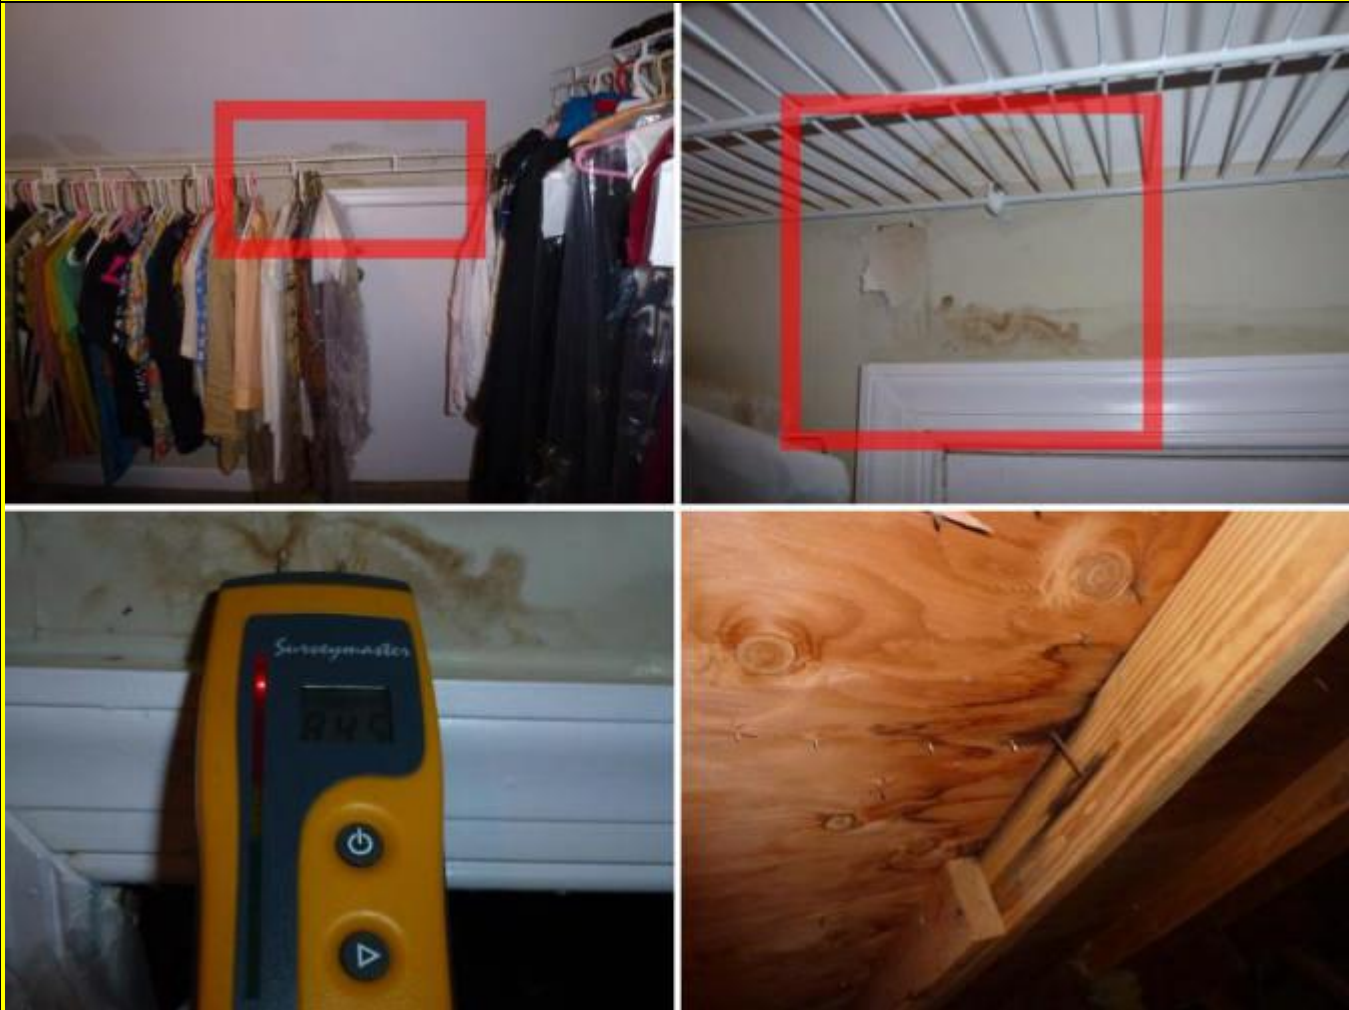
Attic is full size, Truss framing, Accessible, Attic appears serviceable
Active leak is noted at attic door in MBR closet and main attic, A licensed roofing contractor should be called to make further evaluation and repairs as needed.
Truss/rafter/s cracked and repaired; however, unable to determine if the repairs have been performed correctly. Ask seller for documentation of this repair, A licensed structural engineer/architect should be called to make further evaluation and repairs as needed, including proper drawings.

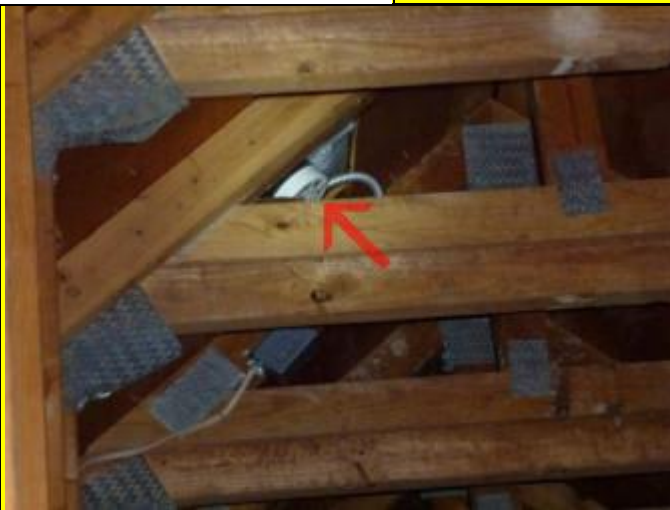
Ventilation is provided, Attic fan is installed, not tested. controls / thermostat was difficult to reach or the temperature was too low for the thermostat to activate.

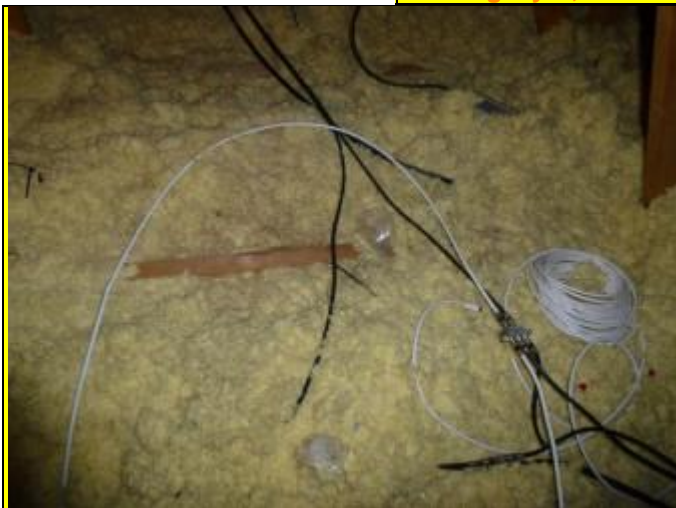
Fiberglass- Blown, Insulation is installed between floor joists, 10-15 inches, **Insulation has been disturbed and good coverage is no longer present.**

Insulation is installed upside down/backwards. Vapor barrier should be installed toward conditioned space. If another layer of insulation is added on top of existing layer, unfaced insulation should be used.

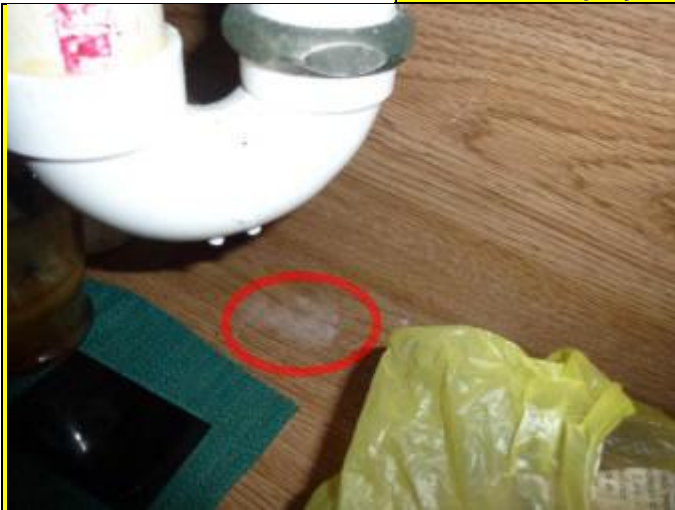
Appears serviceable, Drain appears serviceable. **Stains noted under the sink. Unable to determine if active leakage exists, not wet today. Hidden damage may exist. Make inquiry with the seller as to the history of leaks.**

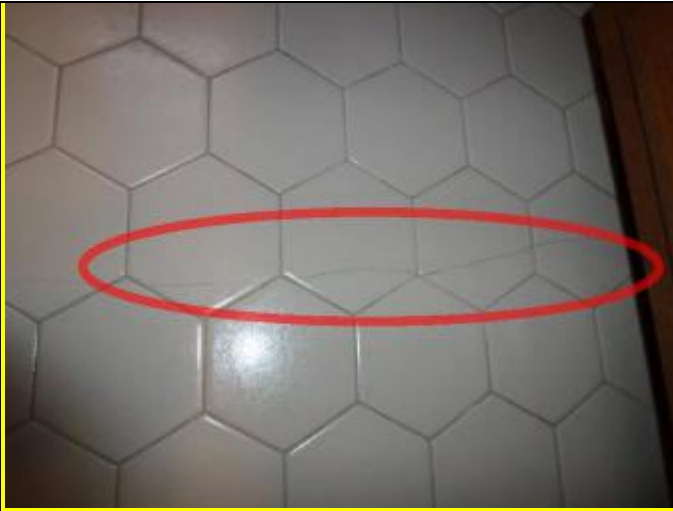
The following problems were noted at the toilet: loose at floor, a new wax seal should be installed under loose toilets, Have a licensed plumber make proper repairs as needed.

Consider installing an exhaust fan to provide additional ventilation.
The following problems were noted at the floor: tile/s are cracked.

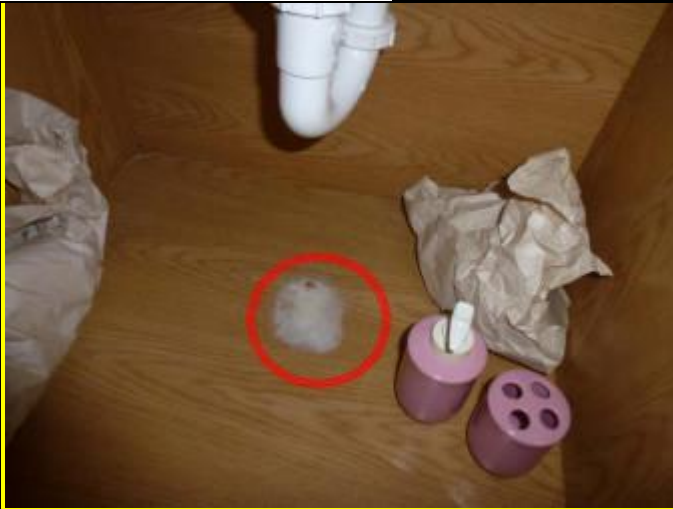
Appears serviceable, Drain appears serviceable, **Stains noted under the sink. Unable to determine if active leakage exists, not wet today. Hidden damage may exist. Make inquiry with the seller as to the history of leaks.**

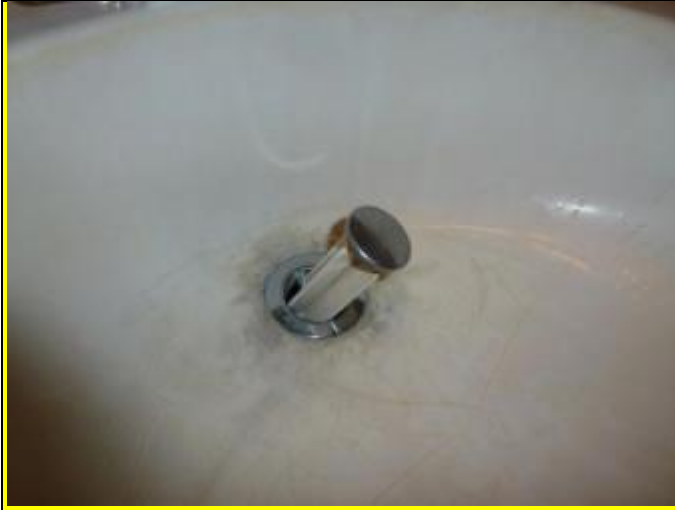
Appears serviceable, Drain appears serviceable, Viewing below sink area is restricted.
The following problems were noted at the drain: Stopper did not operate properly at right sink.

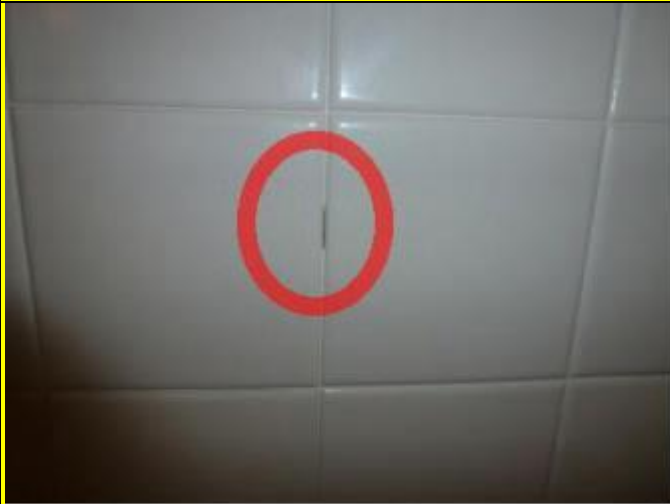
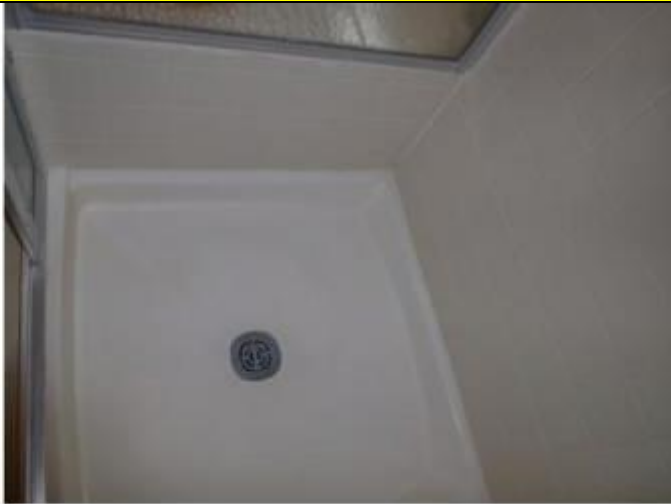
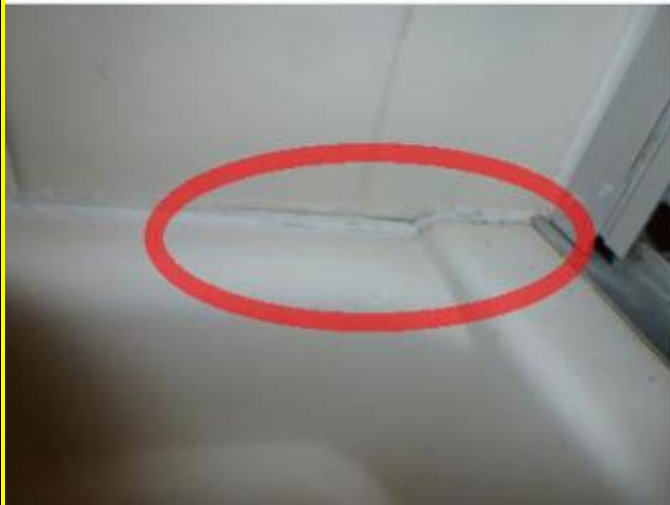
Shower walls appear serviceable, Enclosure appears serviceable, **Grout is missing/deteriorated - re-grouting is needed to prevent water intrusion, Caulk and seal all tub and shower areas including at plumbing fixtures as a precaution.**

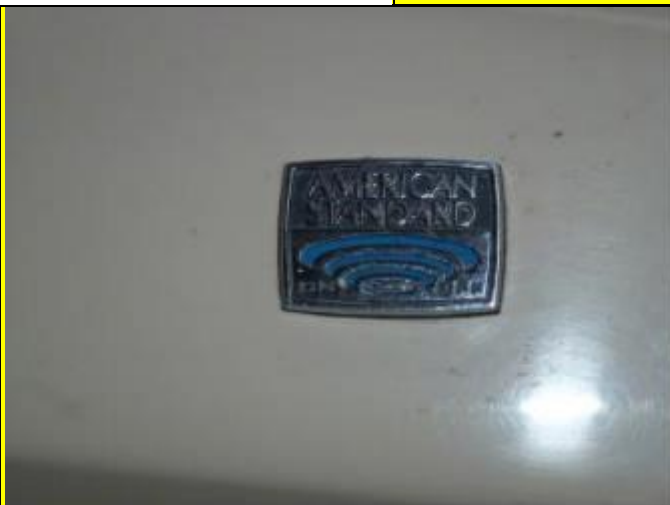
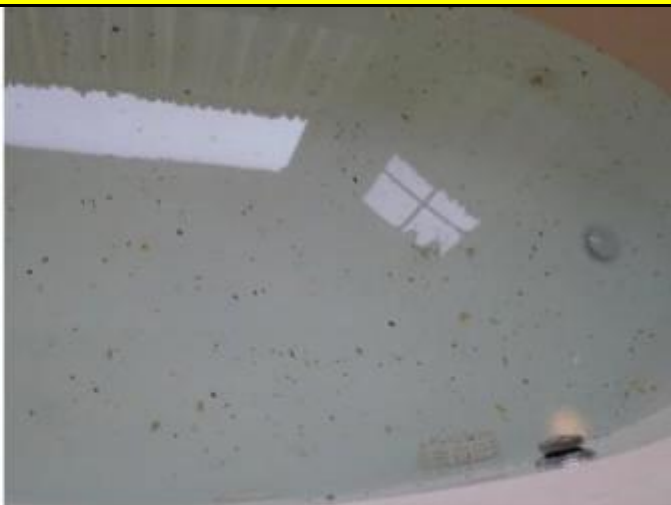
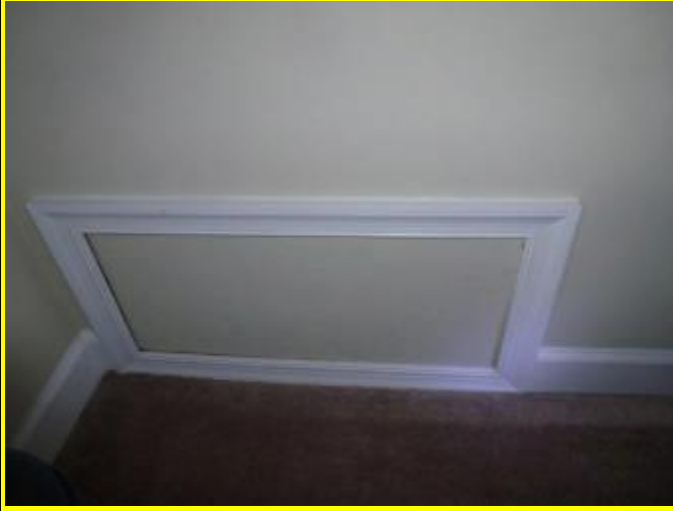
Did not respond to controls properly, stopped several times while running. Clean jets, hoses and pipes. Have a licensed plumber make proper repairs as needed.

Unable to inspect electrical wiring, motor & hoses because access door is sealed shut.

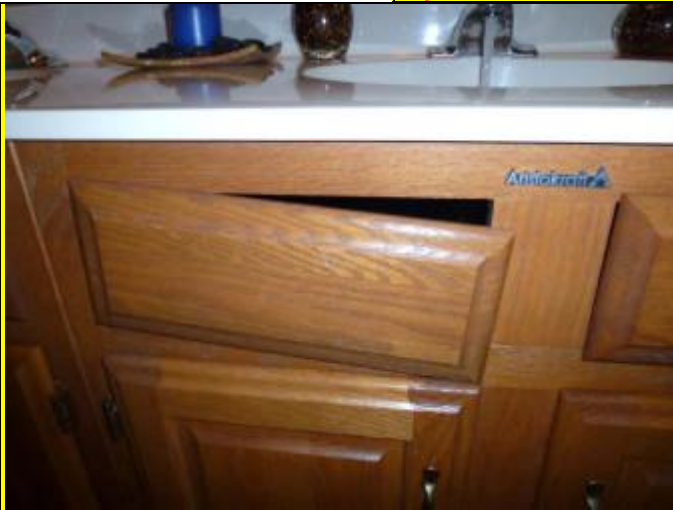
Appears serviceable, Drain appears serviceable, Viewing below sink area is restricted.
The following problems were noted: vanity is damaged.

The following problems were noted at the drain: An improper S-trap drain line is installed. A licensed plumber should be called to make further evaluation and repairs as needed.

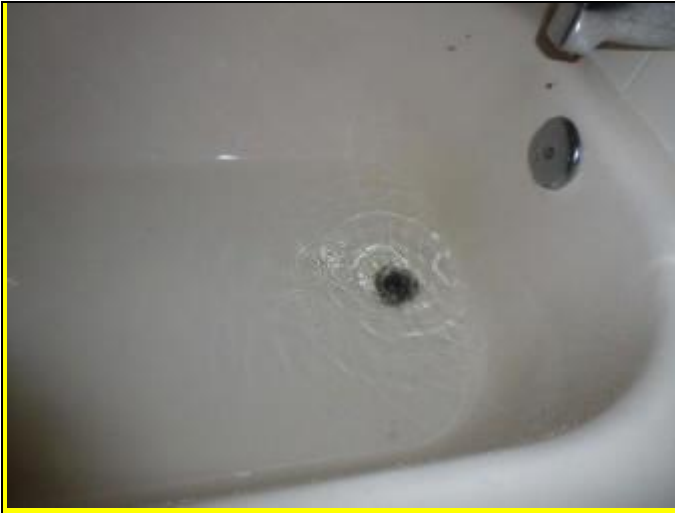
Appears serviceable, **The following problems were noted at the drain: drain is slow at tub.**

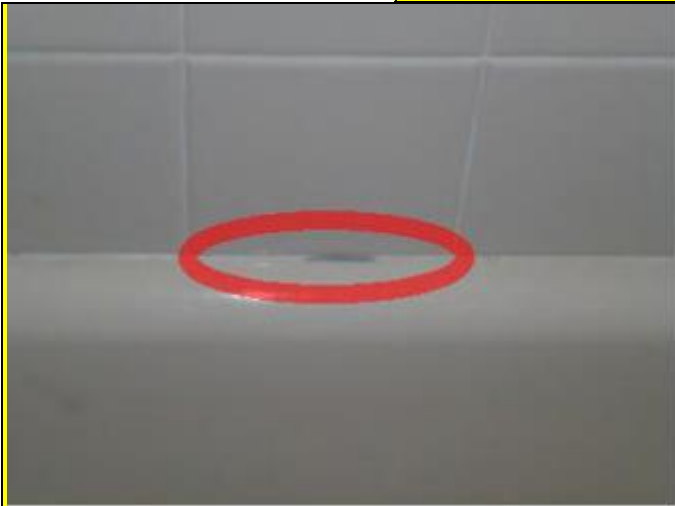
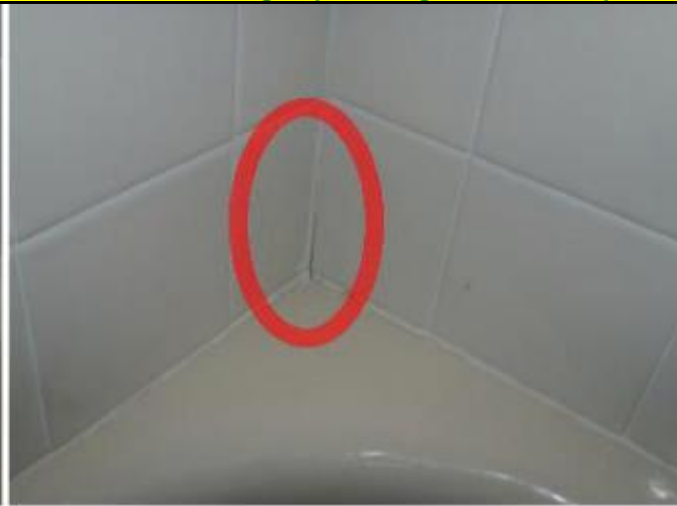
Tub and shower areas appear serviceable, Shower walls appear serviceable, **Caulk and seal all tub and shower areas including at plumbing fixtures as a precaution.**

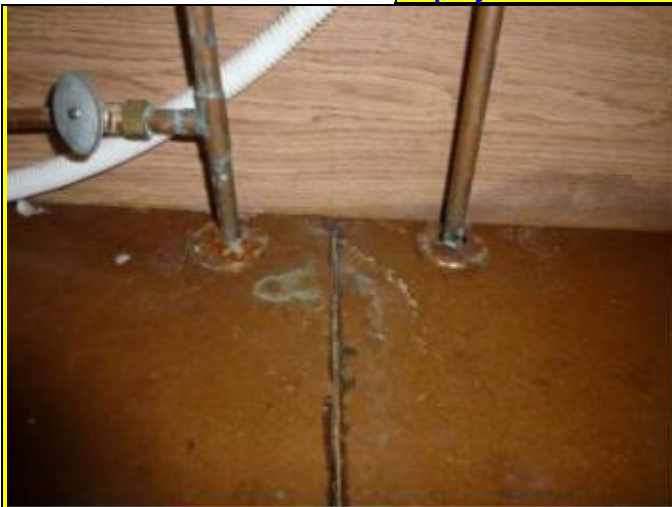
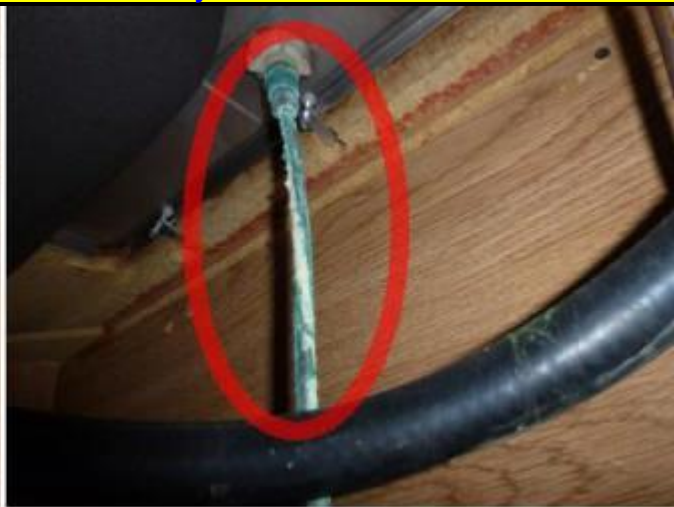
Appears serviceable, Faucet is serviceable, Drain appears serviceable, Viewing below the sink is restricted by stored items, **Stains noted under the sink. Unable to determine if active leakage exists, not wet today. Hidden damage may exist. Make inquiry with the seller as to the history of leaks.**

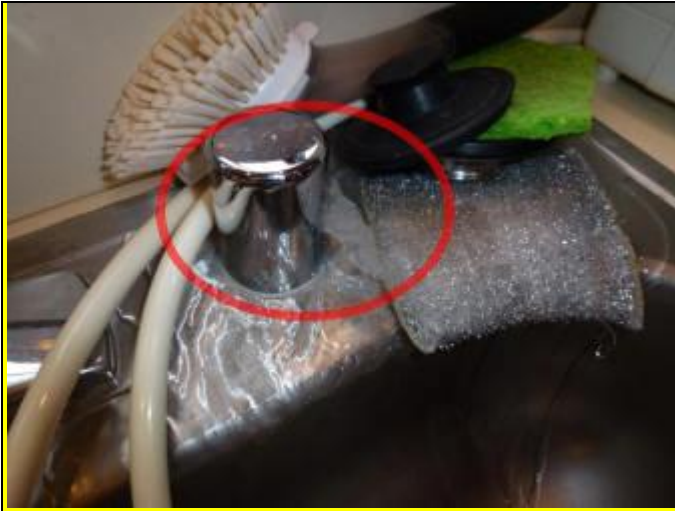
CONDITION:	Older model appliance. Unit is near the end of its useful life.
	The following problems were noted at the air gap: The air gap is clogged and water is being discharged at top of sink, A licensed plumber should be called to make further evaluation and repairs as needed.

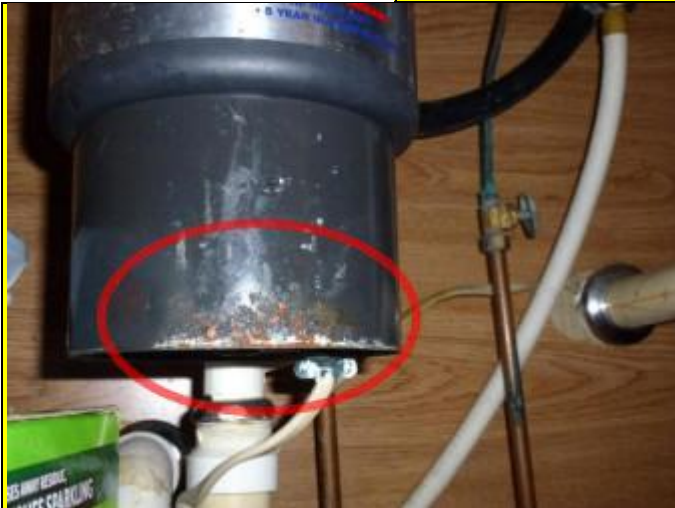
Unit is an older model. Unit is near the end of its useful life. Rusting is noted on body of the disposal.

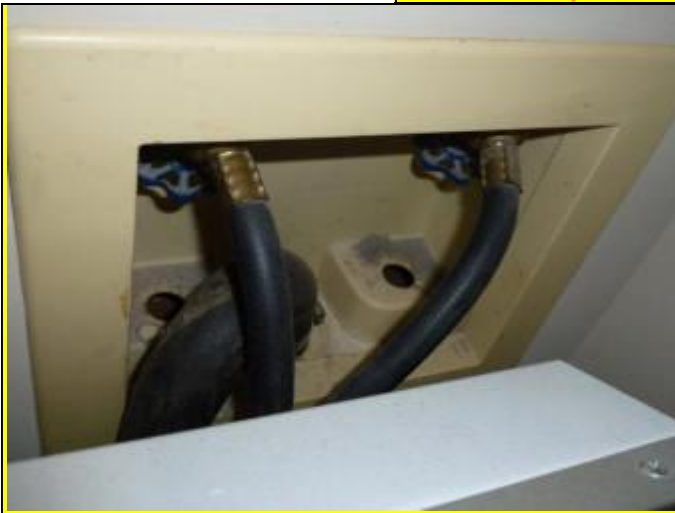
WASHER: Washing machine is an older model. Unit is nearing the end of its useful life, Consider installing burst-proof supply hoses. Our recommendation is to check hoses frequently and replace them every 3-5 years as part of a proactive maintenance plan.
